ASBESTOS SURVEY REPORT

PTB 196-032
Asbestos Survey for Building Demolition (I-80)
554 Shelby Street, Joliet, Illinois
Region One/District One

Asbestos Survey Report
PTB 198-003
FAI-80 (I-80) over Des Plaines River Bridge
Job N. D-91-204-19
554 Shelby Street, Joliet, IL
Parcel No. 1P10190

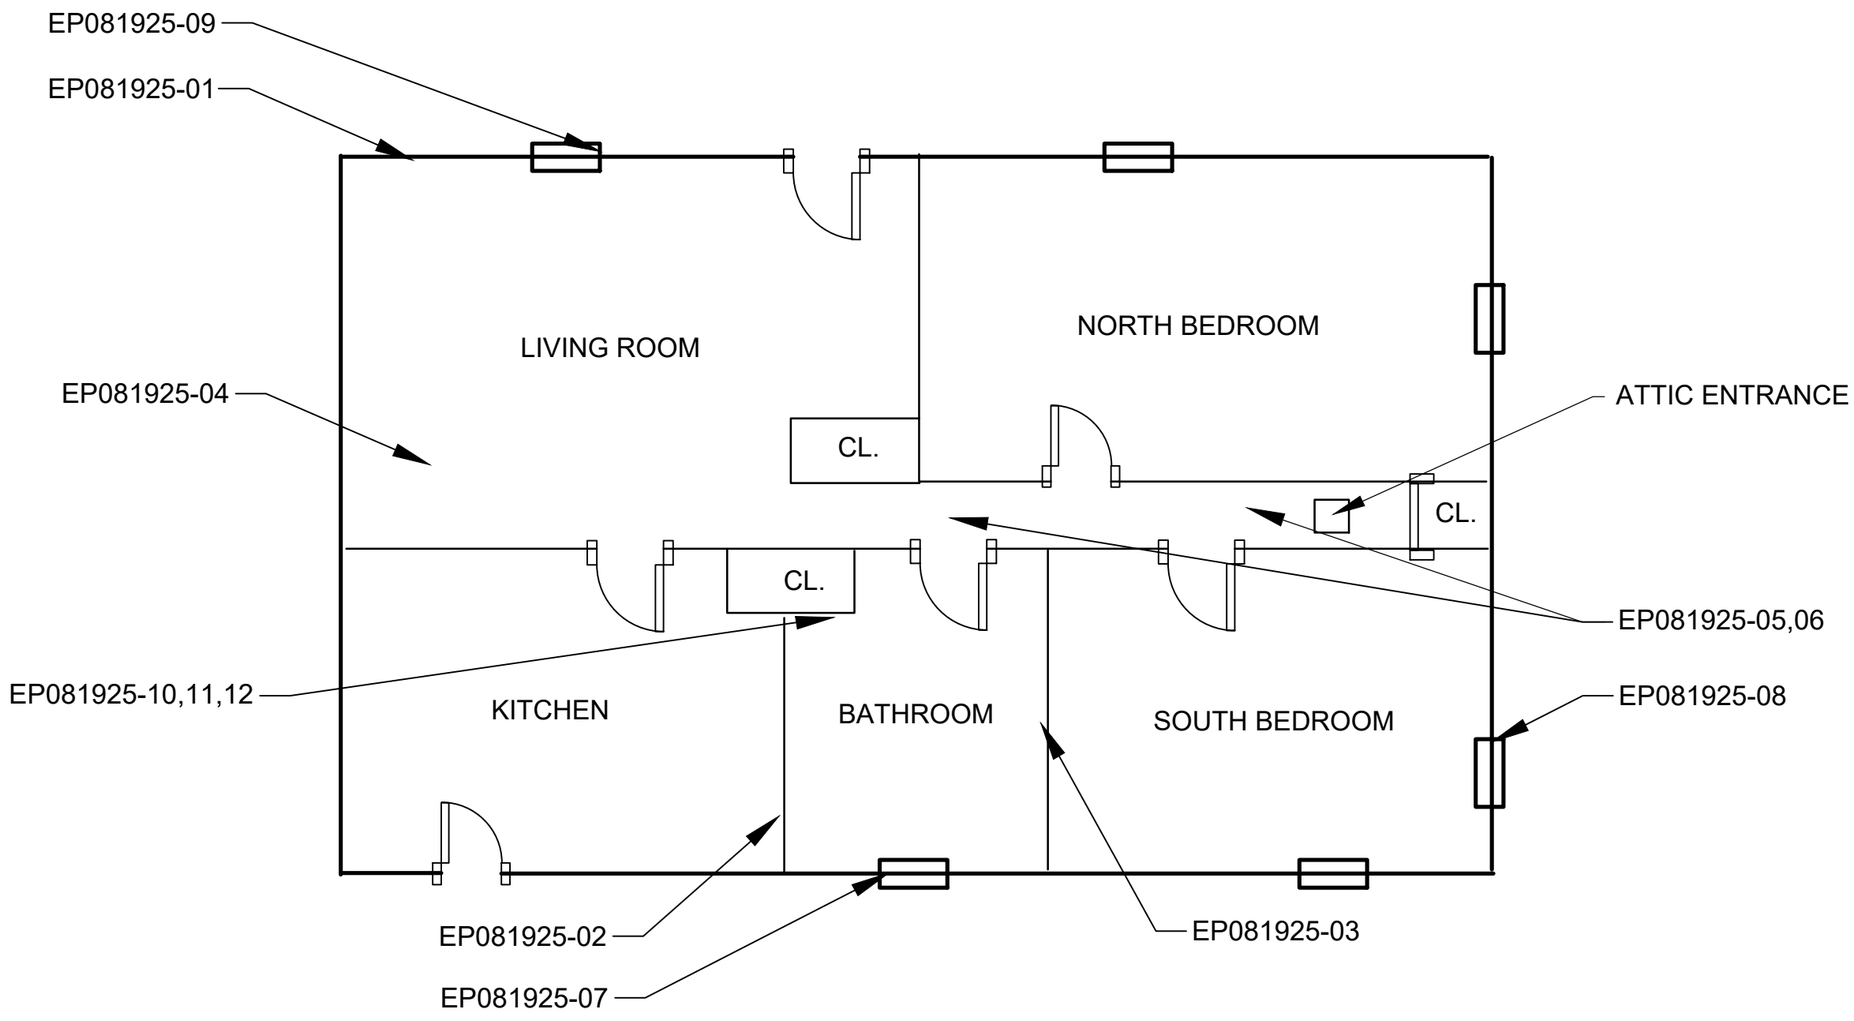
SL-1 and SL-2
Suspect ACM Sample Location Plans

Exhibit 1, Suspect ACM Sample Locations, shows the approximate locations of the suspect ACM collected during the field survey. Samples were placed in new sealable containers and labeled with unique sample numbers using an indelible marker. All non-disposable sampling equipment was wet-wiped and cleaned before and after each use. Bulk material samples were collected in 4-milliliter plastic bags, and tightly sealed for transport to the laboratory. Bulk samples were submitted under a chain-of-custody (COC) protocol to Stat Analysis Corporation (Sterling) in Chicago, Illinois.
