# ASBESTOS SURVEY REPORT

**PTB 196-032**
**Asbestos Survey for Building Demolition (I-80)**
**209 Duncan Street, Joliet, Illinois**
**Region One/District One**

February 17, 2025

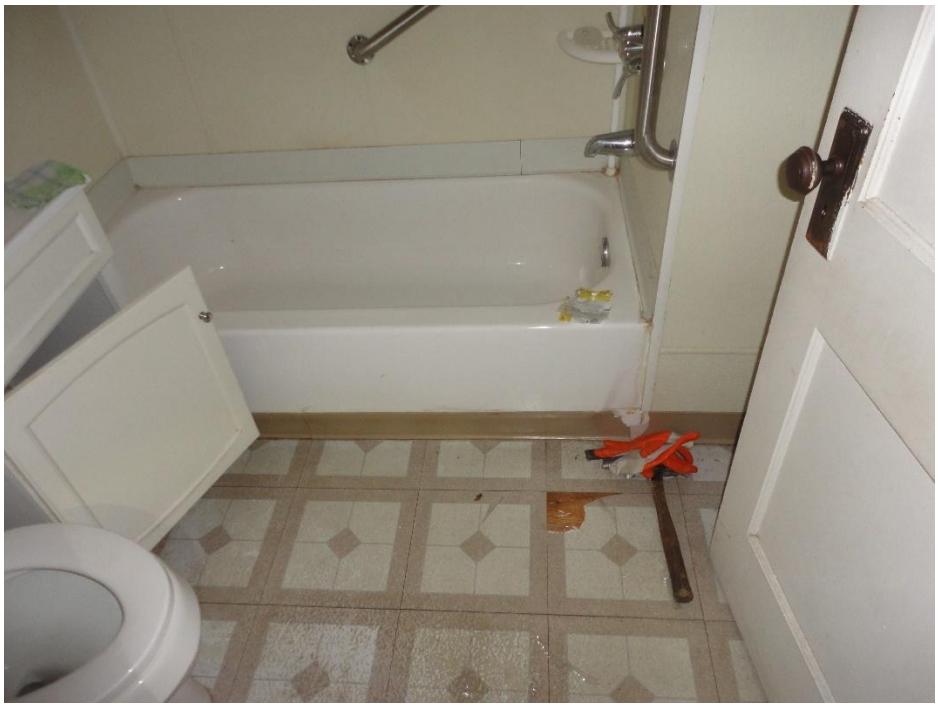
**Photo Location:** Bathroom

| HA No. | Material Description | Location | Type[1] | Condition | Friable | % Asbestos* | # of Samples | Estimated Quantity[2] |
|---|---|---|---|---|---|---|---|---|
| 3 | 4" Base Cove, Dark Grey, Mastic, Beige | Bathroom | Misc. | Good | No | ND | 3 | N/A |

**Material Description:** Suspect ACM 14" Base Cove, Dark Grey, Mastic, Beige

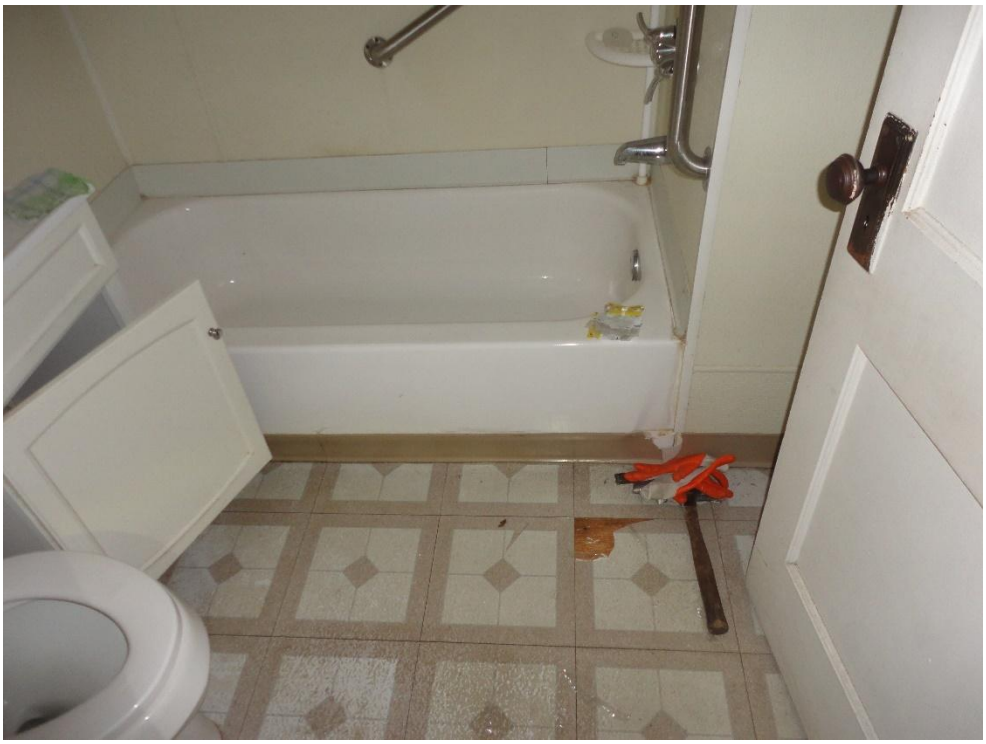
**Photo Location:** Top of Bath Tub Bathroom

| HA No. | Material Description | Location | Type[1] | Condition | Friable | % Asbestos* | # of Samples | Estimated Quantity[2] |
|---|---|---|---|---|---|---|---|---|
| 4 | 4" Base Cove, Tan, Mastic, Beige | Bathroom | Misc. | Good | No | ND | 3 | N/A |

**Material Description:** Suspect ACM 4" Base Cove, Tan, Mastic Beige

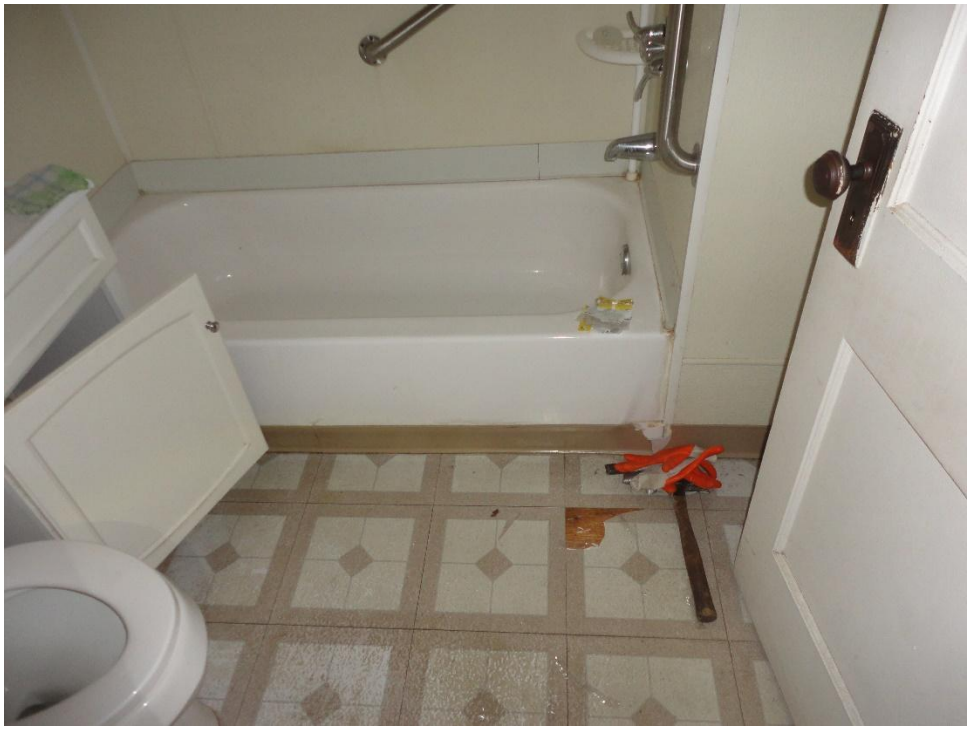
**Photo Location:**
Bathroom

| HA No. | Material Description | Location | Type[1] | Condition | Friable | % Asbestos* | # of Samples | Estimated Quantity[2] |
|---|---|---|---|---|---|---|---|---|
| 6 | 12"x12" Vinyl Floor Tile, Checkered, Adhesive, Beige | Bathroom | Misc. | Good | No | ND | 3 | N/A |

**Material Description:**
Suspect ACM
12”X12” Vinyl Floor Tile, Adhesive Beige

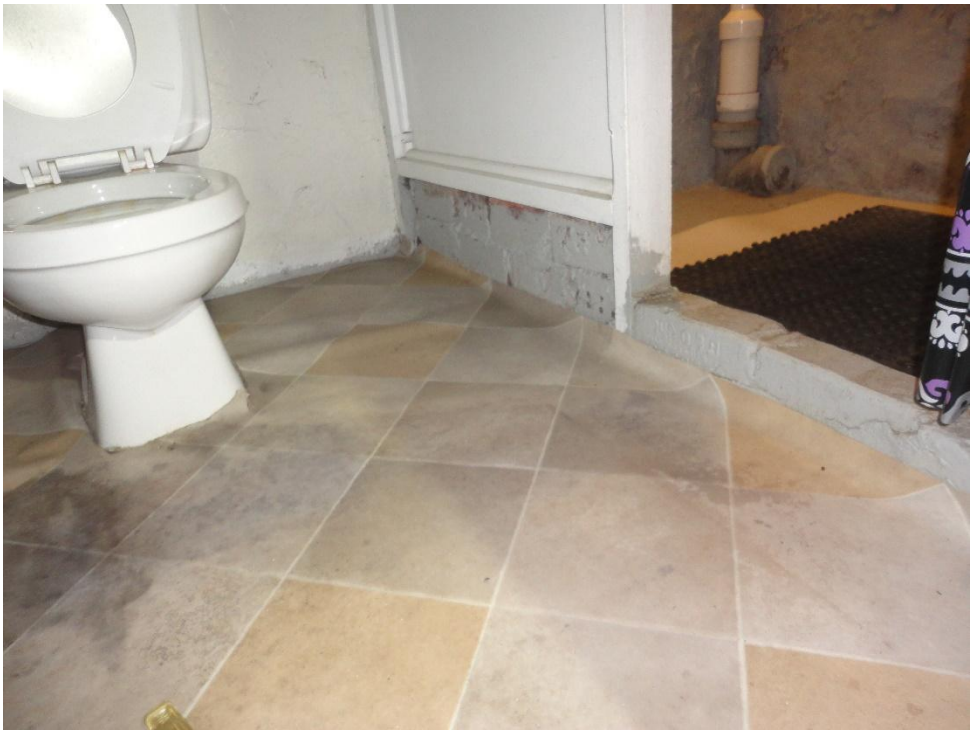
**Photo Location:** Basement

| HA No. | Material Description | Location | Type[1] | Condition | Friable | % Asbestos* | # of Samples | Estimated Quantity[2] |
|---|---|---|---|---|---|---|---|---|
| 10 | Linoleum Sheet Flooring, Adhesive, Beige | Basement | Misc. | Good | No | ND | 3 | N/A |

**Material Description:** Suspect ACM Linoleum Sheet Flooring, Adhesive, Beige
