ASBESTOS SURVEY REPORT

PTB 196-032
Asbestos Survey for Building Demolition (I-80)
220 Duncan Street, Joliet, Illinois
Region One/District One

Asbestos Survey Report
PTB 198-003
FAI-80 (I-80) over Des Plaines River Bridge
Job N. D-91-204-19
220 Duncan Street, Joliet, IL
Parcel No. 1P10168

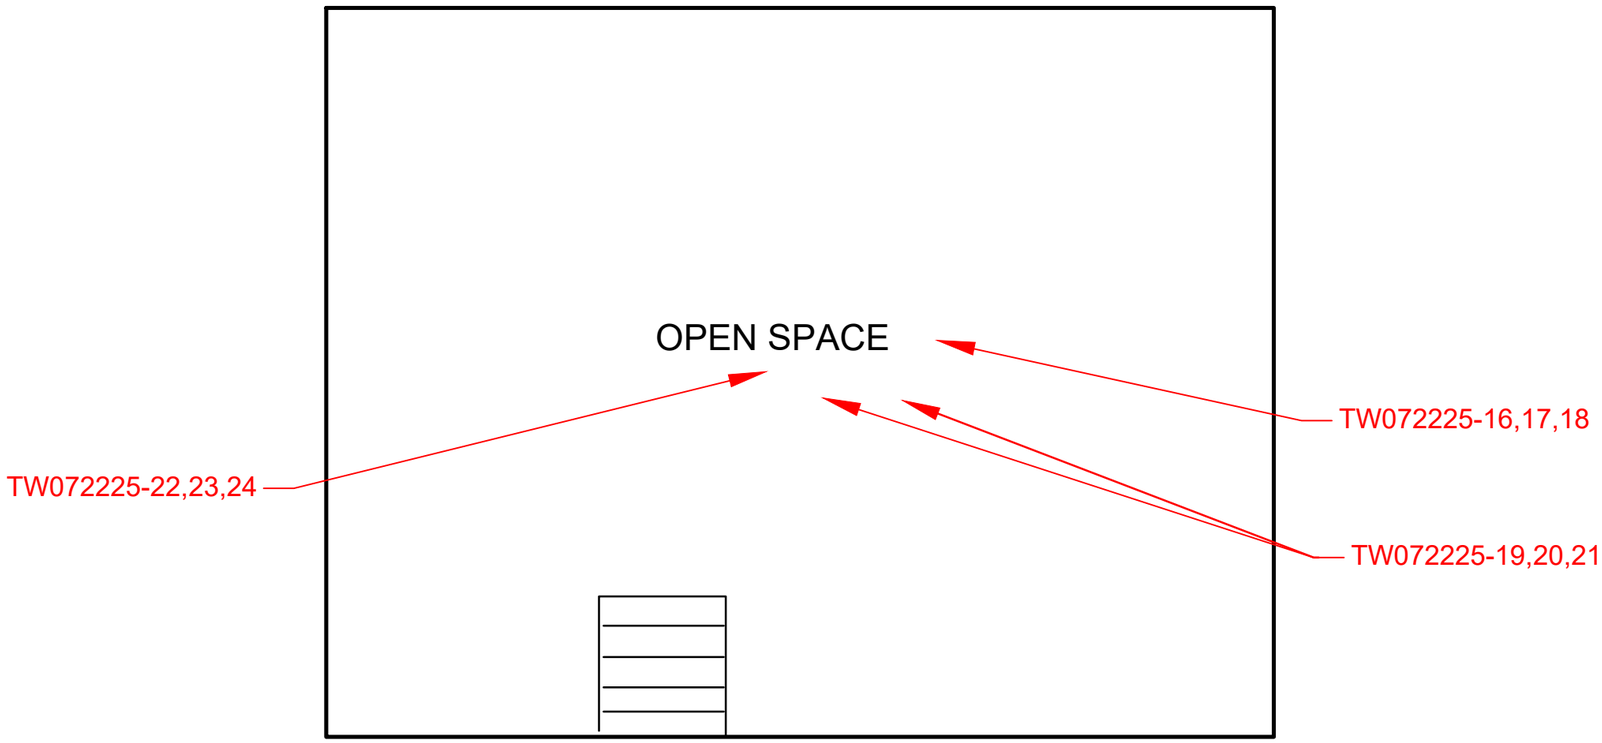
SL-1

BASEMENT
SCALE = N.T.S.

RED SAMPLES TESTED POSITIVE FOR ASBESTOS

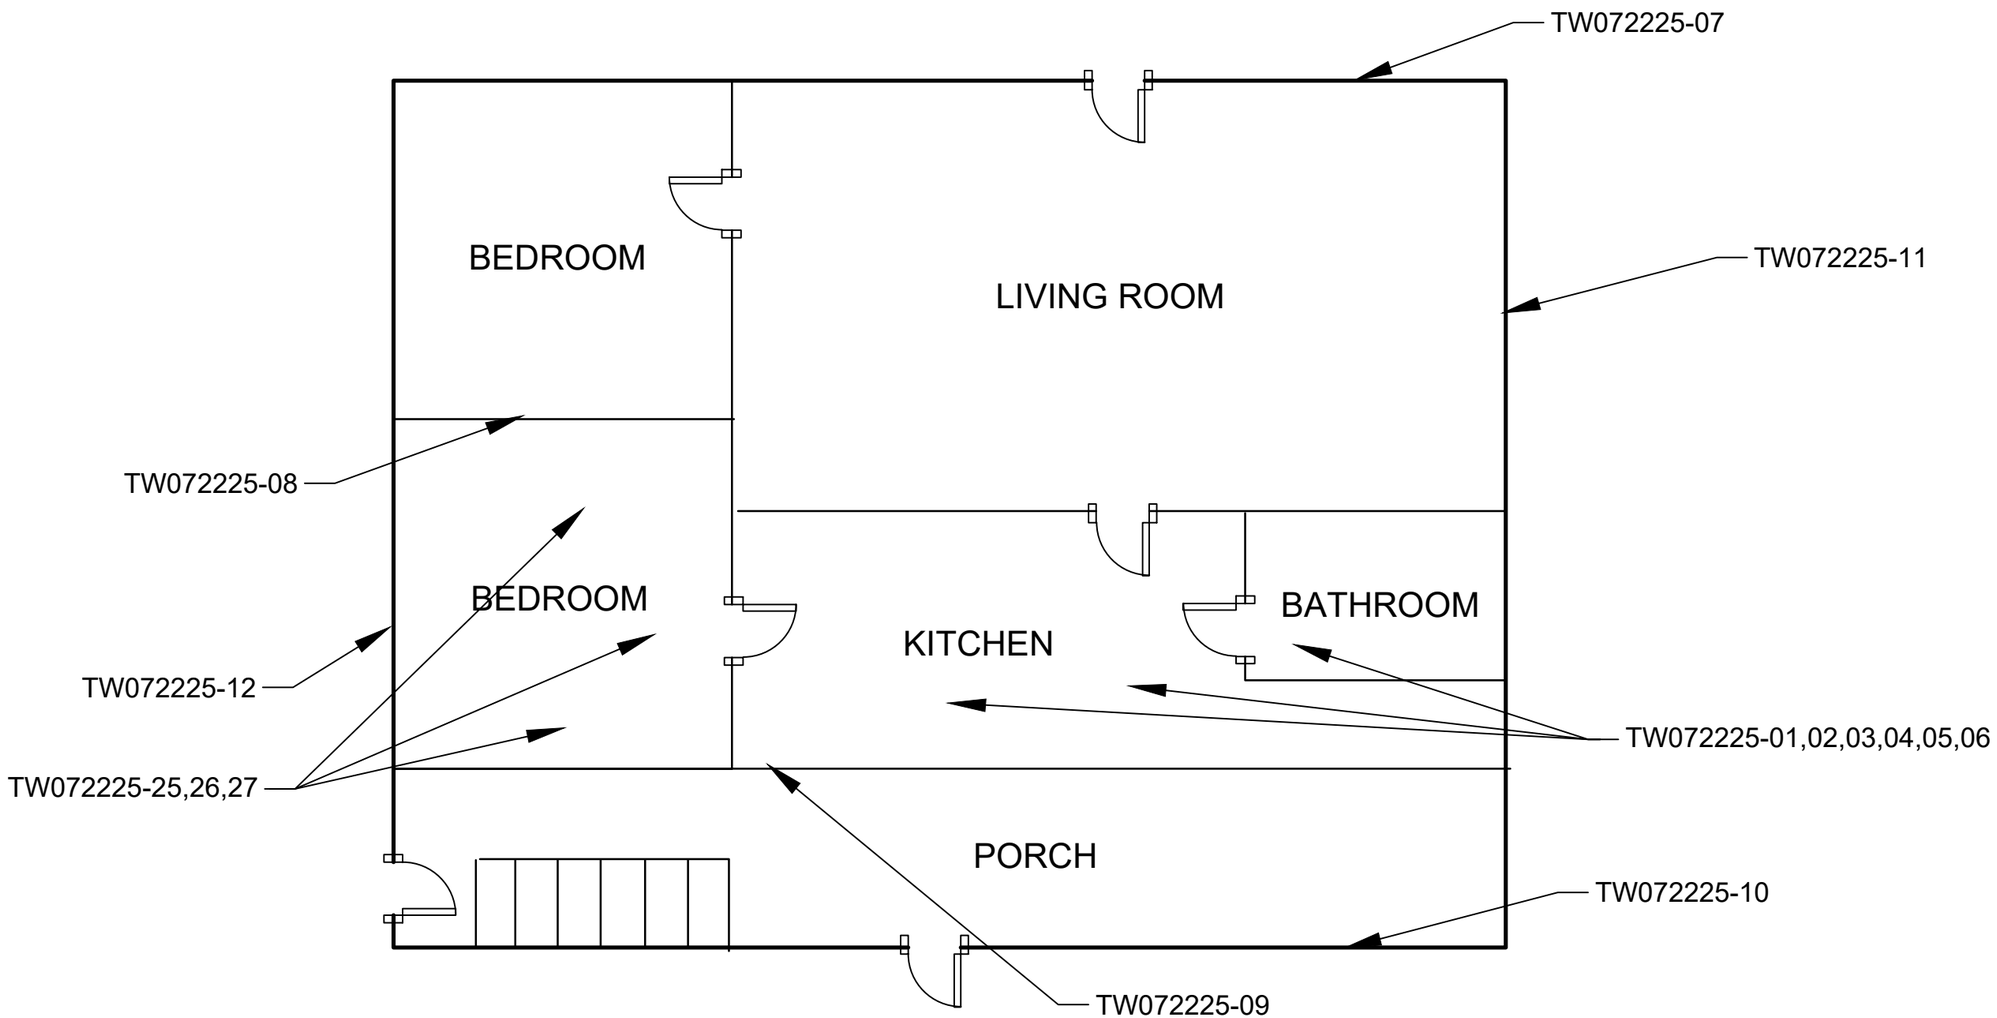
SL-2

FIRST FLOOR
SCALE = N.T.S.

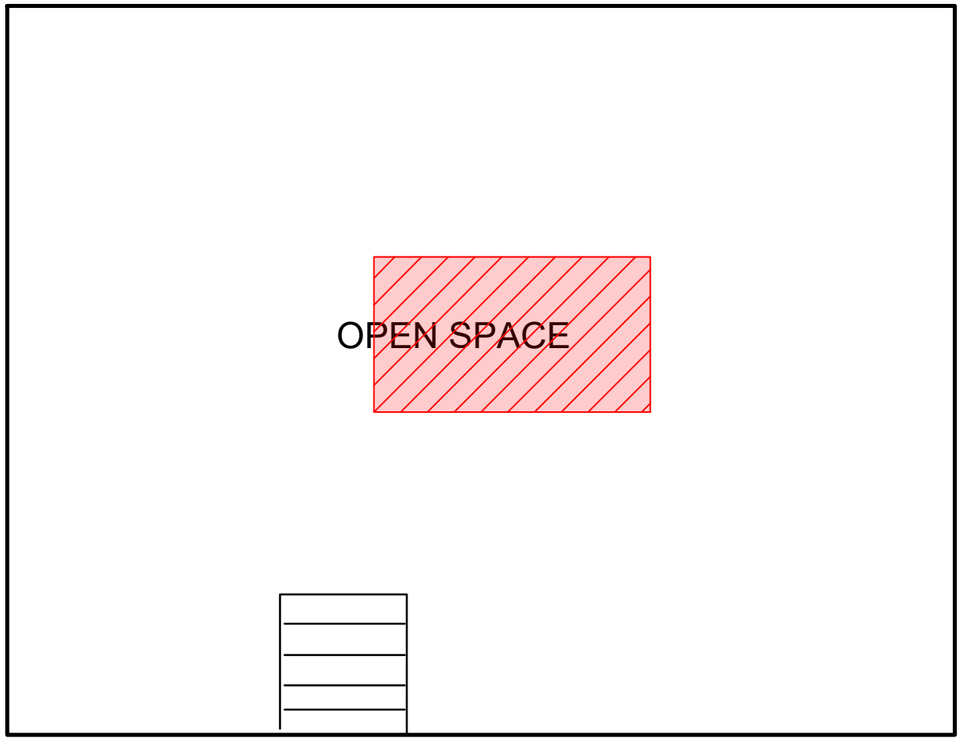
ACM-1

- Pipe Insulation
- Pipe Fittings
- Duct Wrap

BASEMENT
SCALE = N.T.S.

LOCATIONS OF ASBESTOS-CONTAINING MATERIALS

PIPE INSULATION/FITTINGS

DUCT WRAP

All friable asbestos-containing building materials (ACBMs) identified shall be removed from any building(s) or other structures before demolition. Non-friable ACMs may be left in place, unless during demolition, the ACMs may become friable. If other suspect materials not referenced in this survey report, within or on the outside of the buildings, are identified, not listed in **Table 1**, such materials shall be assumed ACMs until the materials are inspected by a licensed asbestos inspector, sampled, and submitted for laboratory analysis.

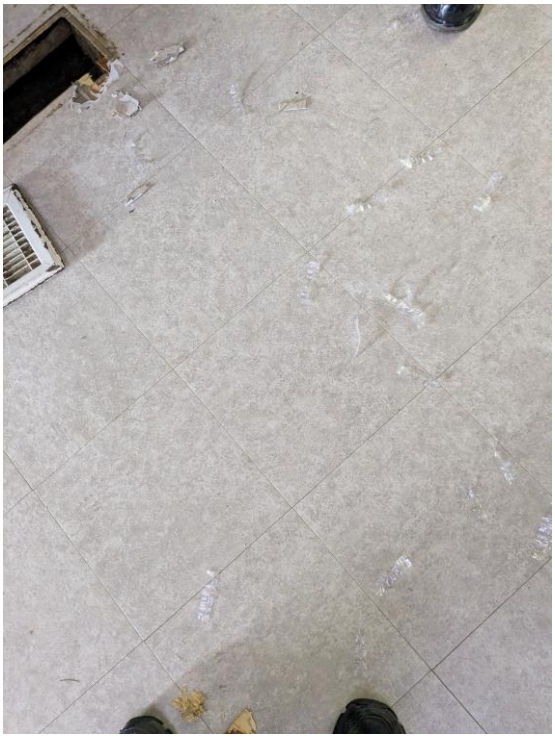
Photo Location:
Kitchen

Material Description:
Suspect ACM 12”x12” White Floor Tile & Mastic
