STATE OF ILLINOIS  
DEPARTMENT OF TRANSPORTATION

FLANGE REPAIR DETAILS  
SN 016-1068

| 94 | 2014-0741 | COOK | 13 |

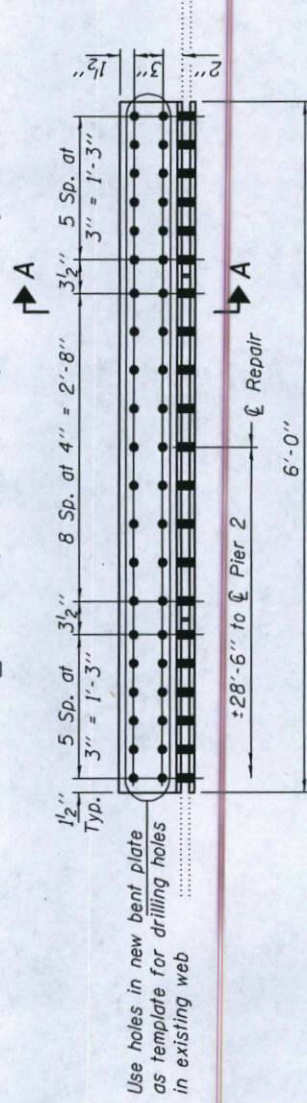
ELEVATION

(A) - Existing Beam to be Straightened & Strengthened.

Hatched area indicates removal. Cost included with Structural Steel Repair.  
Use holes in new bottom flange plate as template for drilling holes in existing bottom flange
