**Table 1. Asbestos Homogeneous Areas Summary**  
**IDOT - Asbestos Abatement Survey**  
**WO # 38**  
**202 W. Main Street, Benton, Illinois**

IDOT / Asbestos Surveys WO #38  
Job No. R-99-009-15  
Route IL 14 Parcel 9033515  
202 W. Main Street  
Benton, Franklin County, Illinois  
**ASBESTOS ABATEMENT SURVEY**

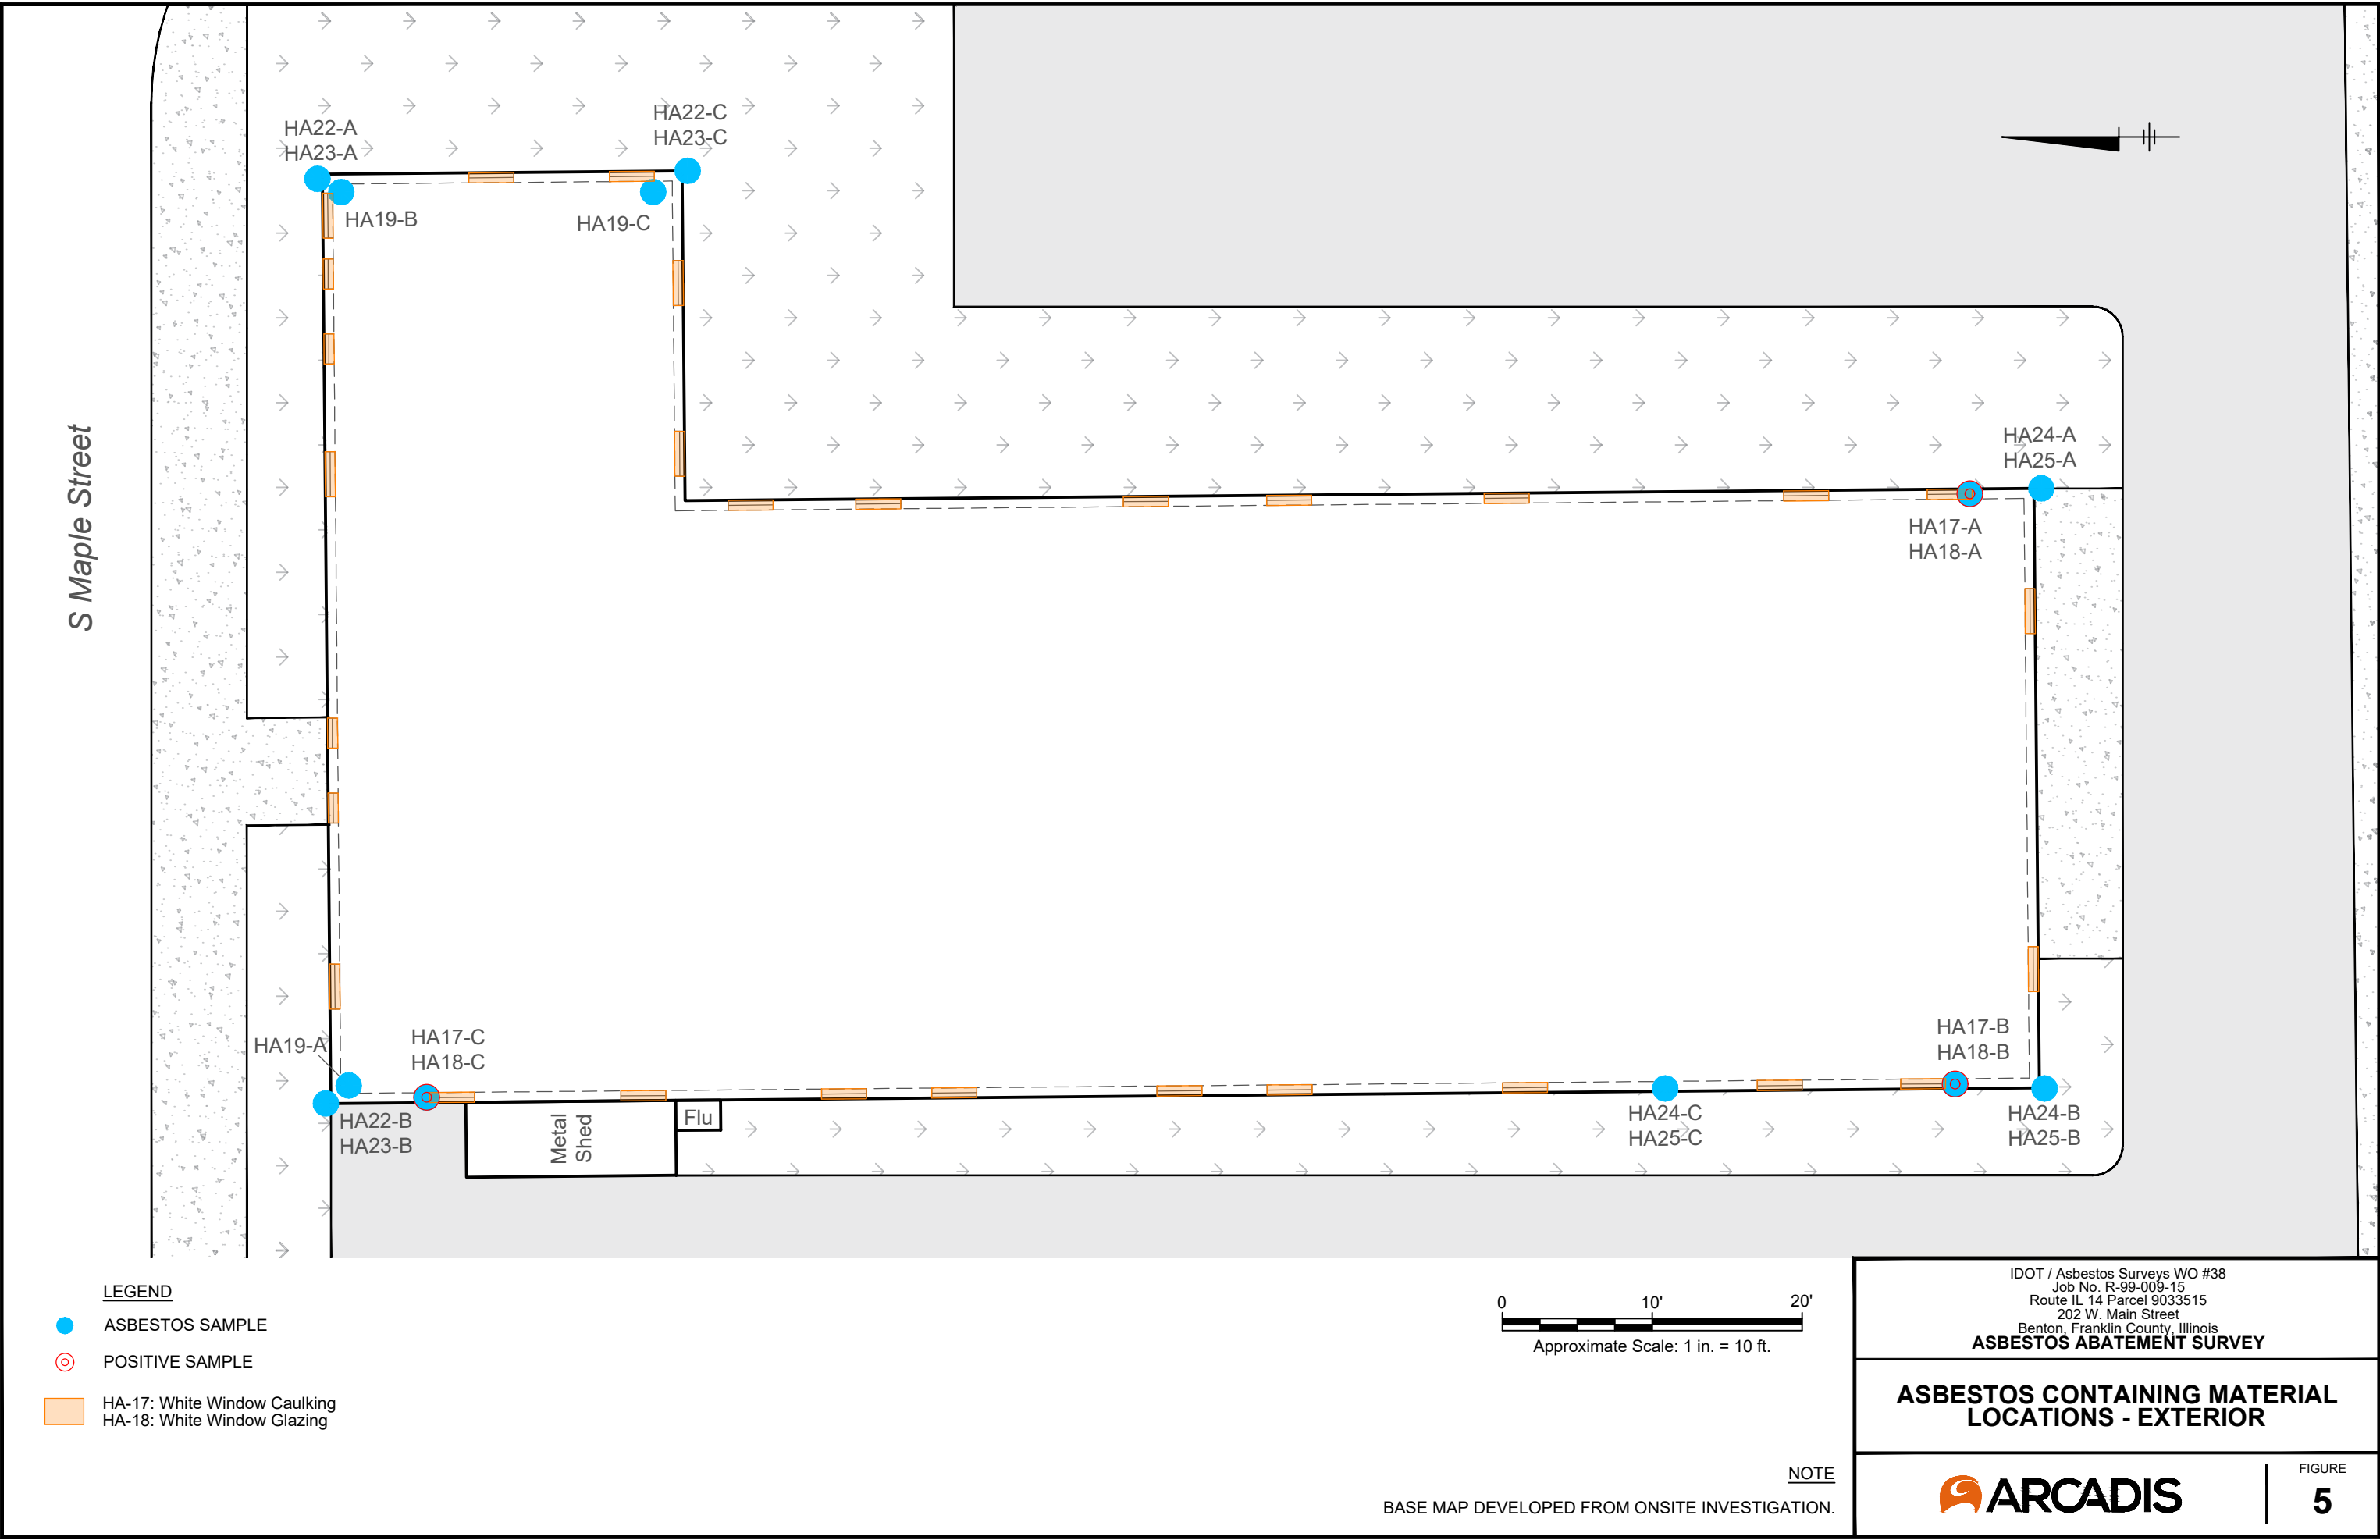
- LEGEND**
- ASBESTOS SAMPLE
  - POSITIVE SAMPLE
  - HA-12: 12 x 12 Smooth Brown Floor Tile  
HA-13: Black Mastic associated with HA-12
  - HA-17: White Window Caulking  
HA-18: White Window Glazing
