ROADWAY GEOTECHNICAL REPORT

PAVEMENT RUBBLIZATION STUDY

INTERSTATE 55

**Illinois Department
of Transportation**

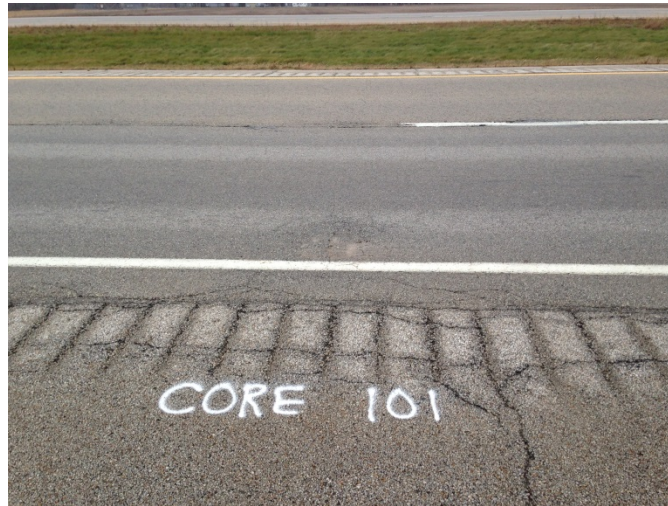
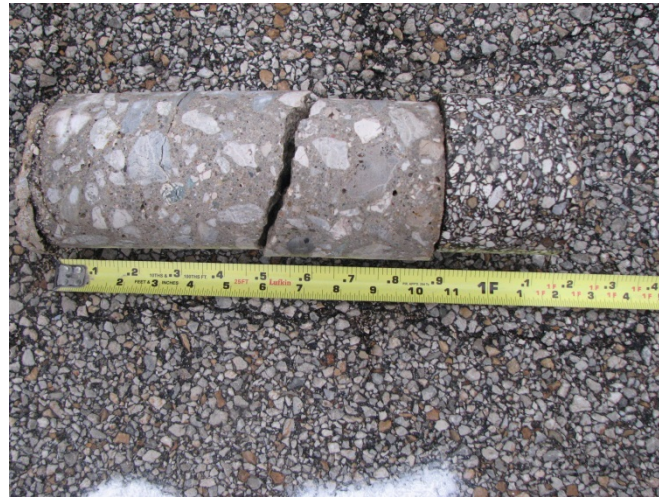
| Comments: | MM 198.47 | | | | | | |

| Lift | Thickness | Material | Condition | Pavement Cracks | Aggregate Cracks | Voids | Comments |
|---|---|---|---|---|---|---|---|
| 1 | 1 3/4" | HMA Surface | Good | None | None | Some | |

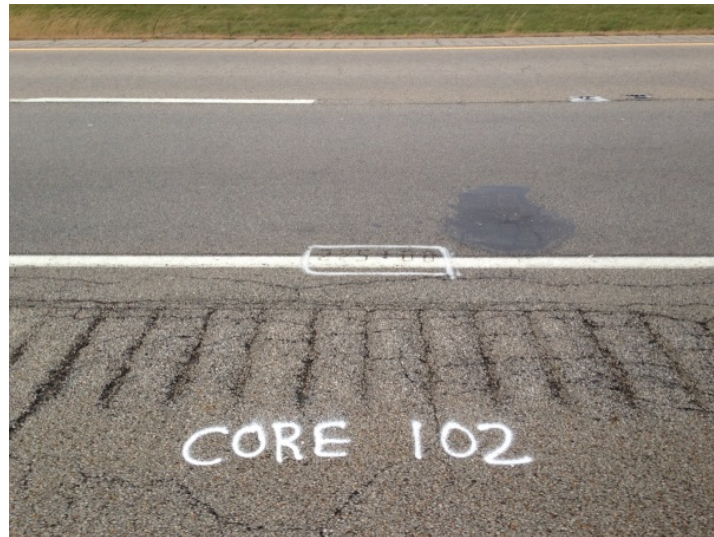
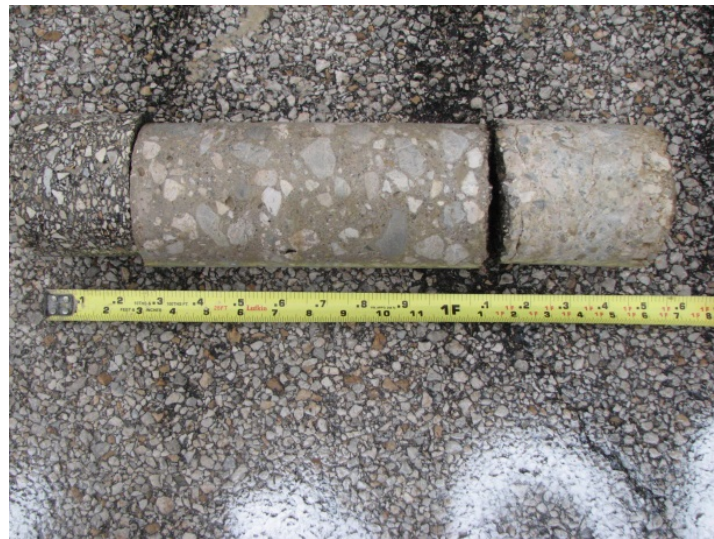
| Comments: | MM 198.84 | | | | | | |

| Lift | Thickness | Material | Condition | Pavement Cracks | Aggregate Cracks | Voids | Comments |
|---|---|---|---|---|---|---|---|
| 1 | 1 3/4" | HMA Surface | Good | None | None | Some | |

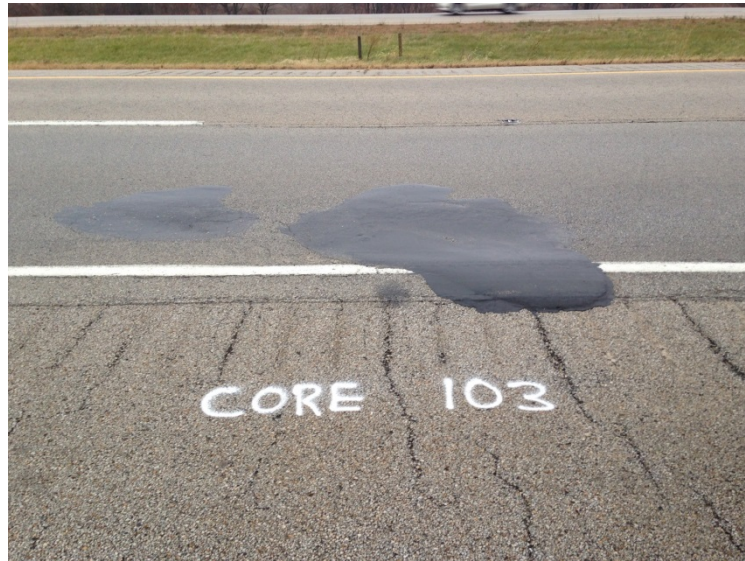
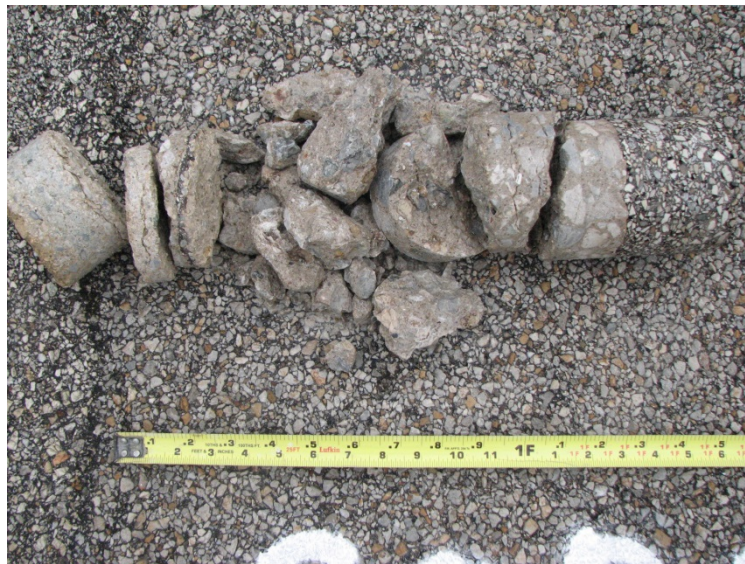
| Comments: | MM 199.11 | | | | | | |

| Lift | Thickness | Material | Condition | Pavement Cracks | Aggregate Cracks | Voids | Comments |
|---|---|---|---|---|---|---|---|
| 3 | Unknown | PCC | Poor | Many | Many | Some | Broken into many pieces |

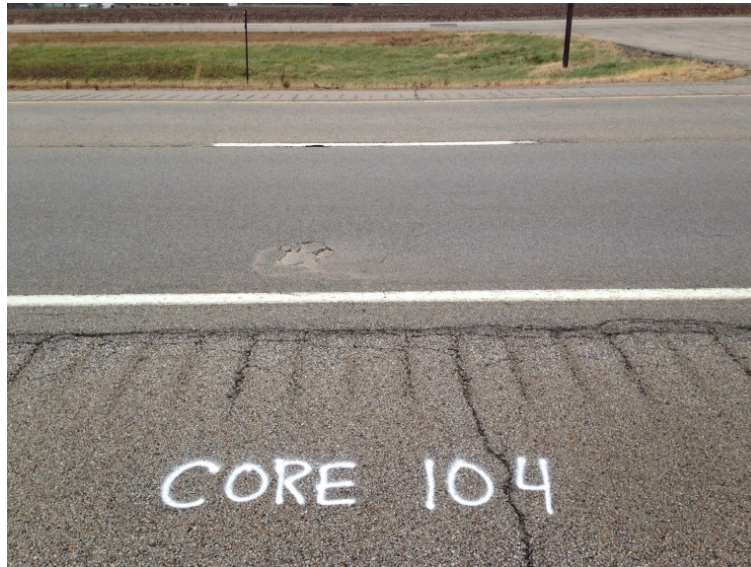
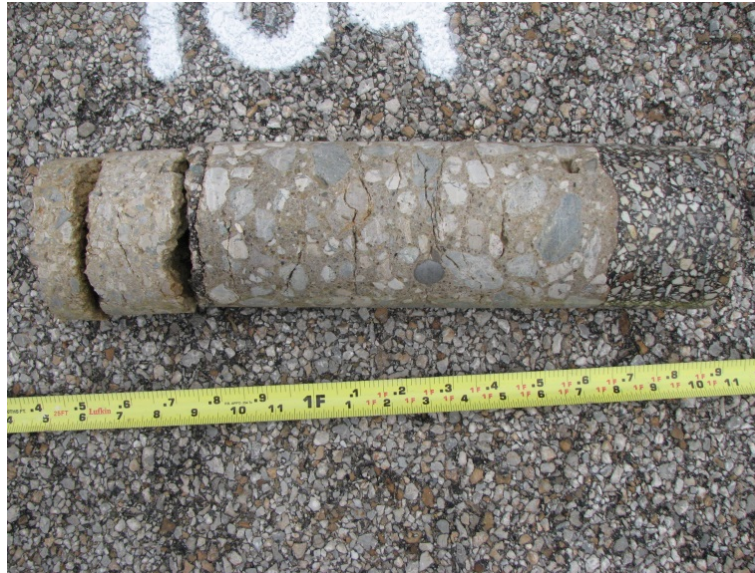
| Comments: | MM 199.54 | | | | | | |

| Lift | Thickness | Material | Condition | Pavement Cracks | Aggregate Cracks | Voids | Comments |
|---|---|---|---|---|---|---|---|
| 1 | 1 3/4" | HMA Surface | Good | None | None | Some | |

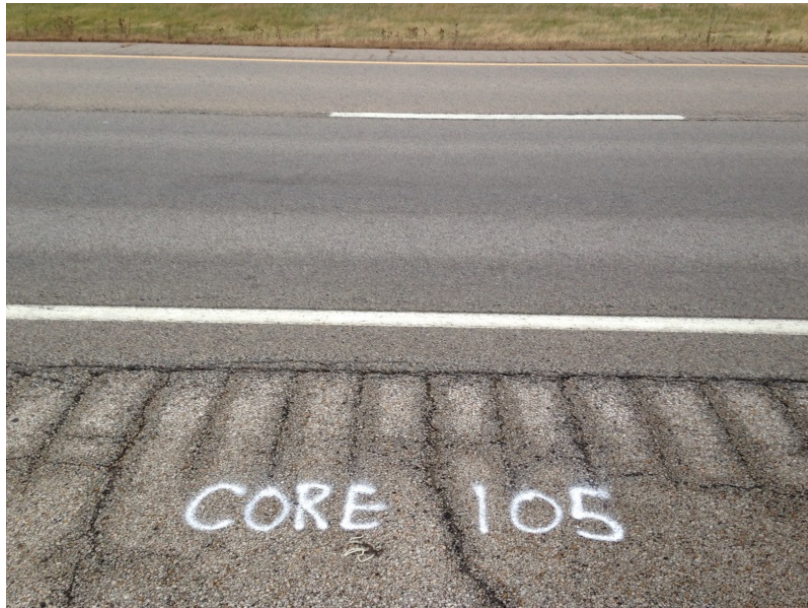
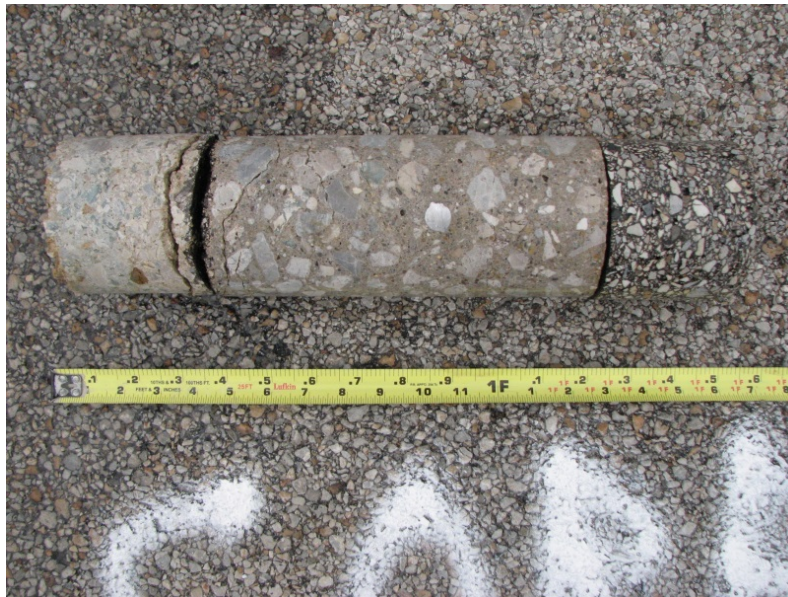
| Comments: | MM 200.00 | | | | | | |

| Lift | Thickness | Material | Condition | Pavement Cracks | Aggregate Cracks | Voids | Comments |
|---|---|---|---|---|---|---|---|
| 1 | 1 3/4" | HMA Surface | Good | None | None | Some | |

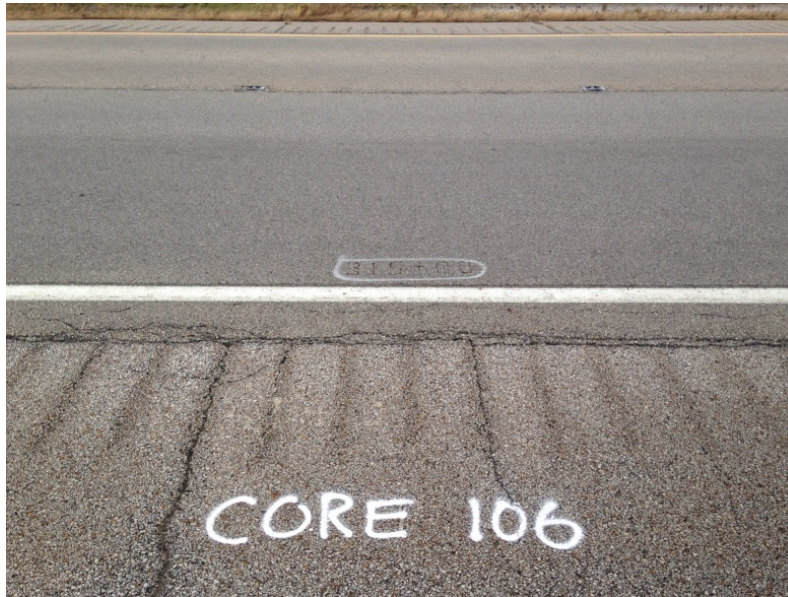
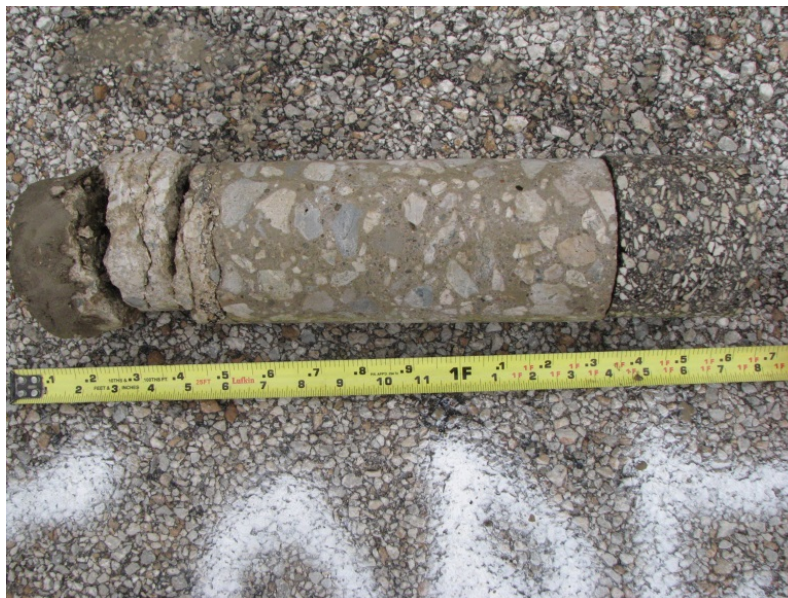
| Comments: | MM 200.55 | | | | | | |

| Lift | Thickness | Material | Condition | Pavement Cracks | Aggregate Cracks | Voids | Comments |
|---|---|---|---|---|---|---|---|
| 1 | 1 5/8" | HMA Surface | Good | None | None | Some | |

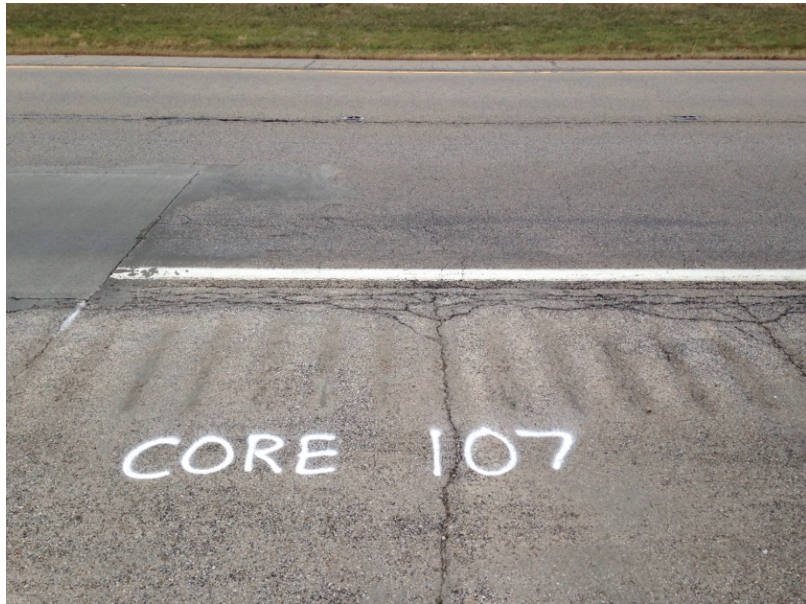
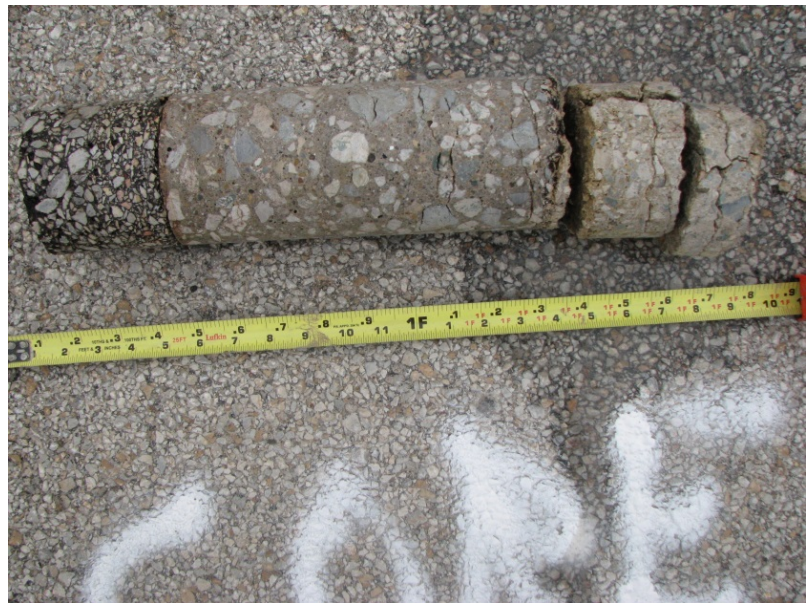
| Comments: | MM 201.66 | | | | | | |

| Lift | Thickness | Material | Condition | Pavement Cracks | Aggregate Cracks | Voids | Comments |
|---|---|---|---|---|---|---|---|
| 1 | 1 3/4" | HMA Surface | Good | None | None | Some | |

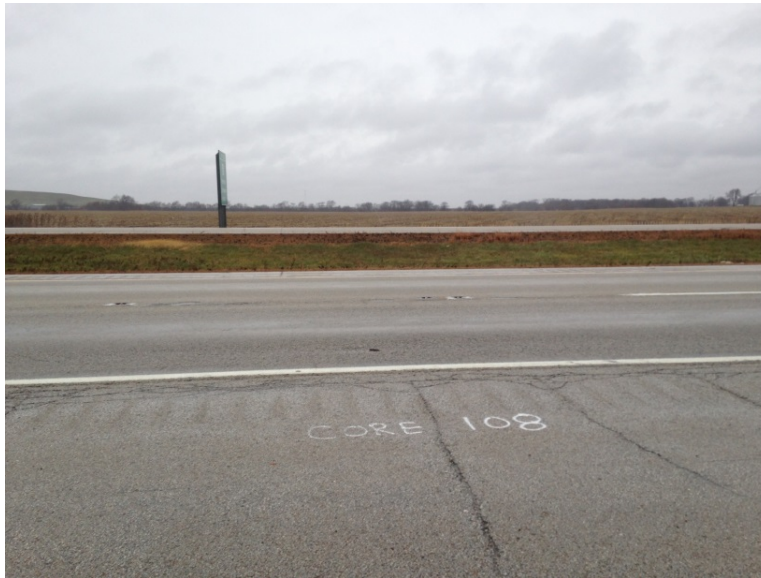
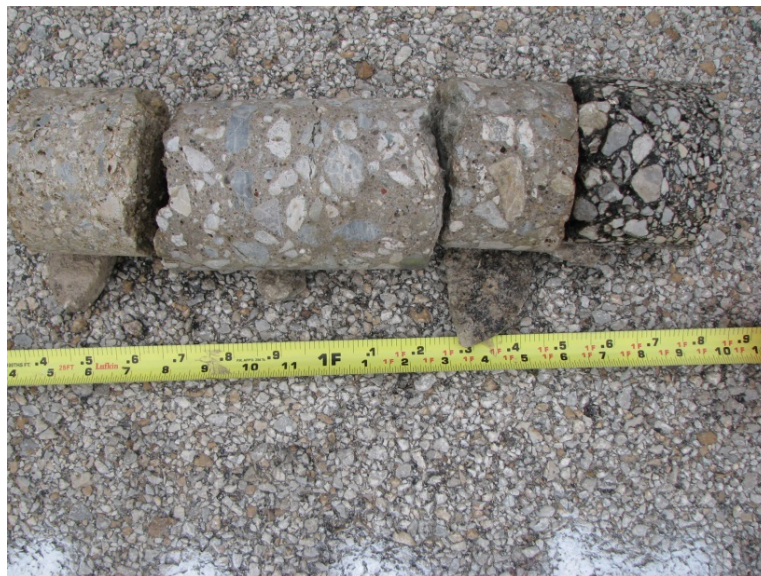
| Comments: | MM 201.35 | | | | | | |

| Lift | Thickness | Material | Condition | Pavement Cracks | Aggregate Cracks | Voids | Comments |
|---|---|---|---|---|---|---|---|
| 1 | 1 3/8" | HMA Surface | Good | None | None | Some | |

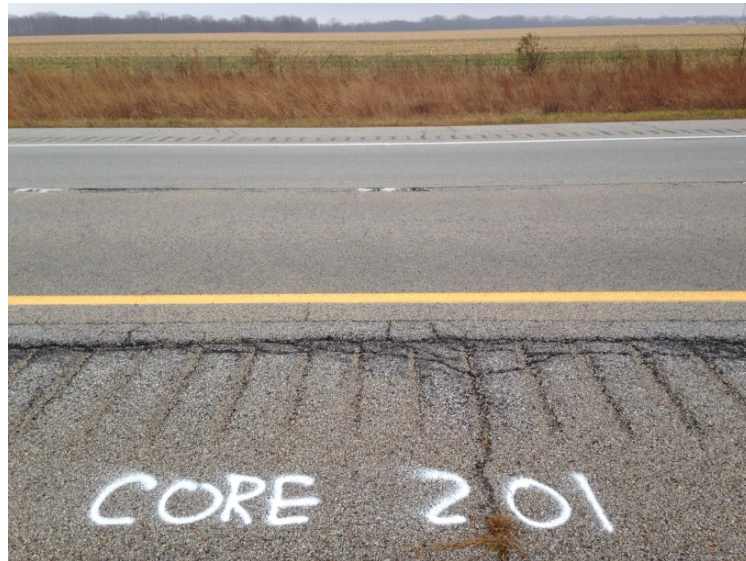
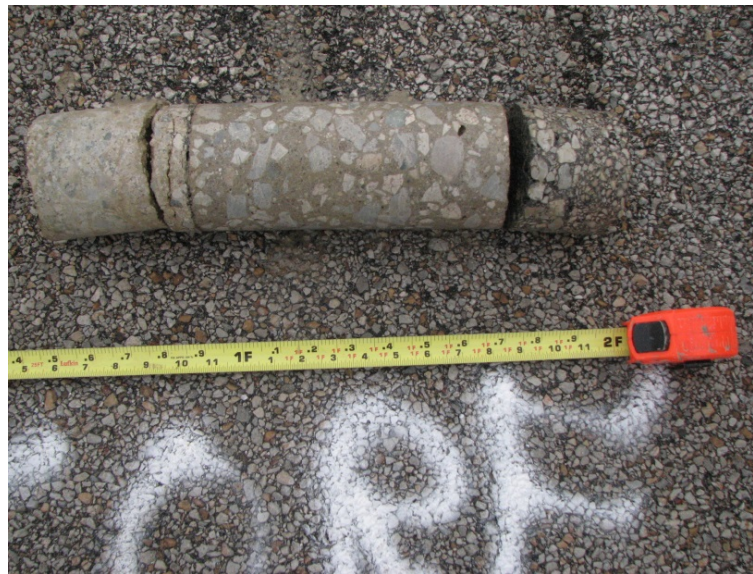
| Comments: | MM 198.38 | | | | | | |

| Lift | Thickness | Material | Condition | Pavement Cracks | Aggregate Cracks | Voids | Comments |
|---|---|---|---|---|---|---|---|
| 1 | 1 3/4" | HMA Surface | Good | None | None | Some | |

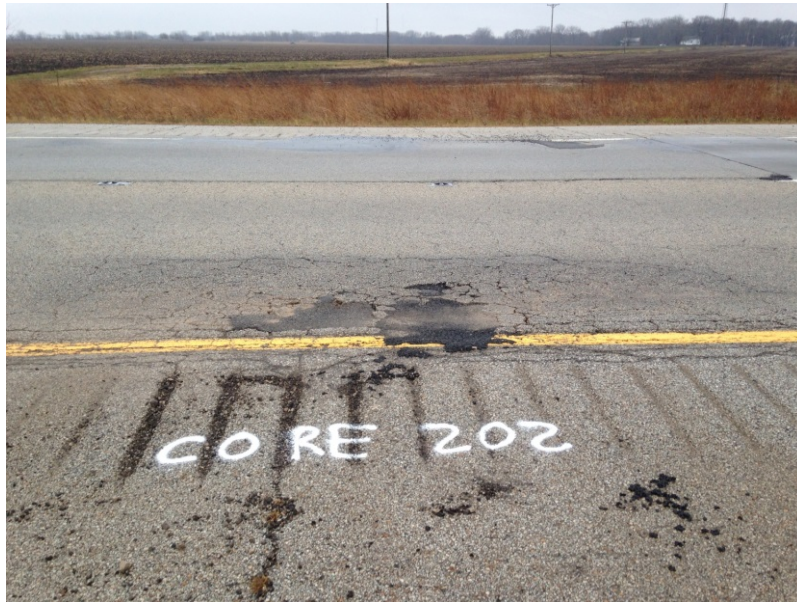
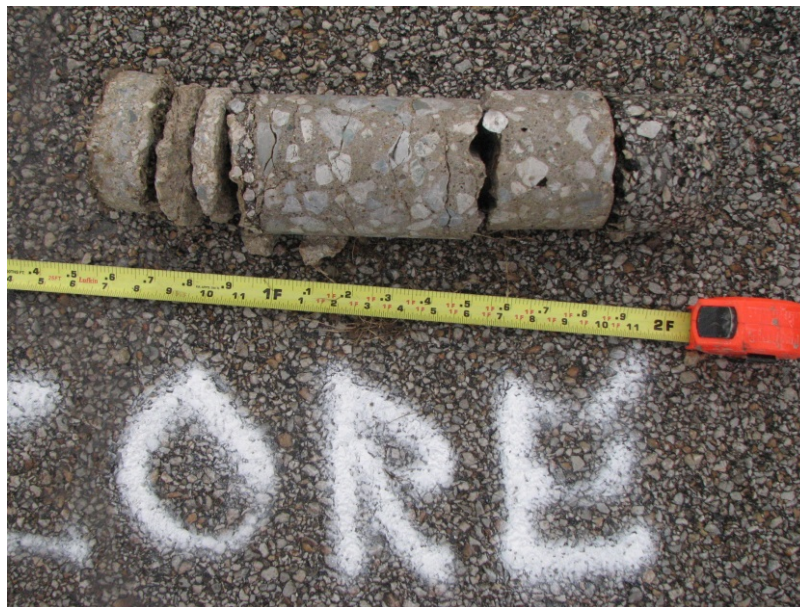
| Comments: | MM 199.32 | | | | | | |

| Lift | Thickness | Material | Condition | Pavement Cracks | Aggregate Cracks | Voids | Comments |
|---|---|---|---|---|---|---|---|
| 1 | 1 ½" | HMA Surface | Good | None | None | Some | |

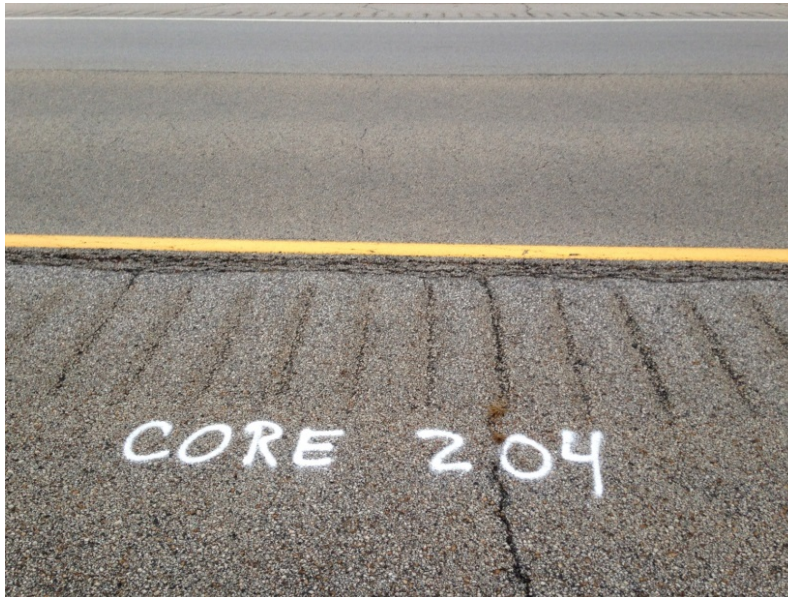
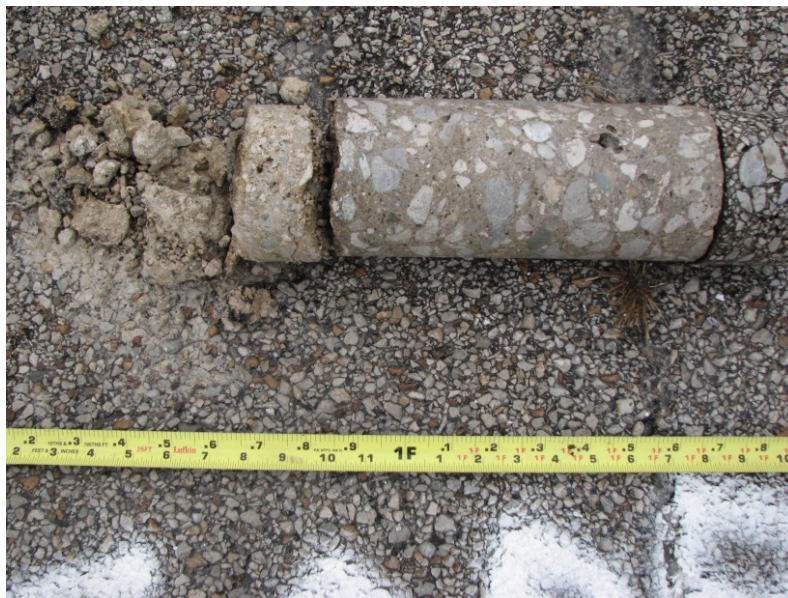
| Comments: | MM 200.37 | | | | | | |

| Lift | Thickness | Material | Condition | Pavement Cracks | Aggregate Cracks | Voids | Comments |
|---|---|---|---|---|---|---|---|
| 1 | 1 1/2" | HMA Surface | Good | None | None | Some | |

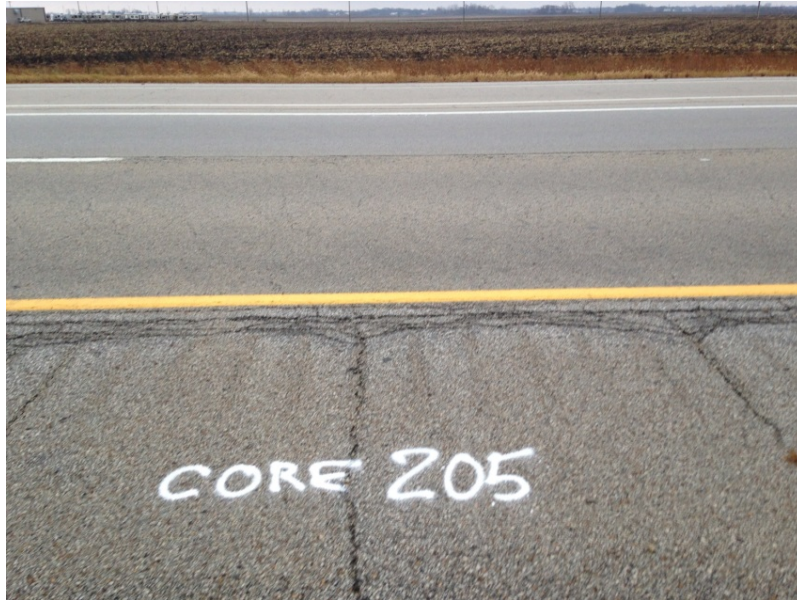
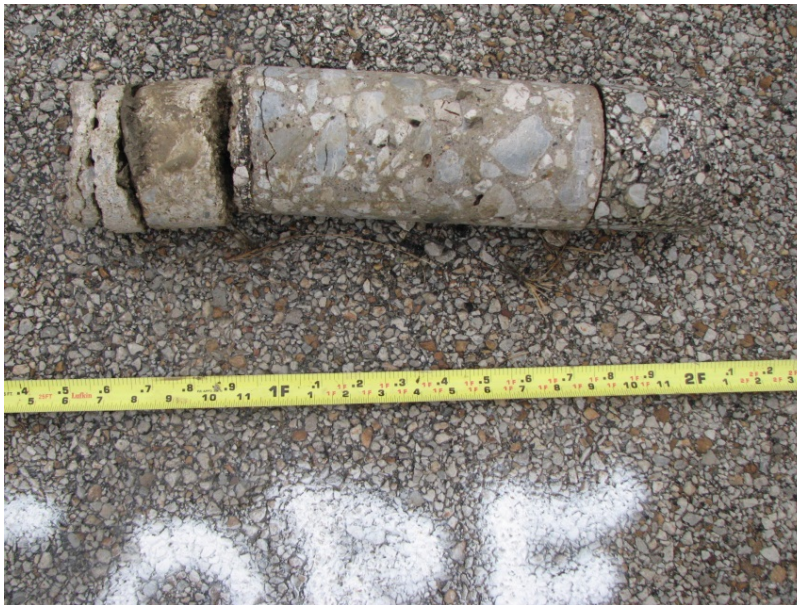
| Comments: | MM 200.76 | | | | | | |

| Lift | Thickness | Material | Condition | Pavement Cracks | Aggregate Cracks | Voids | Comments |
|---|---|---|---|---|---|---|---|
| 1 | 1 3/4" | HMA Surface | Good | None | None | Some | |

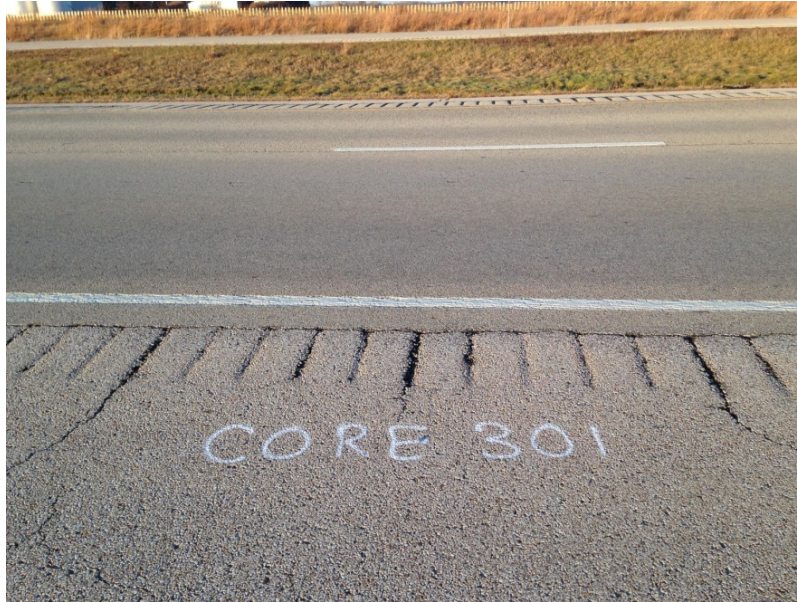
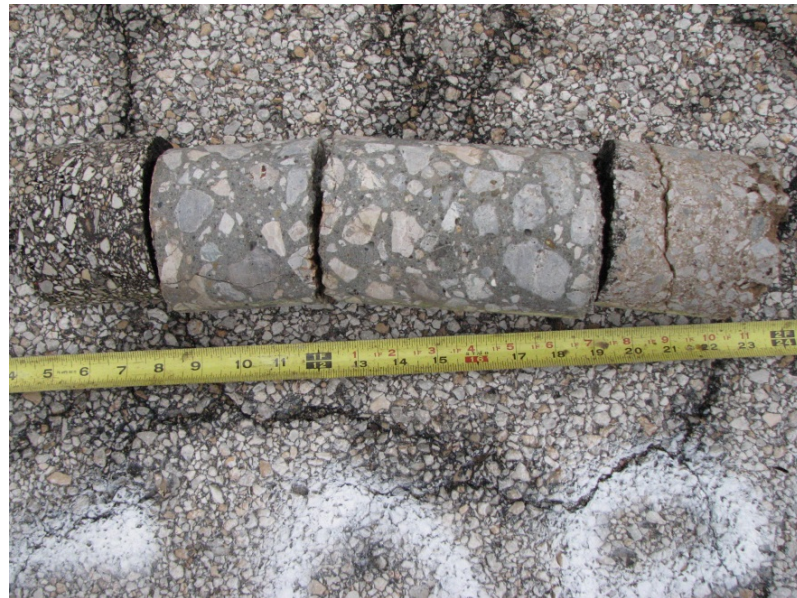
| Comments: | MM 196.00; Good Pavt. | | | | | | |

| Lift | Thickness | Material | Condition | Pavement Cracks | Aggregate Cracks | Voids | Comments |
|---|---|---|---|---|---|---|---|
| 1 | 1 9/16" | HMA Surface | Good | None | None | Some | |

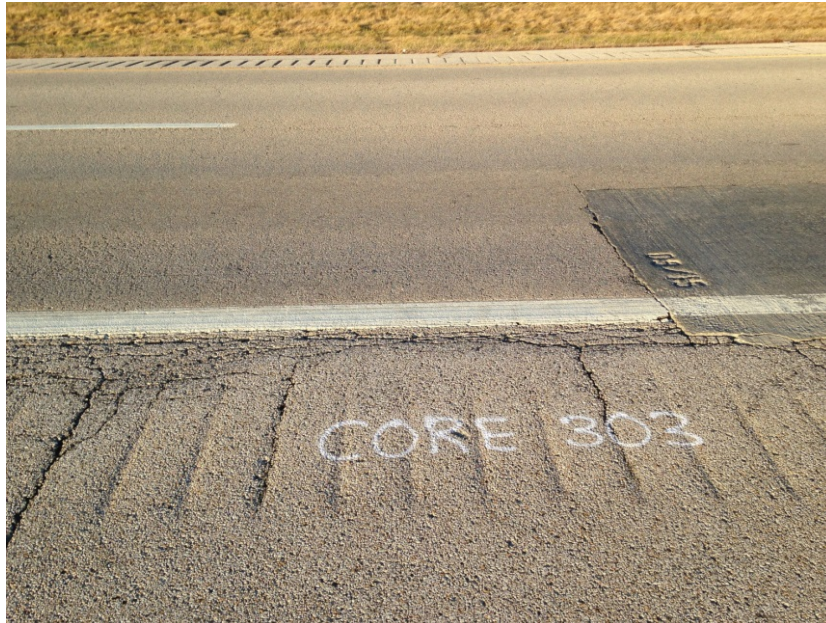
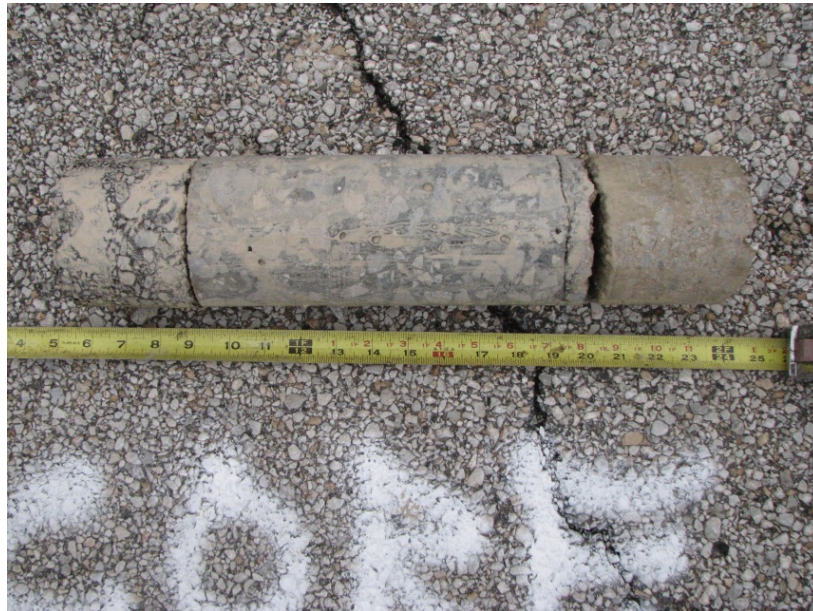
| Comments: | MM 196.90, Patch in Rt. Wheel Path | | | | | | |

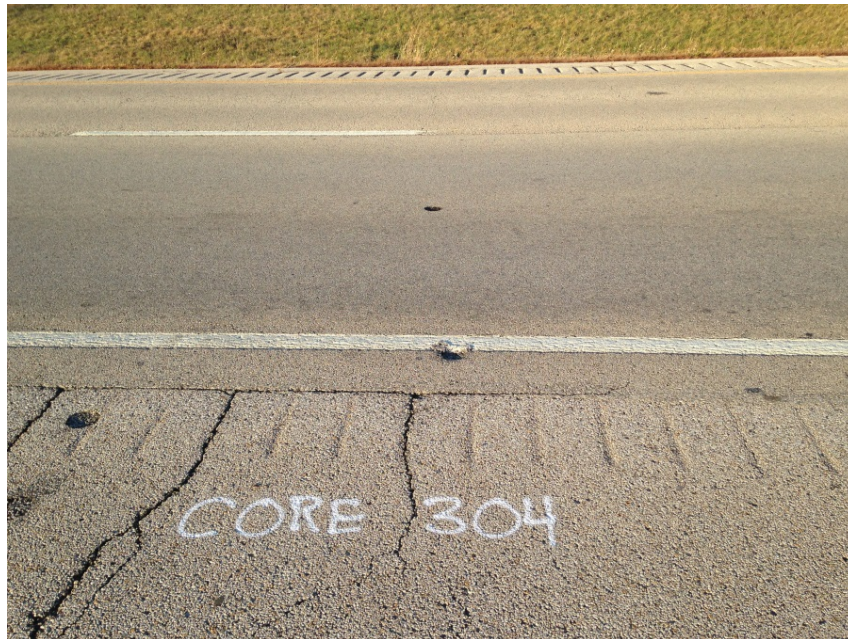
| Comments: | MM 198.00, Good Pavement | | | | | | |

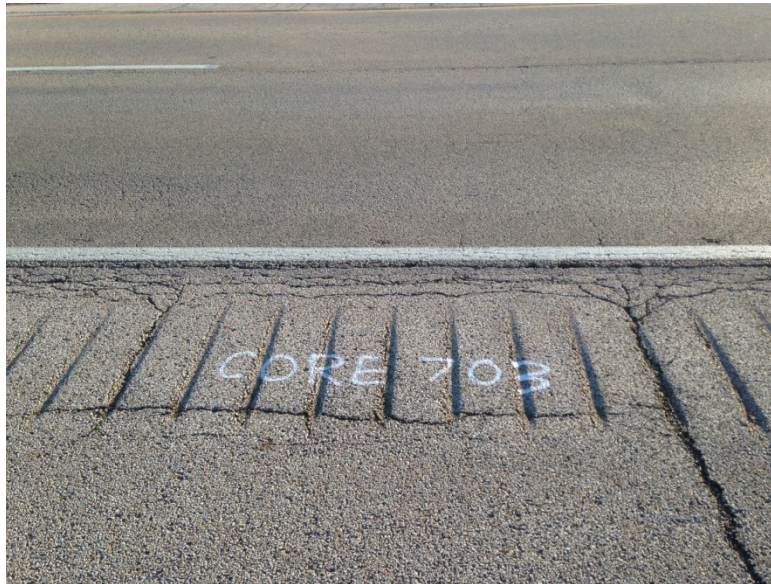
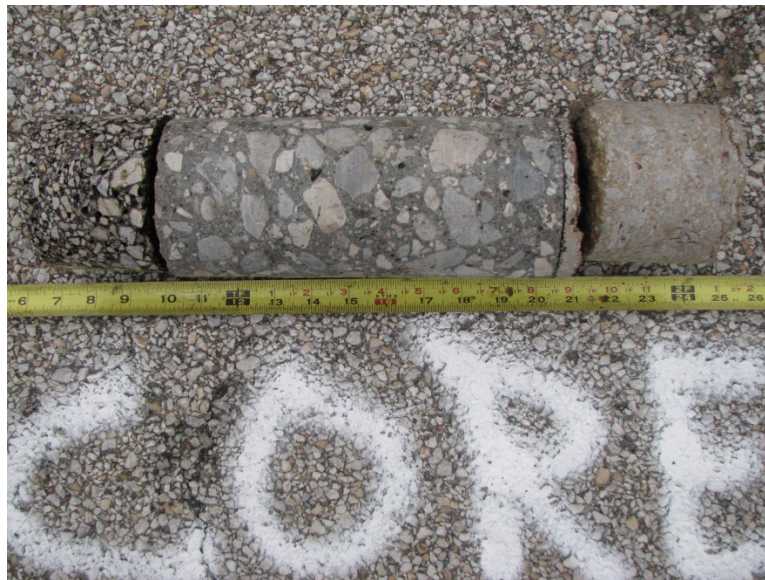
| Comments: | MM 196.00, Good Condition, in cut section | | | | | | |

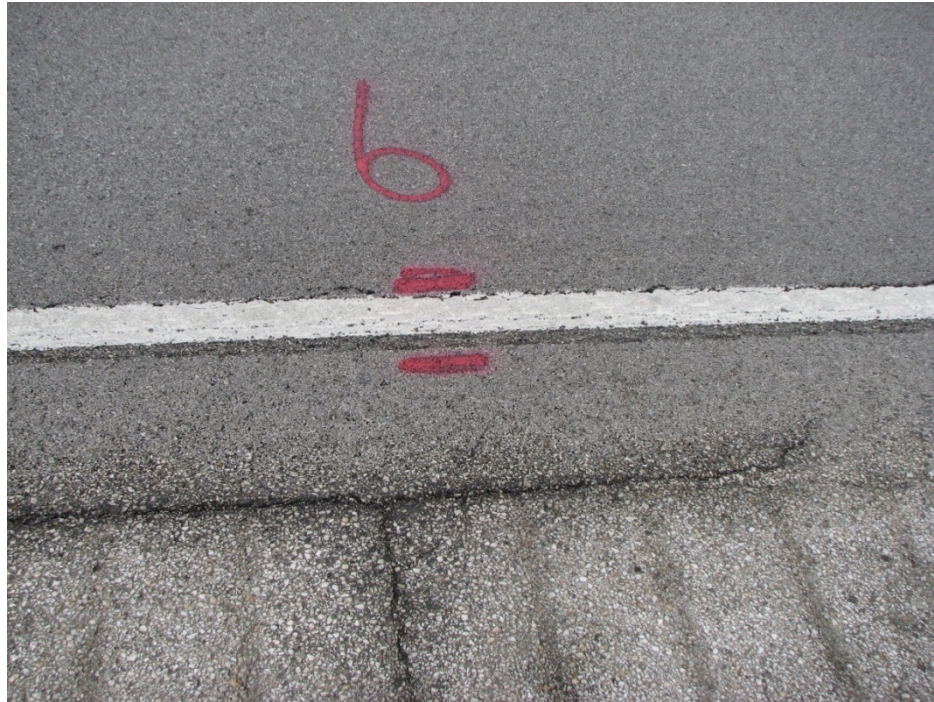
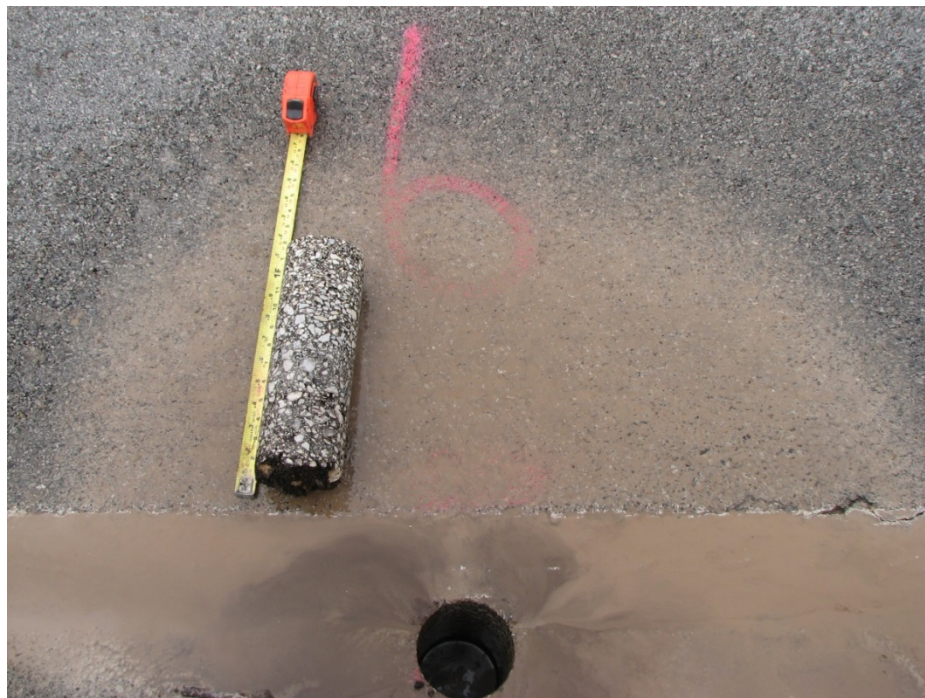
Core #6

6" o/s EOP N.B. Outside Shoulder, M. M. 198.00

| Lift #1 | 3 1/2" HMA Surface Course – Fair Condition – No Cracks – Some Voids |
| Lift #2 | 2 1/2" HMA Binder Course – Fair Condition – No Cracks – Some Voids |
| Lift #3 | 2 1/2" HMA Binder Course – Fair Condition - No Cracks – Some Voids |
| Lift #4 | 3 1/2" HMA Binder Course – Poor Condition – Some Cracks – Some Voids |
