**SN 064-0035
I-24 BRIDGE
Over Ohio River
Metropolis, IL**

2023 Bridge Inspection Report

Bridge Inspection By: Collins Engineers, Inc. and WHKS & Co.

Bridge Inspection Report By: WHKS & Co.

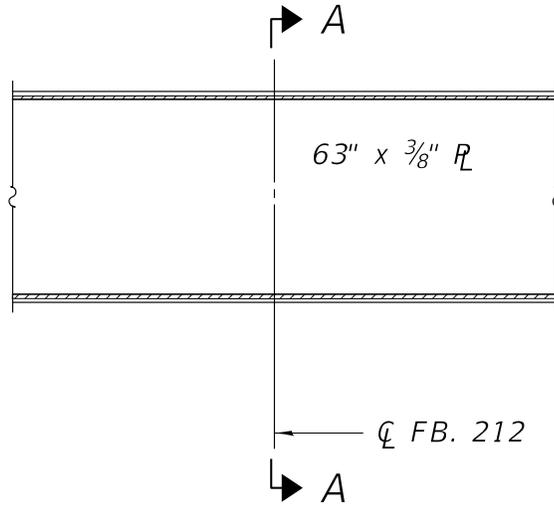
SN 064-0035
 District 9
 Insp Date: 3/6/2023
 Item #208
 Detail 8
 Span 19

93A2-Remarks: Isolated areas with 26% section loss top flange, 22% section loss bottom flange at midspan (Item 208). 1" crack in Floorbeam 32 web near top flange at Stringer 4 (Item 179) has been arrested with 12-month Special Inspection implemented in 2021.

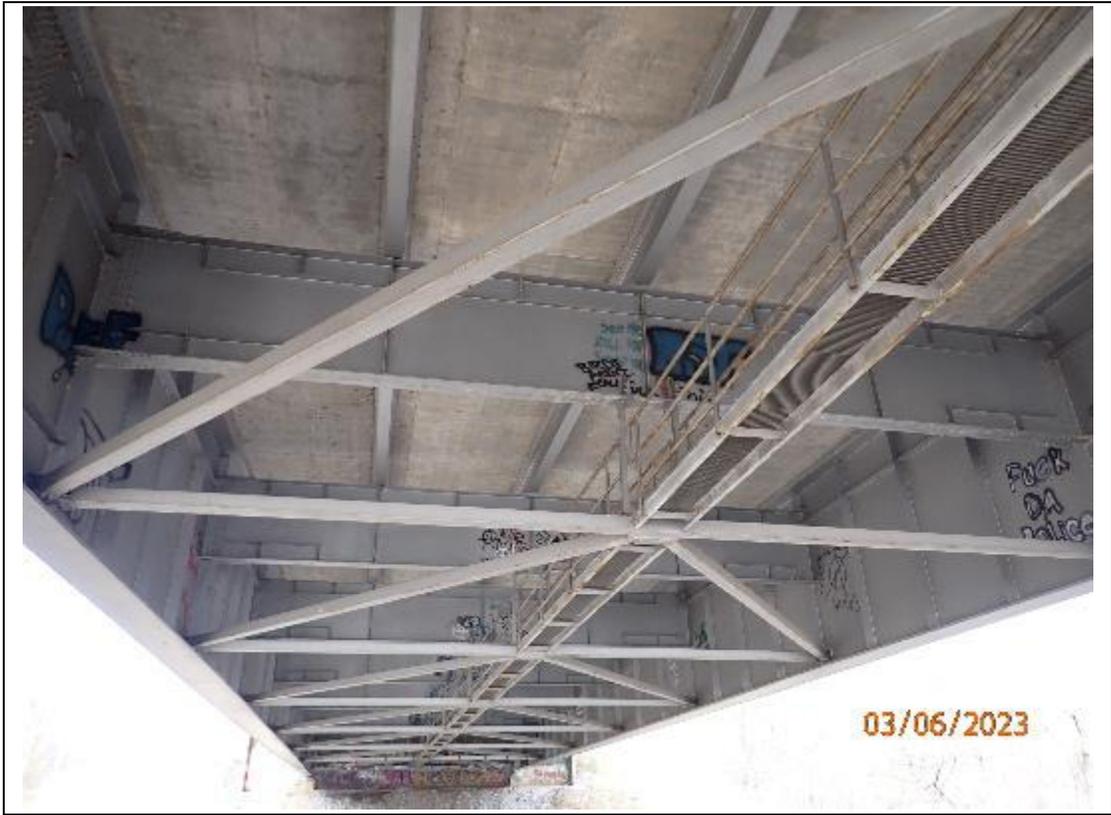
PHOTO 1

Item #	Span(s)	Member(s)	Location(s)	Photo(s)	Deficiency(ies)	Corrective Action	Year	Load Cap. Re-Eval.
1	All	Paint	Typ.	1, 2, 3, 4, 5	See ELI Forms	Zone paint @ joints N/A	2001	
2	All	Deck	Typ.	6, 7, 8, 9, 10	See ELI Forms	N/A	2001	
3	All	Overlay	Typ.	11, 12, 13	See ELI Forms	N/A	2001	
65	All	Parapet	Typ.	14, 15	See ELI Forms Parapet cracking and spalling throughout.	N/A	2009	
226	All	Aluminum Railing	Typ.	16, 17, 18	See ELI Forms Impact damage, broken supports, missing fasteners (See Table 10)	N/A	2021	
227	4&13	Arch Hangers	All rib connection sockets	19 LW	Socket slip up to 1/2", zinc cone seal broken, cotter pin corrosion	N/A	2021	
211	4&13	Gusset Plates	All lower Gus. Plate	20 LNW	Up to 25% SL along Lower Chord	N/A	2019	
143	4&13	Sway Brace	Throughout	21 LNW	Drain holes plugged, retaining water, active corrosion	Repair	2015	
285	4 and 13	Ties	Each End Panel	220 LN	Diaphragm plates added, each end of each tie not accessible for inspection	N/A	2023

Span 1, Looking North

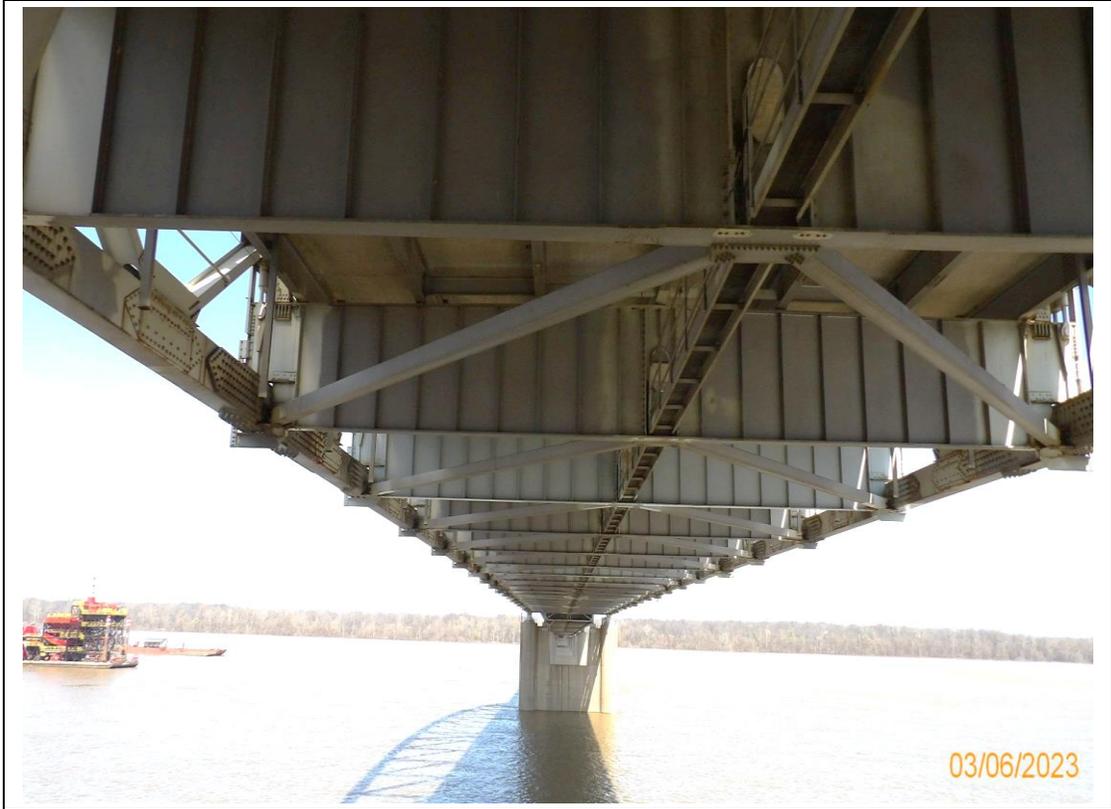
PHOTO 2

Span 13, Looking North

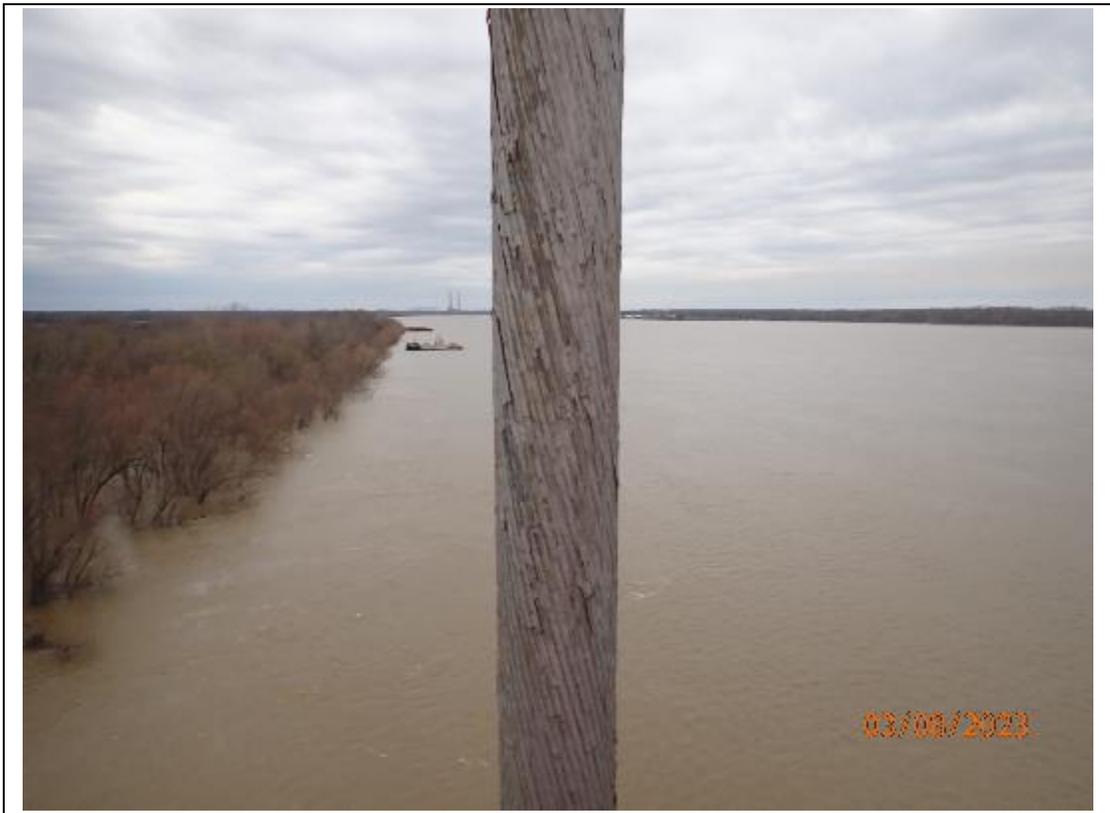
PHOTO 3

Span 13, Looking West

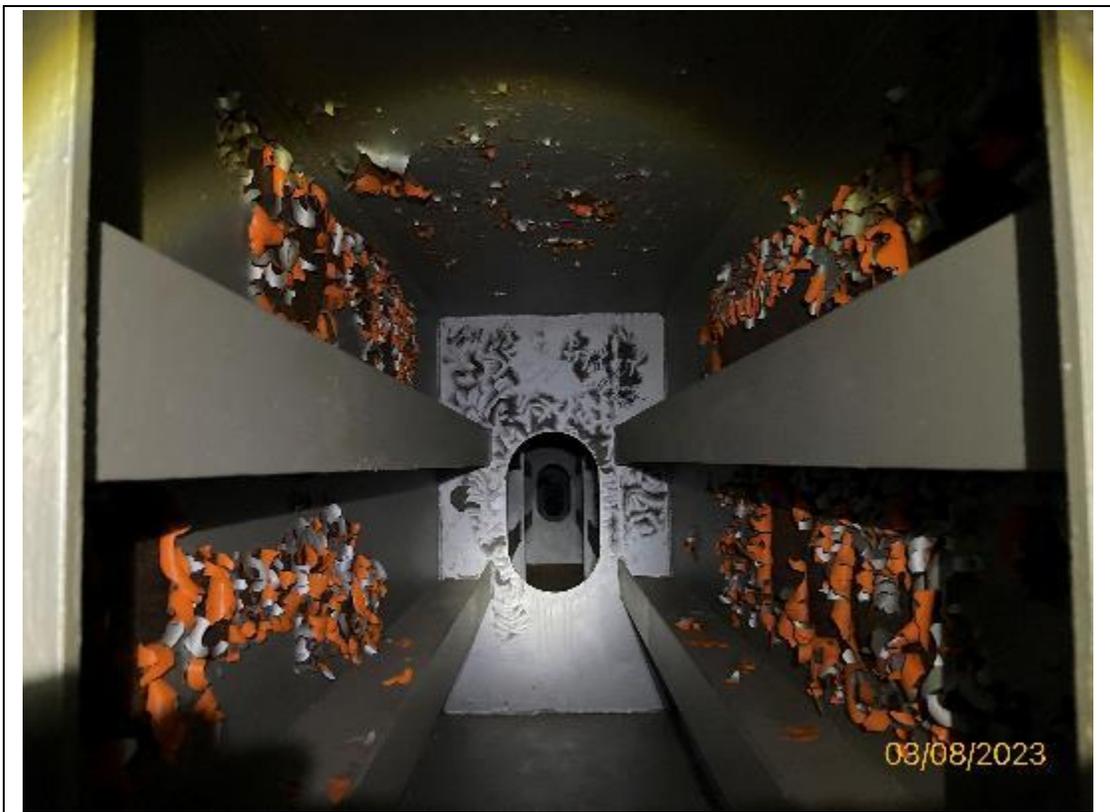
PHOTO 4

Span 13, West Arch, Upper Chamber, Looking South

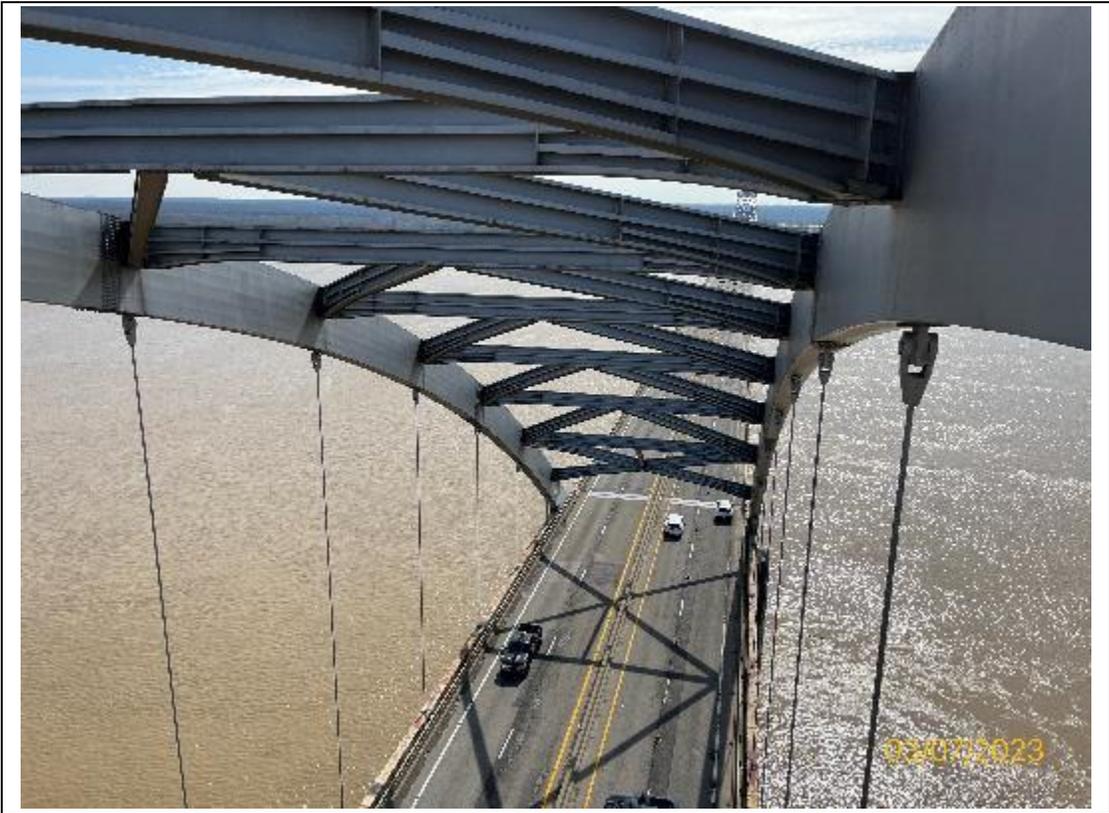
PHOTO 5

Span 4, Looking South

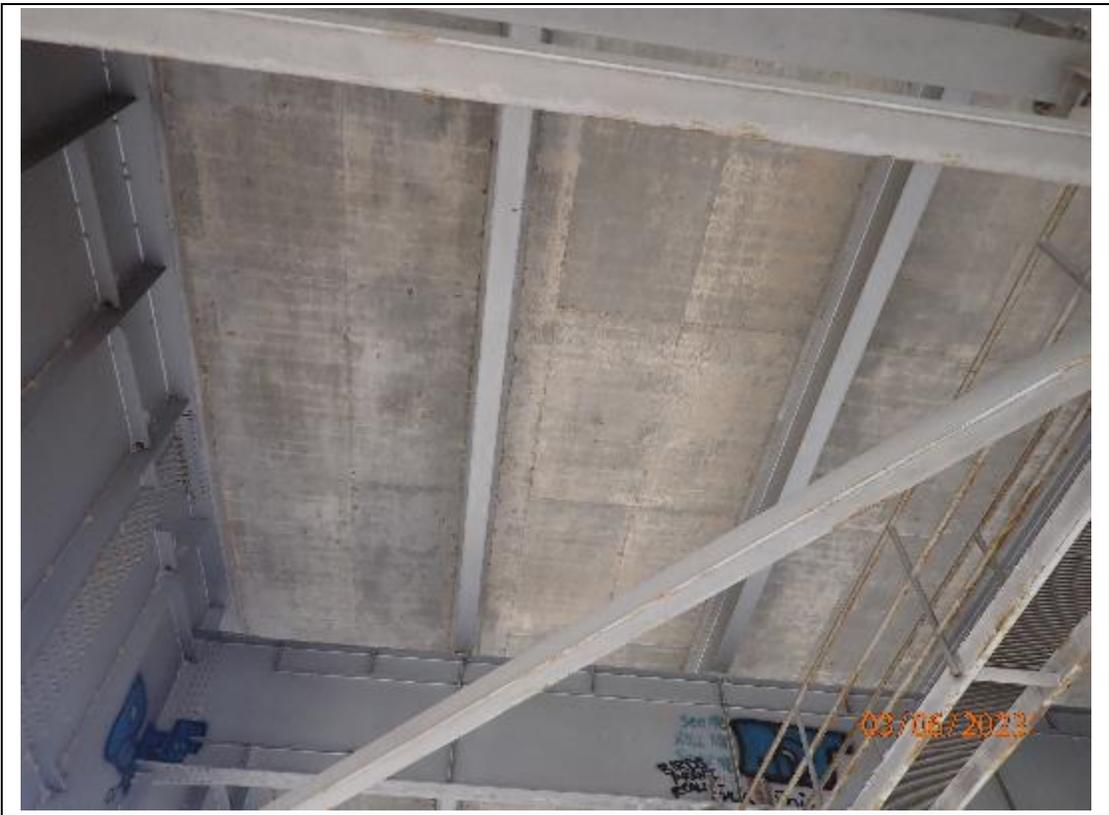
PHOTO 6

Span 1, Looking North

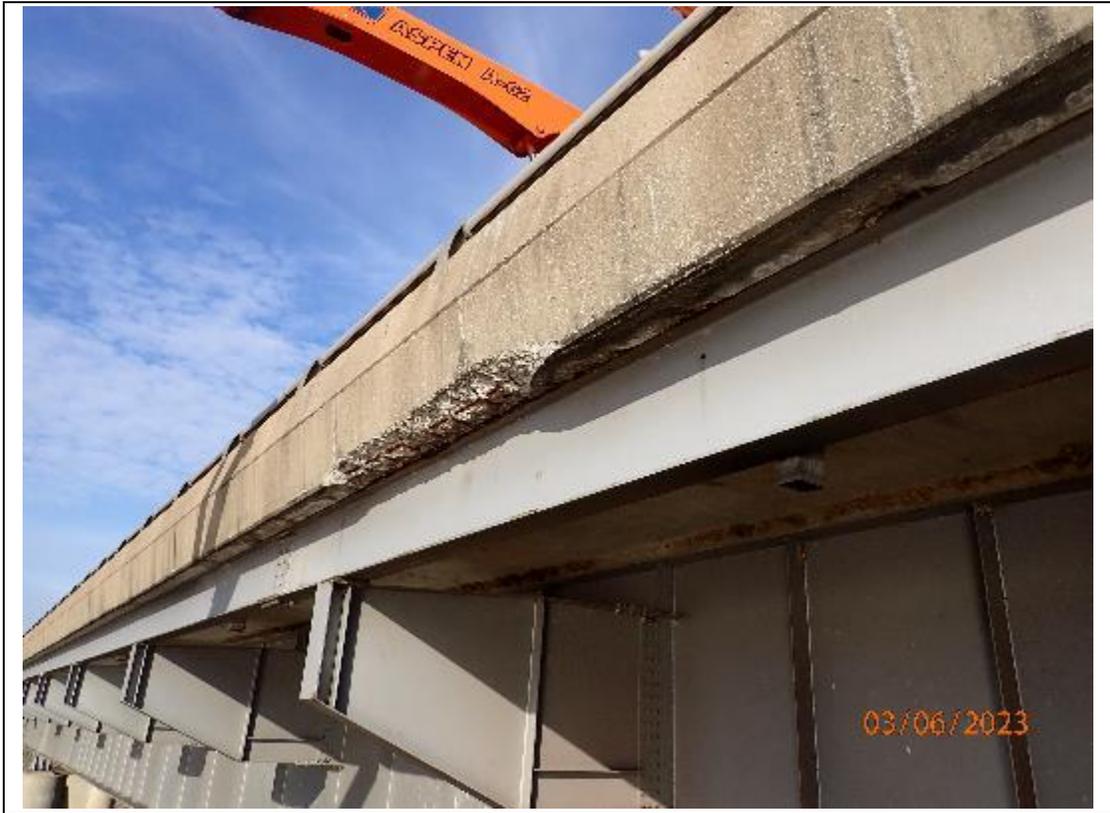
PHOTO 7

Span 3, Looking West

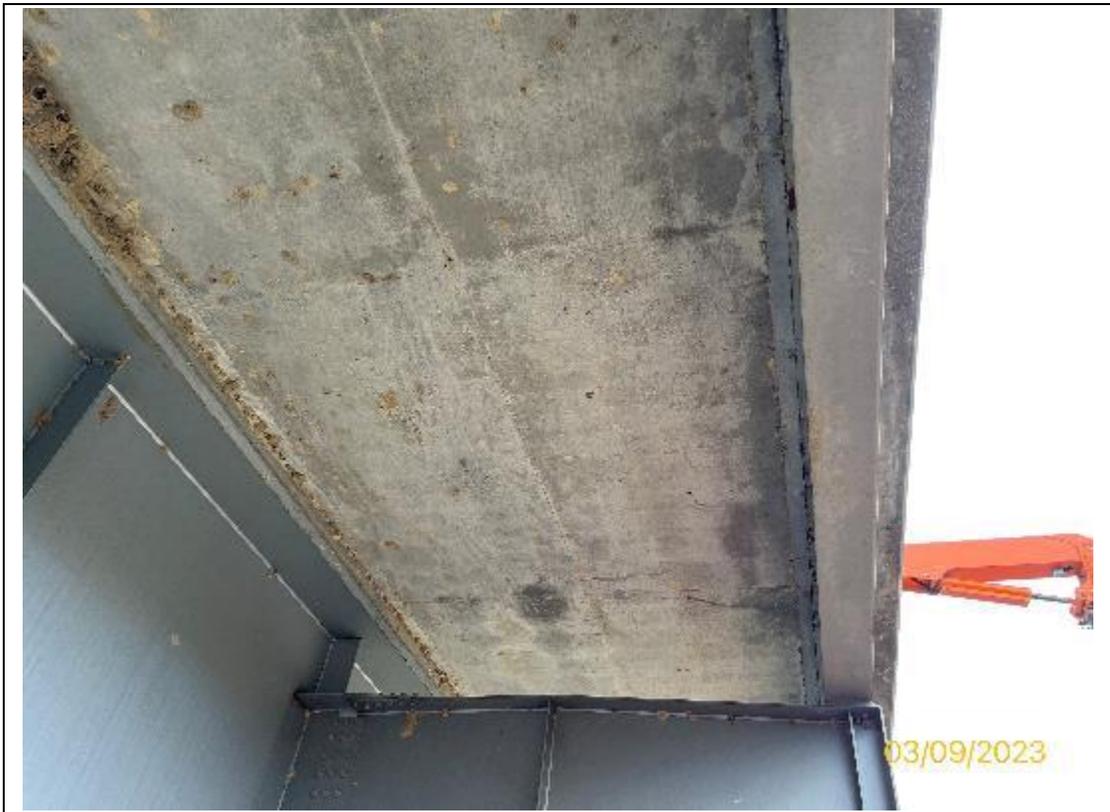
PHOTO 8

Span 19, Looking North

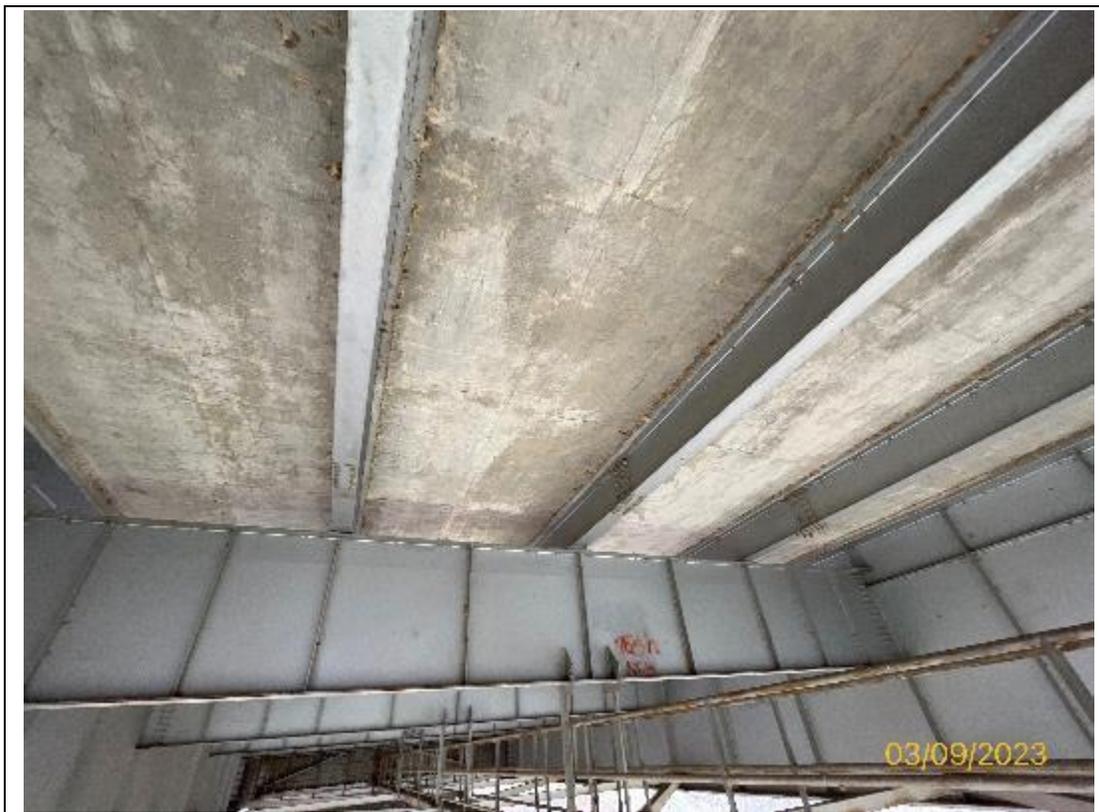
PHOTO 9

Span 19, Looking Southwest

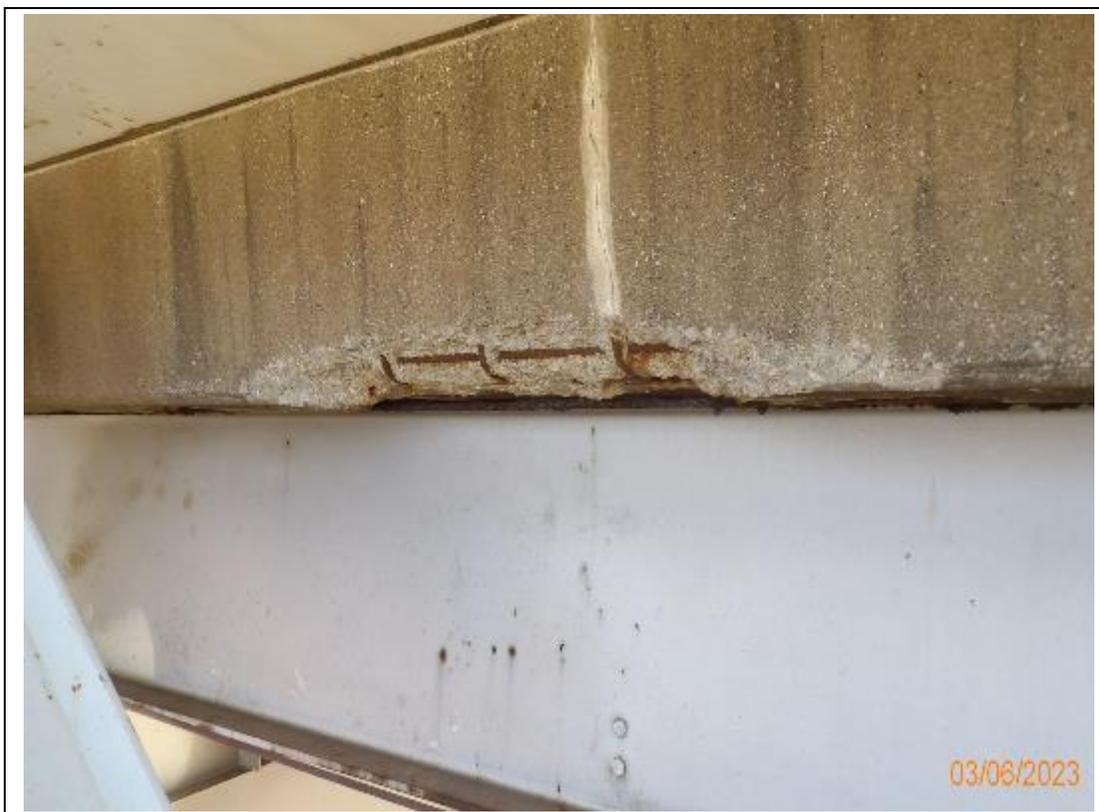
PHOTO 10

Span 13, Looking East

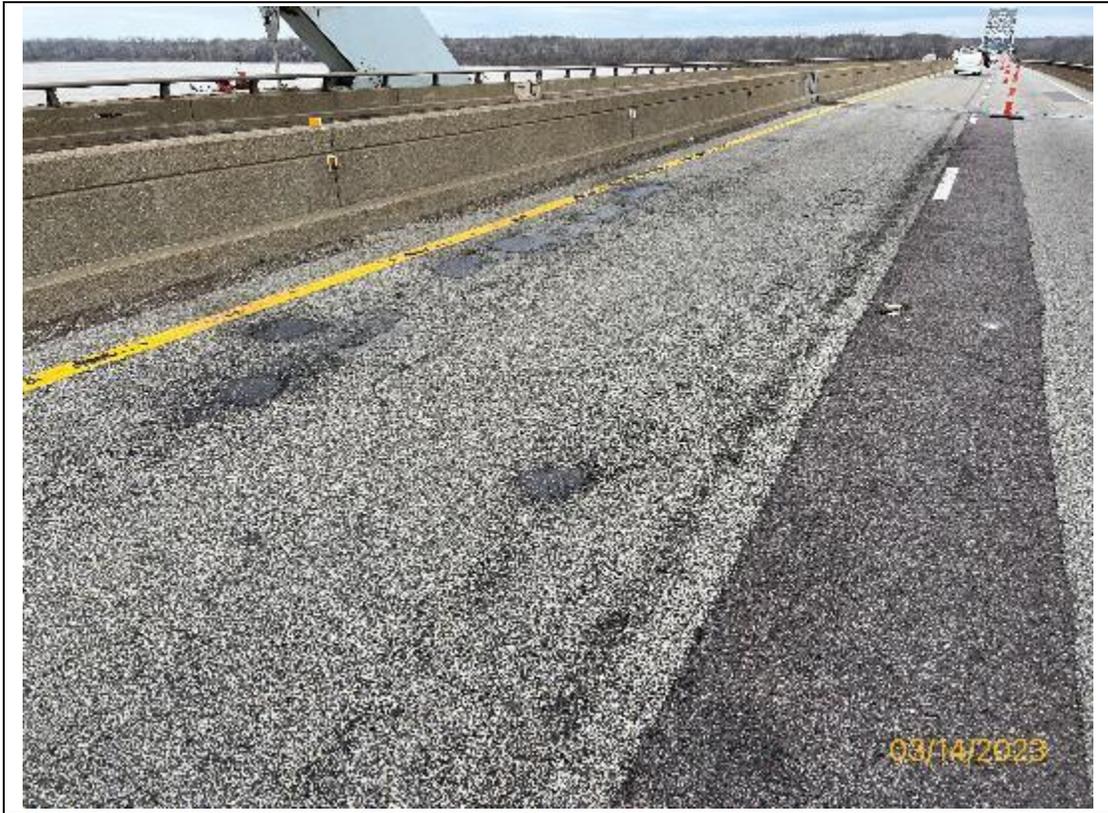
PHOTO 11

Span 13, Looking Northwest

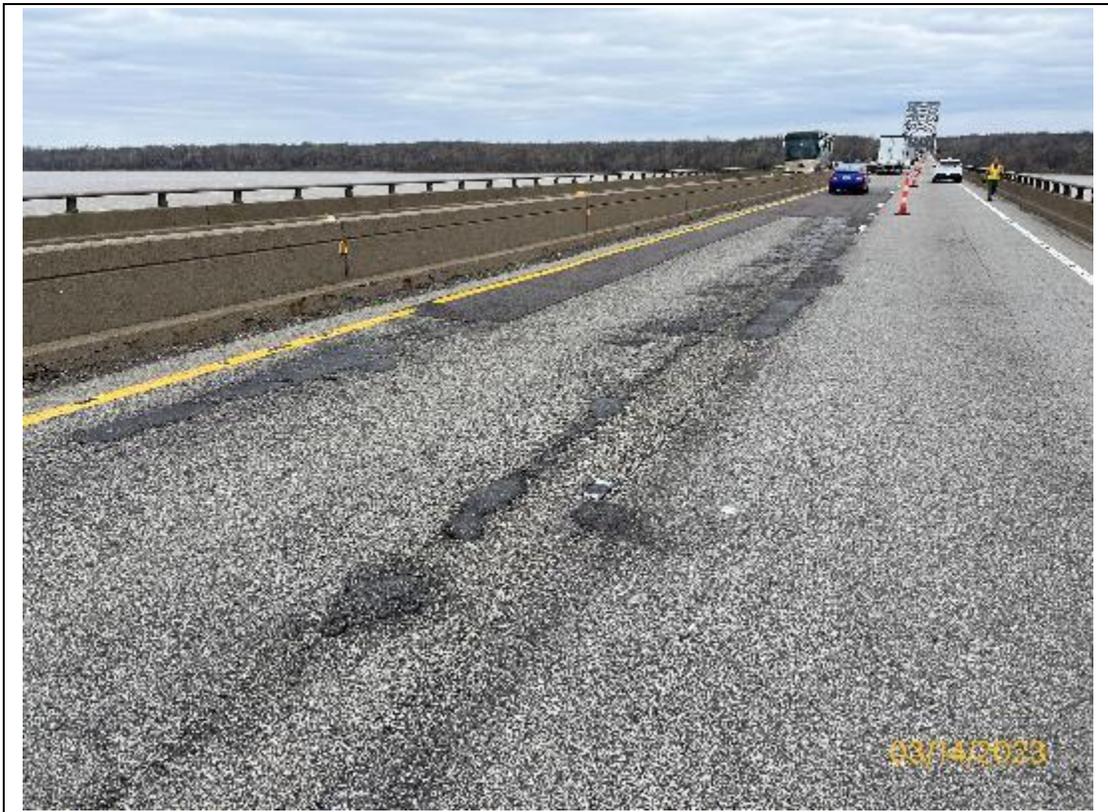
PHOTO 12

Span 11, Looking Northwest

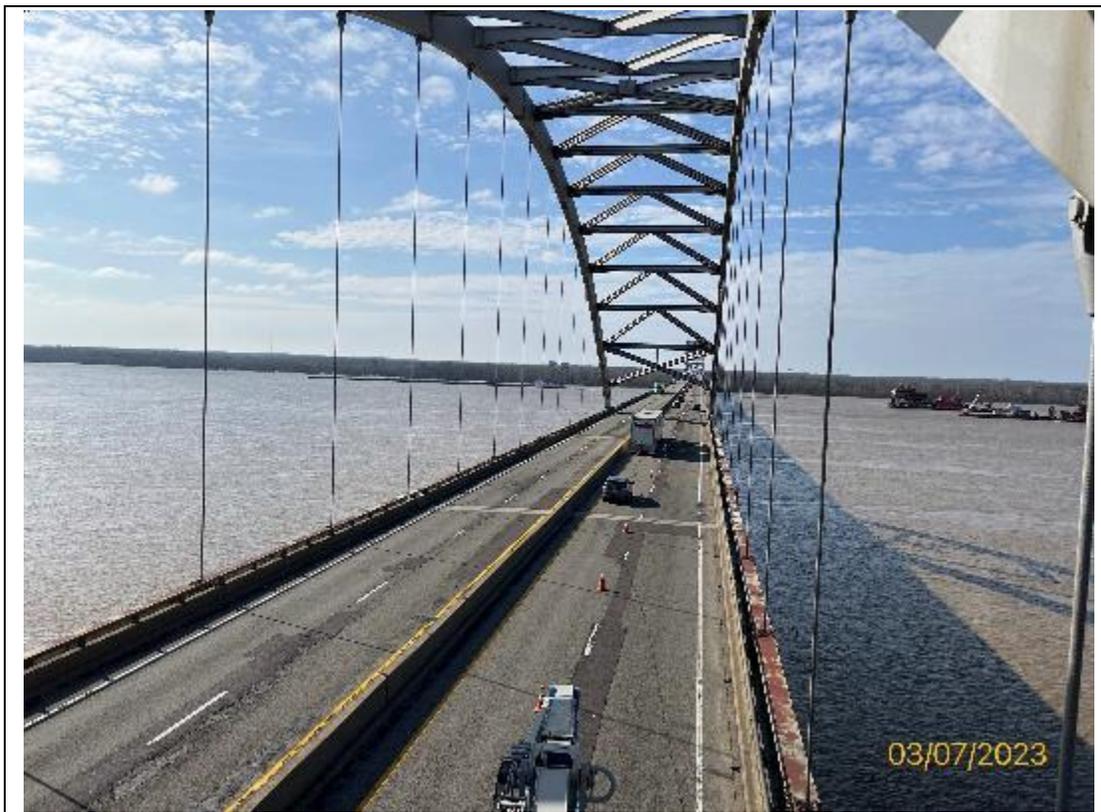
PHOTO 13

Span 4, Looking South

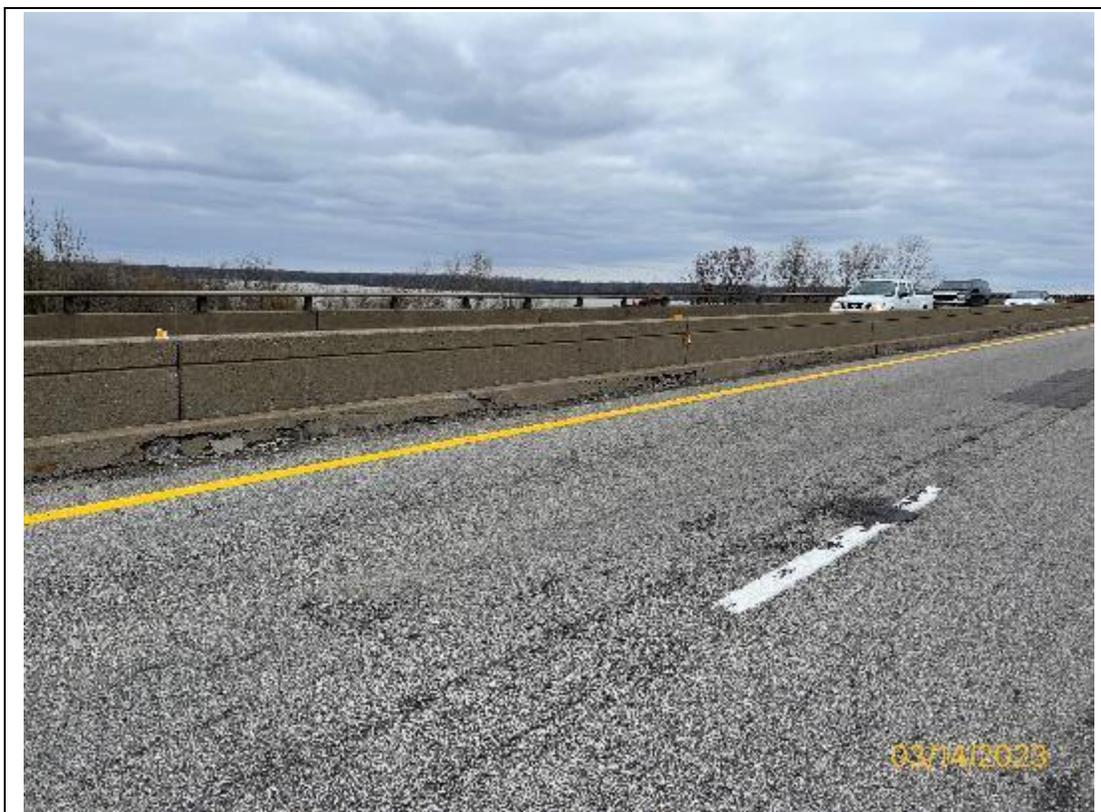
PHOTO 14

Span 16, Looking Northwest

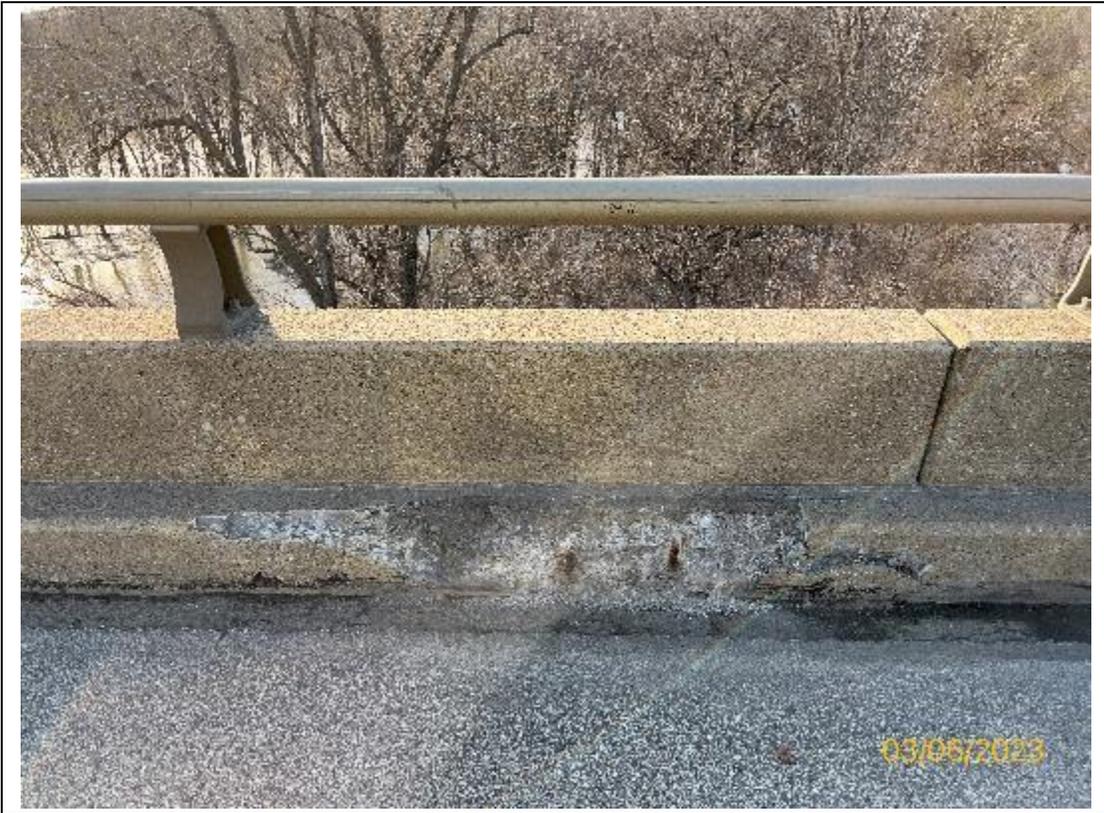
PHOTO 15

Span 16, Looking West

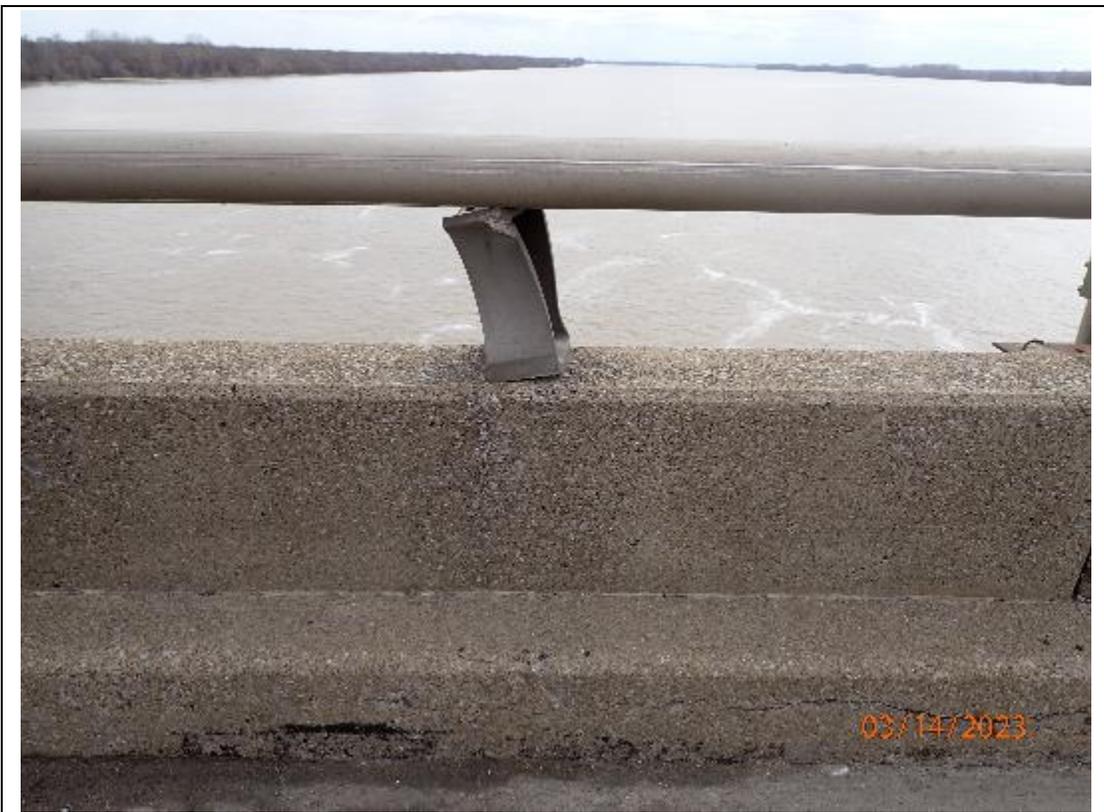
PHOTO 16

Spans 6 & 7, Looking East

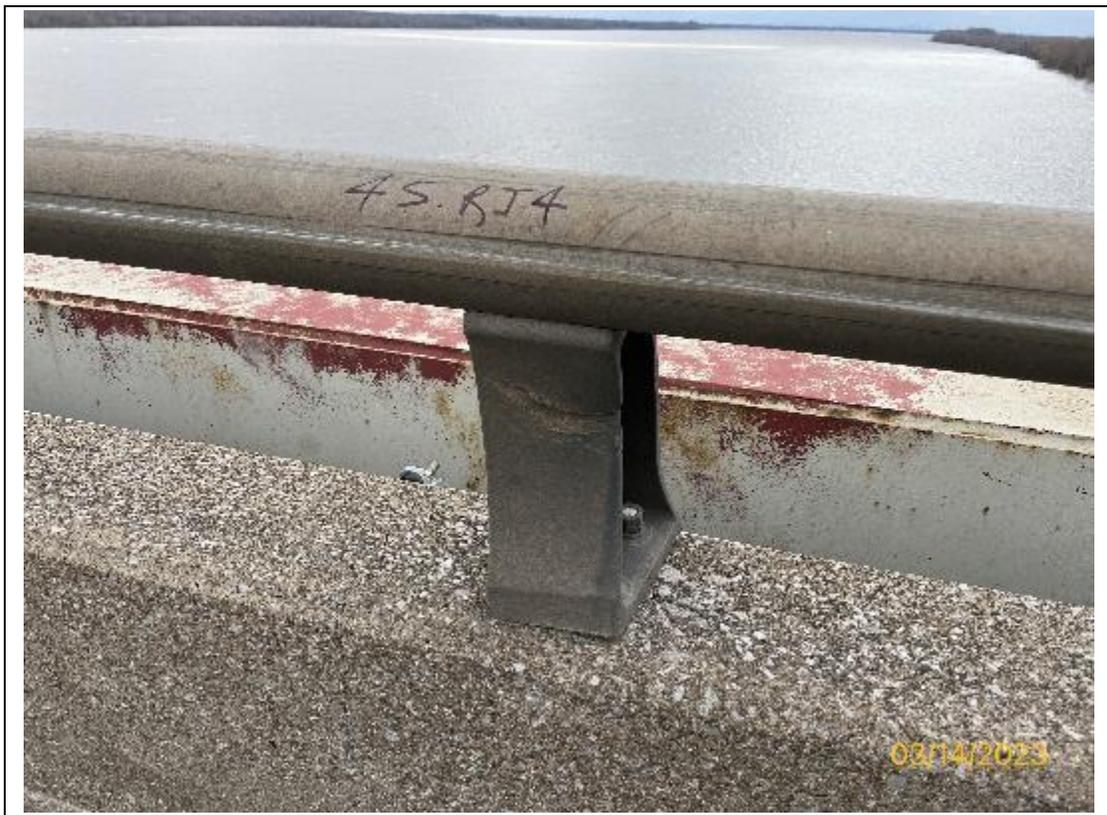
PHOTO 17

Span	Guardrail	Deficiency	Photo
3 & 4	Eastbound @ finger joint	3 twisted brackets	
4	Eastbound, Between T4 & T5	1 twisted bracket	
4	Eastbound, Between T11 & T12	1 twisted bracket	
5,6	Eastbound, @ Pier 5	1 cracked bracket	
6	Westbound, 80 ft north of Pier 6	1 bracket twisted and cracked	
6	Westbound, 88 ft north of Pier 6	1 bracket gouged	
6,7	Westbound, @ Pier 6	1 bracket twisted and cracked	16 (LE)
7	Eastbound, @ Pier 6	1 twisted bracket	
7	Eastbound, 9 th & 10 th brackets north Pier 7	2 twisted brackets	
10	Westbound, 19 th bracket south Pier 9	1 twisted bracket	
11	Westbound, 12 th & 22 nd brackets from P11	2 brackets twisted and cracked	
12	Westbound, 2 nd , 3 rd , & 4 th brackets from P11	3 cracked brackets	
13	Eastbound, 8 th , 9 th , 10 th , 17 th , 42 nd , and 43 rd brackets from P12	6 twisted, cracked, and broken brackets	
13	Westbound, 4 th bracket south T4	1 twisted and gouged bracket	17 (LNE)

Span 13, Looking Northeast

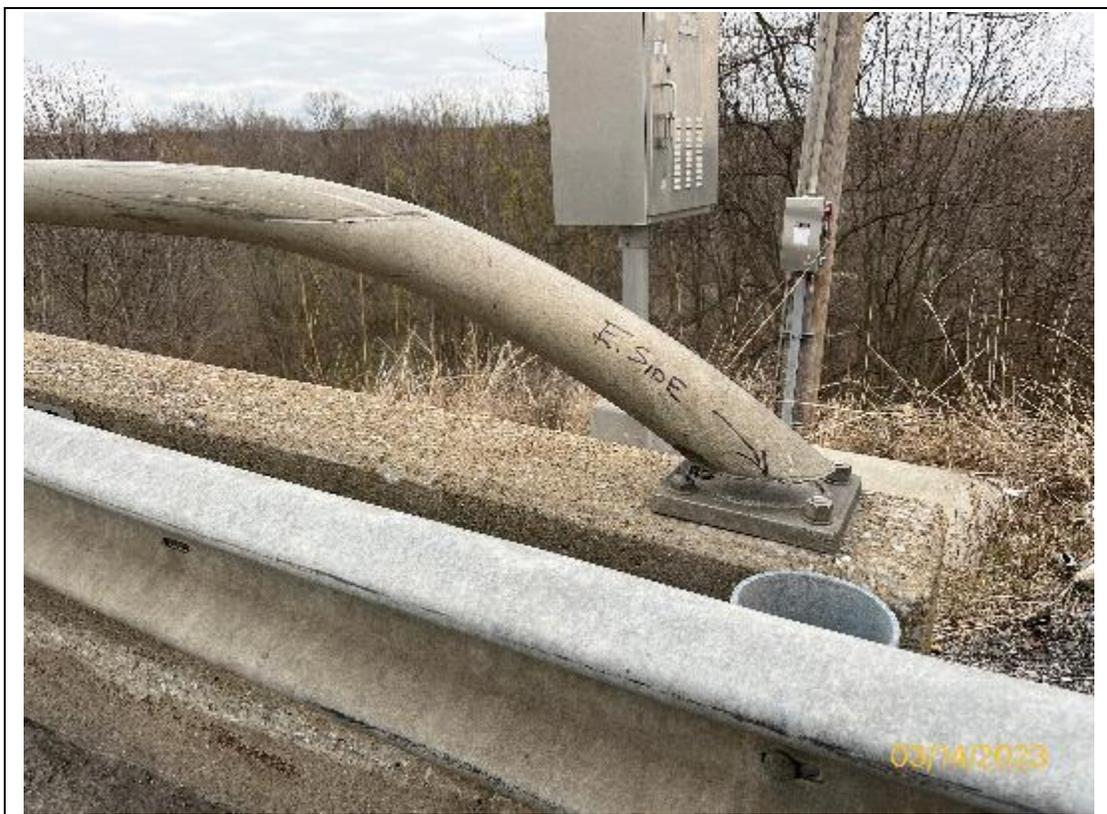
PHOTO 18

15	Eastbound, 15 ft south Pier 14	1 twisted and cracked bracket	
15	Westbound, 11 th bracket from P15	1 bracket gouged	
18	Eastbound, 1 st , 2 nd , & 3 rd south Pier 18	3 twisted brackets	
19	Eastbound, 1 st , 2 nd , & 3 rd brackets from South Abut.	3 brackets twisted and railing weld broken at termination	
19	Westbound, S. Abut.	Weld broken at termination	18 (LE)

Span 19, Looking East

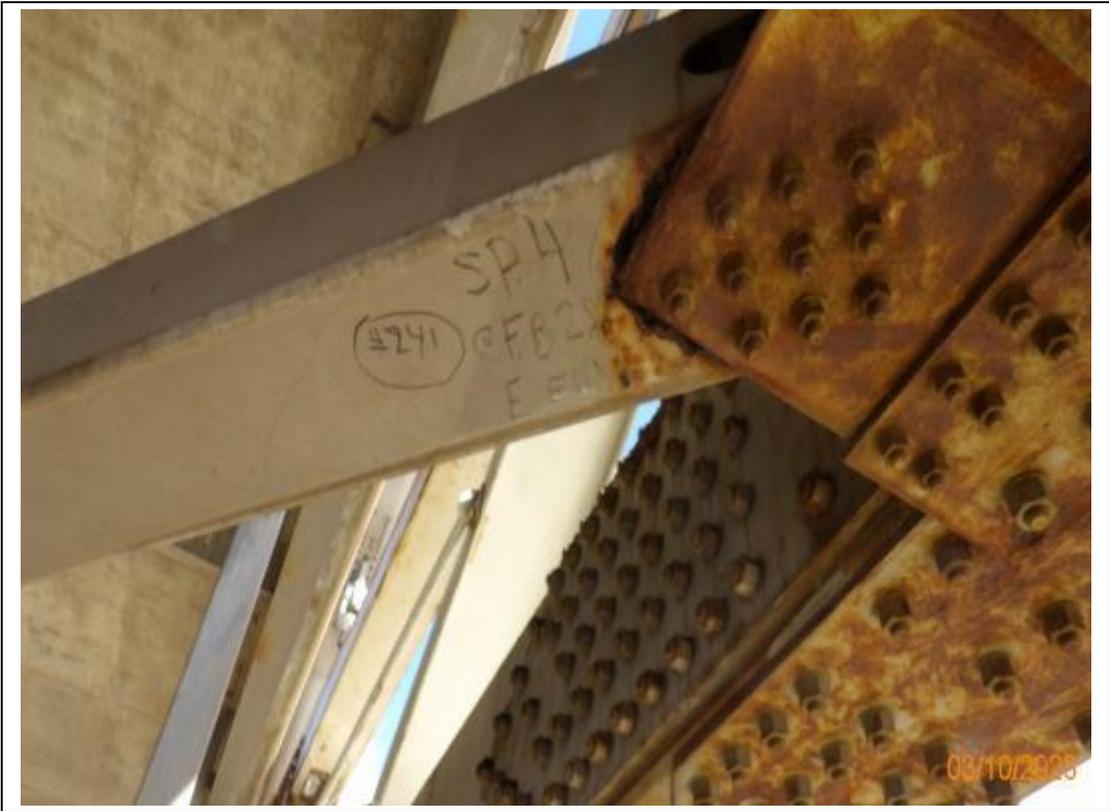
PHOTO 52

Item #	Span(s)	Member(s)	Location(s)	Photo(s)	Deficiency(ies)	Corrective Action	Year	Load Cap. Re-Eval.
177	4	West Arch	5' North of R2, upper chamber, inside Web	52 LS	3" x 1/2" offset in longitudinal stiffener	N/A	2017	
241	4	Lateral Brace	@ Floorbeam 28, East end	53 LE	50% SL, 12" x 1"L hole in bottom plate	Repair	2021	
178	4	West Arch	@ R2, upper chamber, outside Web, North side of horz. stiffener & South diaphragm connection	54 LS	2" crack weld of longitudinal stiffener to diaphragm	N/A	2017	
7	4	East Arch	@ R2, lower chamber, inside Web @ bottom	55 LSW	1" crack in weld @ hanger plate to Web	N/A	2003	
8	4	Floorbeam 29	@ West Tie	56 LW	1 missing bolt	Repair (must be inside & out to replace) (6½" bolt required)	2005	
90	4	West Arch	@ R3, lower chamber, outside Web, South side of hanger @ bottom	57 LN	1 1/4" crack in Web to hanger plate	N/A	2011	
92	4	East Arch	Midpoint between R4 & R5, upper chamber, inside Web @ top plate	58 LSW	1" crack in Web to diaphragm	N/A	2011

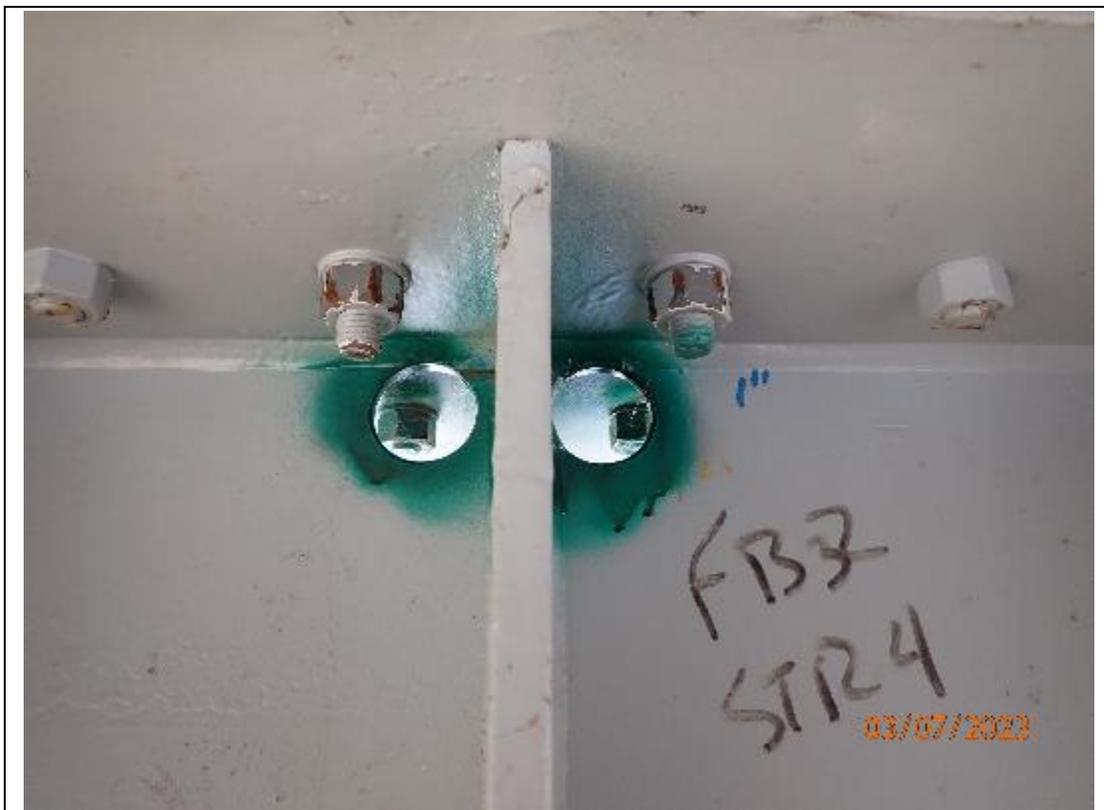
PHOTO 59

147	4	Floorbeam 31	@ midspan	59 LNW	1% SL, 2-5/8" misdrilled holes in Web, 1 in section	N/A	2015	
179	4	Floorbeam 32	@ midspan, East & West sides of catwalk & top. Flange	60 LS 61 LS	2 – 1" holes in web near top flange – crack arrestor holes, 3 – 1/2" holes (West side) & 2 – 1" holes (East side) in Web – all misdrilled holes	Monitor (2 Crack Arrestor Holes – 2023)	2017	
288	4	East Tie	3' south of T6 at splice	223 LNW	Missing lower cover plate	Repair	2023	
289	4	East Arch	4' North of R6, Lower Chamber, Inside Web	224 LNW	1 loose bolt/nut in horizontal splice plate	Repair	2023	
12	4	West Arch	@ R6, lower chamber, outside Web @ bottom plate	62 LS	1 1/2" crack in Web to hanger plate	N/A	1995

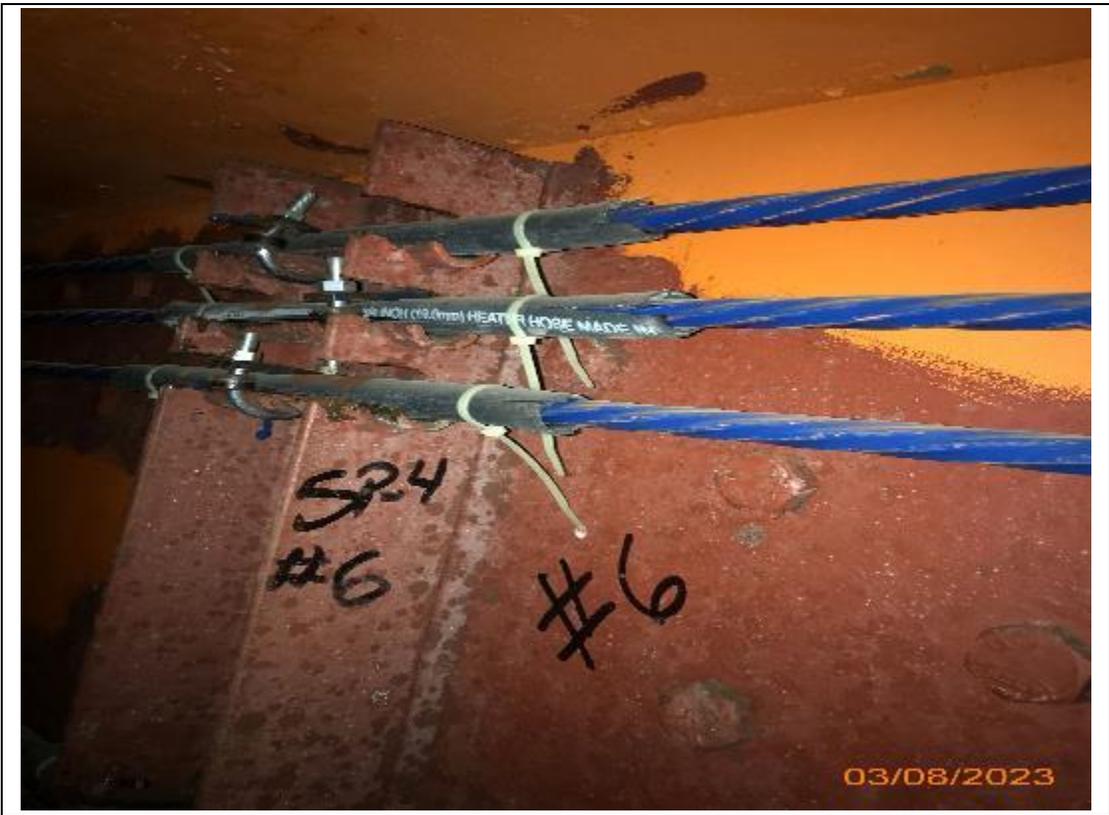
PHOTO 63

Item #	Span(s)	Member(s)	Location(s)	Photo(s)	Deficiency(ies)	Corrective Action	Year	Load Cap. Re-Eval.
94	4	East Arch	@ R6, lower chamber, inside Web	63 LSW	Hanger not welded to horizontal stiffener @ South Side	N/A	2011	
242	4	West Tie	@ T6, outside upper post tension cables	64 LSW	Post tensioning hardware is loose, protective sleeves are wearing from vibration	Repair	2021	
14	4	West Arch	Diaphragm between R7 & R8, upper chamber @ top plate	65 LS	Improper fit between diaphragm & top plate, 1/2" gap	N/A	1995	
148	4	Floorbeam 33	@ midspan	66 LS	1% SL, 2-1/2" & 4-5/8" misdrilled holes in Web, 1 in section	N/A	2015	
95	4	Floorbeam 34	@ Stringer 3, top	67 LNW	1 % SL, 1" crack w/ arrester hole (See Detail 5)	N/A	2011	
290	4	East Arch	Between R8 and R9, Upper Chamber	225 LS	Bird house and debris	Remove/Clean	2023	
15	4	West Arch	Between R8 & R9 @ Peak, upper chamber	68 LS 69 LW	Standing water 1" deep, 3/4" open hole in inside Web plate @ bottom	Repair (Damp 2023)	1995

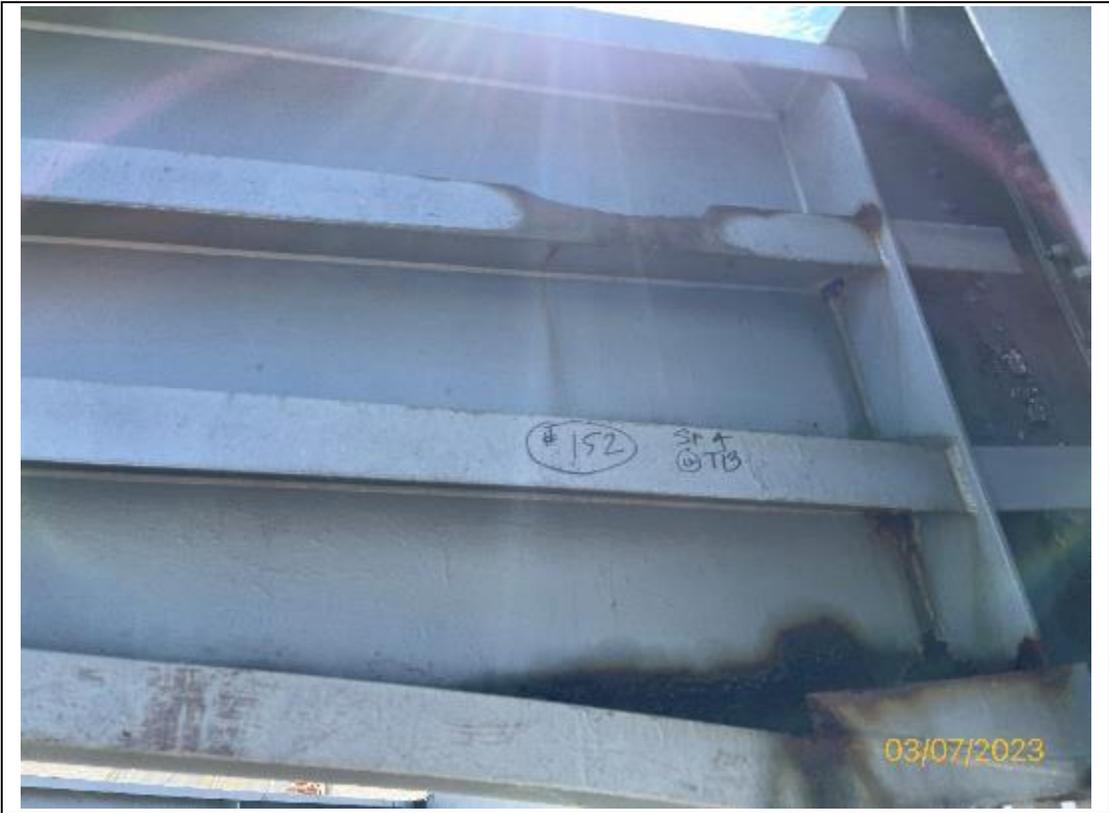
PHOTO 78

Item #	Span(s)	Member(s)	Location(s)	Photo(s)	Deficiency(ies)	Corrective Action	Year	Load Cap. Re-Eval.
292	4	East Tie	5' north of T11 at center opening	227 LN	Water intrusion. Source of intrusion appears to be from the access hatch.	Repair - remove water/corrosion and reseal access hatch	2023	
293	4	Stringer 2	@ Floorbeam 37, Panel 36	228 LS	1 missing bolt, 1 loose bolt	Repair	2023	
212	4	Floorbeam 37	@ Stringer 3, under bearing plate	75 LNE	4% SL in Top Flange, 1.08" avg. rem., 1 1/8" nom.	N/A	2019	
180	4	Stringer 3	@ Floorbeam 37, Panel 38	75 LN	1 broken bolt in Stringer to Floorbeam connection	Repair	2017	
213	4	Stringer 5	@ Floorbeam 37, Panel 38	76 LN	1 broken bolt in Stringer to Floorbeam connection	Repair	2019	
151	4	Stringer 6	@ Floorbeam 37, Panel 38	77 LN	2 broken bolts in Stringer to Floorbeam connection	Repair	2015	
128	4	West Arch	Between R11 & R12, upper chamber, inside Web	78 LS	2-1/2" cracked welds at top 1 st & 2 nd stiffener South of T11	N/A	2013

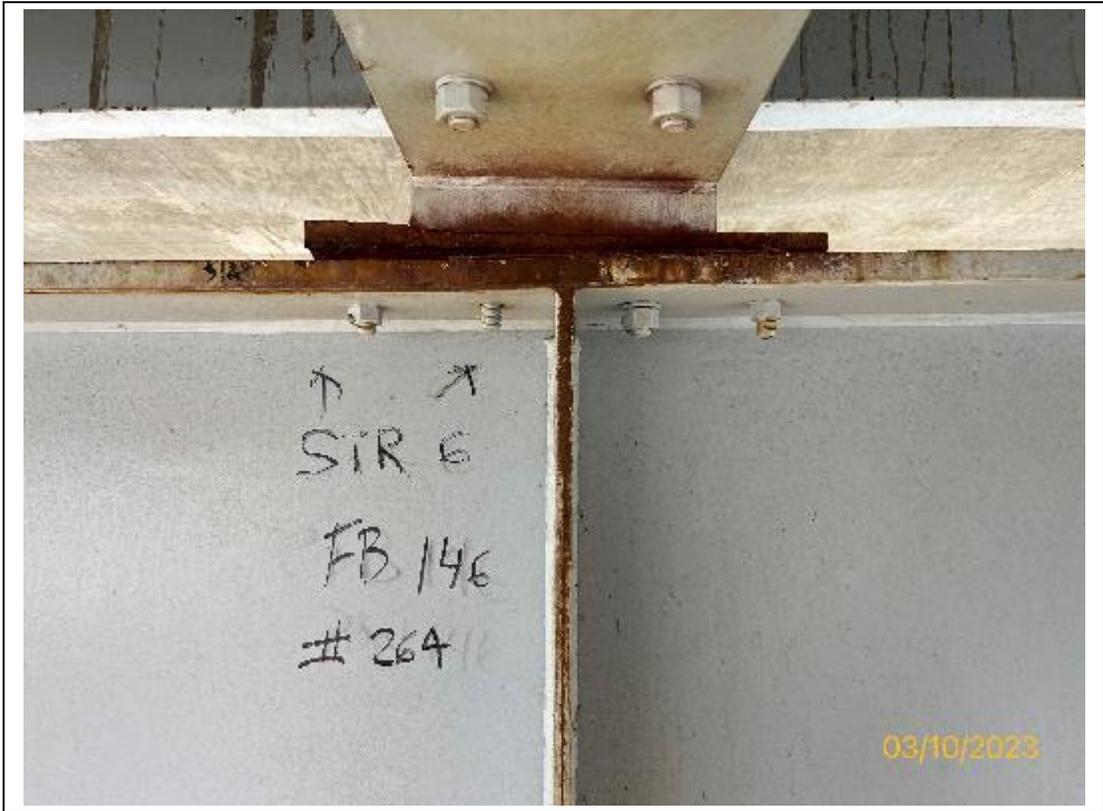
PHOTO 140

223	13	Floorbeam 146	East of Stringer 5, under bearing plate	140 LSW	17% SL in Top Flange, (See Detail 11)	Repair 17% SL, Top Flange IRF=0.50	2019	
188	13	Stringer 5	@ Floorbeam 146, Panel 146	140 LSW	Bearing plate offset 3/4" due to pack rust	N/A	2017	
264	13	Stringer 6	@ Floorbeam 146, Panel 146	141 LSW	1 bolt w/ missing nut in Stringer to Floorbeam connection	Repair	2021	
303	13	East Arch	@ R4, Lower Chamber	238 LSW?	Full-length crack in weld between longitudinal stiffener and diaphragm plate.	N/A	2023	
304	13	East Arch	First stiffener from R4, Lower Chamber	239 LNE	Full-length crack in weld between longitudinal stiffener and vertical stiffener.	N/A	2023	
305	13	Stringer 6	@ Floorbeam 146, Panel 146	240 LN	1 broken bolt in Stringer to floorbeam connection	Repair	2023	
306	13	Stringer 4	@ Floorbeam 146, Panel 146	241 LNW	1 broken bolt in Stringer to floorbeam connection	Repair	2023
