**SN 064-0035
I-24 BRIDGE
Over Ohio River
Metropolis, IL**

2023 Bridge Inspection Report

Bridge Inspection By: Collins Engineers, Inc. and WHKS & Co.

Bridge Inspection Report By: WHKS & Co.

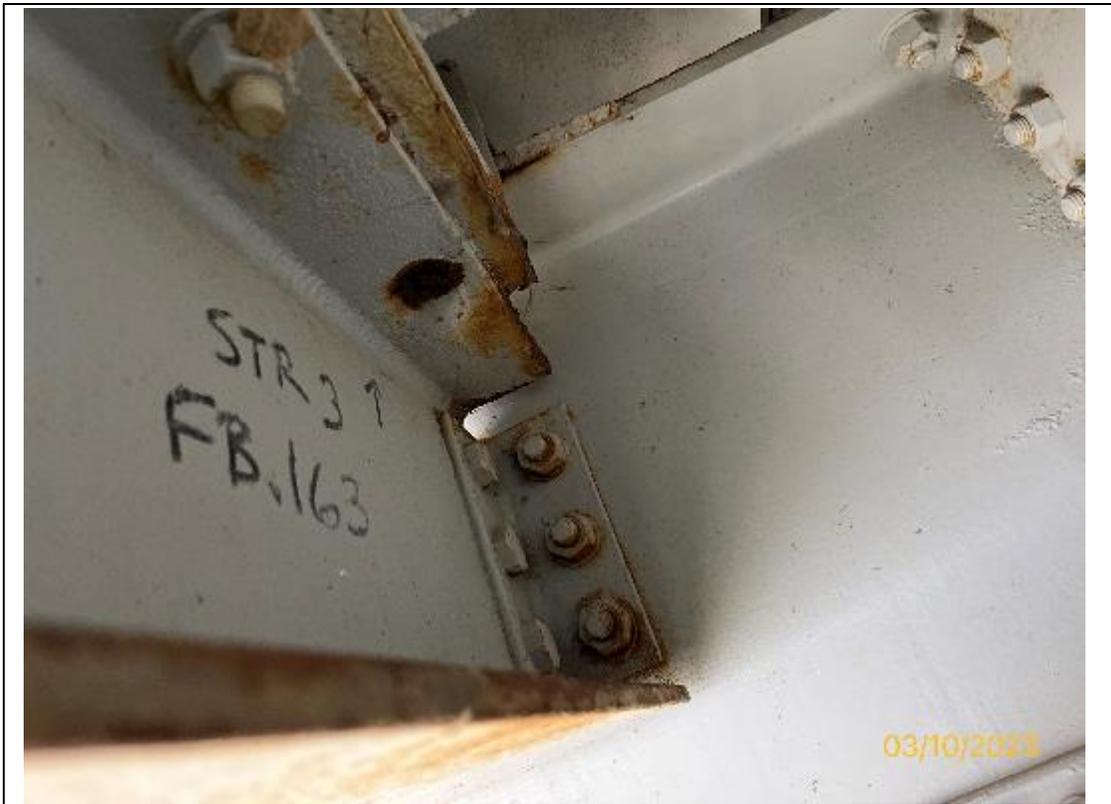
PHOTO 197

Item #	Span(s)	Member(s)	Location(s)	Photo(s)	Deficiency(ies)	Corrective Action	Year	Load Cap. Re-Eval.
276	13	Stringer 2	@ Floorbeam 163, Panel 163	197 LS	1 broken bolt in Stringer to Floorbeam connection	Repair	2021	
277	13	Diaphragm	@ Floorbeam 163, between Stringer 2 & Stringer 3	198 LE	1 broken bolt in Top Flange	Repair	2021	
201	13	Stringer 3	@ Floorbeam 163, Panel 163	199 LS	4 broken bolts in Stringer to Floorbeam connection	Repair	2015	
202	13	Stringer 4	@ Floorbeam 163, Panel 163	200 LS	1 broken bolt in Stringer to Floorbeam connection, 1 broken bolt in Top Flange	Repair	2015	
203	13	Stringer 5	@ Floorbeam 163, Panel 163	201 LS	2 broken bolts in Stringer to Floorbeam connection	Repair	2015	
278	13	Diaphragm	@ Floorbeam 163, between Stringer 6 & Stringer 7	202 LSE	1 broken bolt in Top Flange	Repair	2021	
279	13	Stringer 7	@ Floorbeam 163, Panel 163	203 LSE	Stringer pumping 1/16" @ bearing	N/A	2021

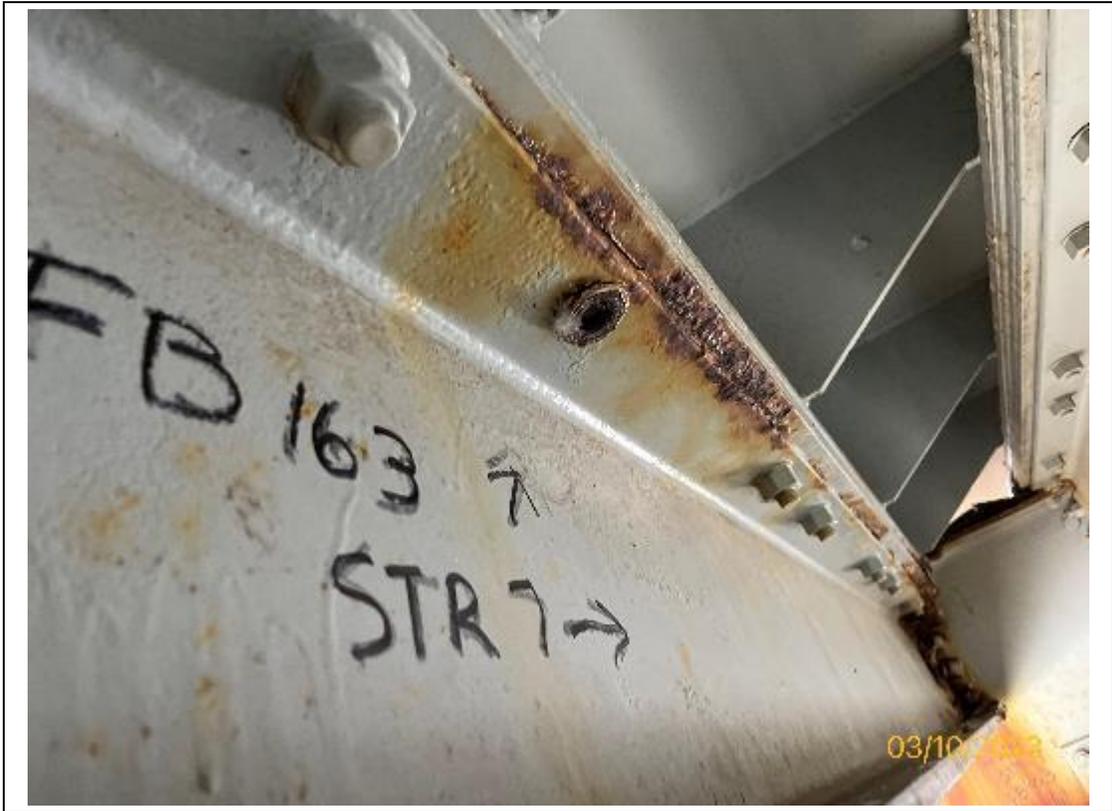
PHOTO 204

122	13	Floorbeam 163	Midspan, Bottom Flange	204 LN	8% SL, 40"L x 9" area of loss, 0.85" avg. rem, nom. 1" x 18"	N/A	2011	
205	13	Finger Joint Support	@ Floorbeam 163, between Stringer 6 & Stringer 7	205 LSE	1 missing bolt in Top Flange (Not shown in picture)	Repair	2017	
280	14	Finger Joint Support	@ Floorbeam 164, between Stringer 4 & Stringer 5	206 LN	4 missing bolts in Top Flange	Repair	2021	
281	14	Stringer 4	@ Floorbeam 164, Panel 164	207 LN	1 broken bolt in Stringer to Floorbeam connection	Repair	2021	
139	14	Diaphragm	@ Floorbeam 164, Between East Girder & Stringer 7	208 LNE	100% SL Bottom Flange @ Stringer 7, 9% SL Web, 1"x15"L hole, & 2 missing bolts in diaphragm connection to expansion joint	Repair	2013	
204	14	Catwalk	Connection to support channel, West side, @ Floorbeam164	209 LNW	11% SL in Web, 100% SL Top Flange, connection plate bent out due to pack rust (See Detail 7)	N/A	2017

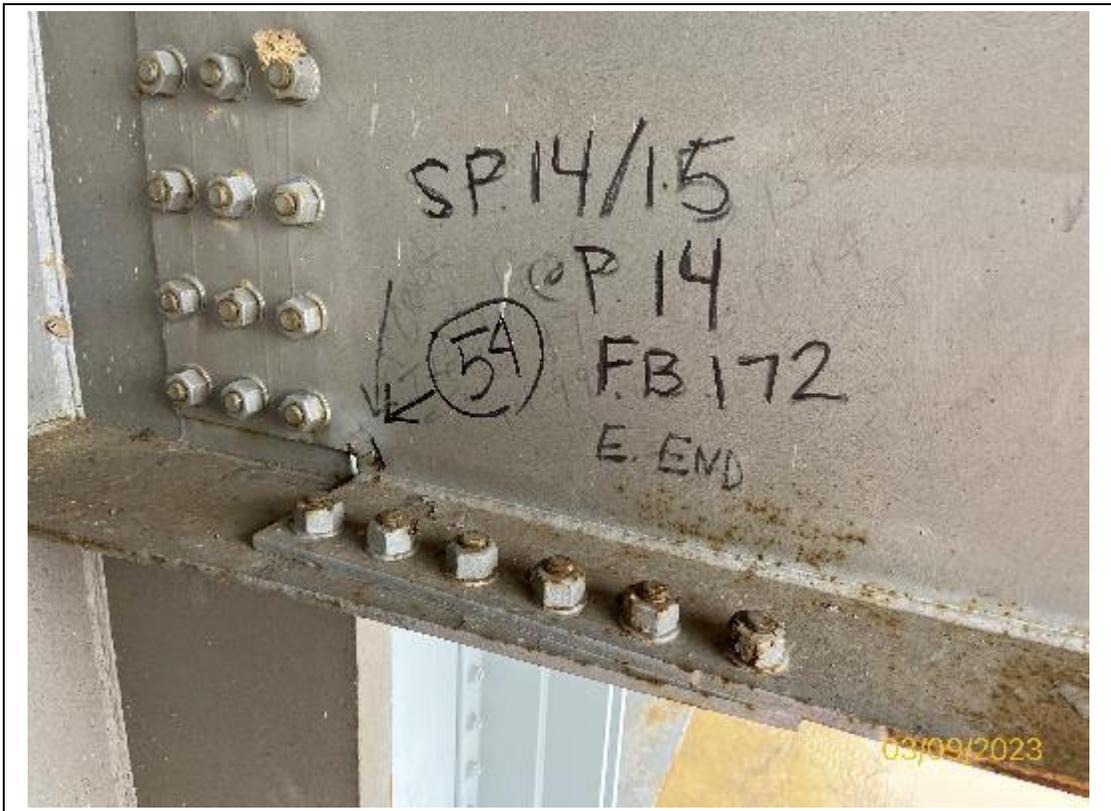
PHOTO 210

Item #	Span(s)	Member(s)	Location(s)	Photo(s)	Deficiency(ies)	Corrective Action	Year	Load Cap. Re-Eval.
140	14	Stringer 7	8' from Floorbeam 164	210 LE	49% SL, Top Flange, 26% SL, Bottom Flange, 35% SL Web (See Detail 4) (Verify length of deterioration in Detail 4)	Repair 50% SL, Top Flange, 26% SL, Bottom Flange, 35% SL Web IRF=0.94	2013	
54	14 & 15	Cantilever Floorbeam 172	@ P14, East cantilever bracket	211 LN	1" crack in Web @ Bottom Flange, no propagation from 1997	N/A	1997	
83	14, 15	Cantilever Floorbeam 172	@ P14, East cantilever bracket	212 LN	18" x 1/4" offset in bottom flange	N/A	2009	
141	15	West Girder	10'- 6" North of P15	213 LW	6% SL, 2" drilled hole in Top Flange	N/A	2013	
85	18	Cantilever Floorbeam 201	West side	214 LN	30" x 3/4" offset, Bottom flange	N/A	2009	
142	18	Lateral Brace	@ West Girder under Floorbeam 201	215 LW	1 loose bolt	Repair	2013	
282	19	Lateral Brace	Panel 206, Floorbeam 205 @ catwalk, West Lateral Brace	216 LN	4 loose bolts in bottom plate	Repair	2021

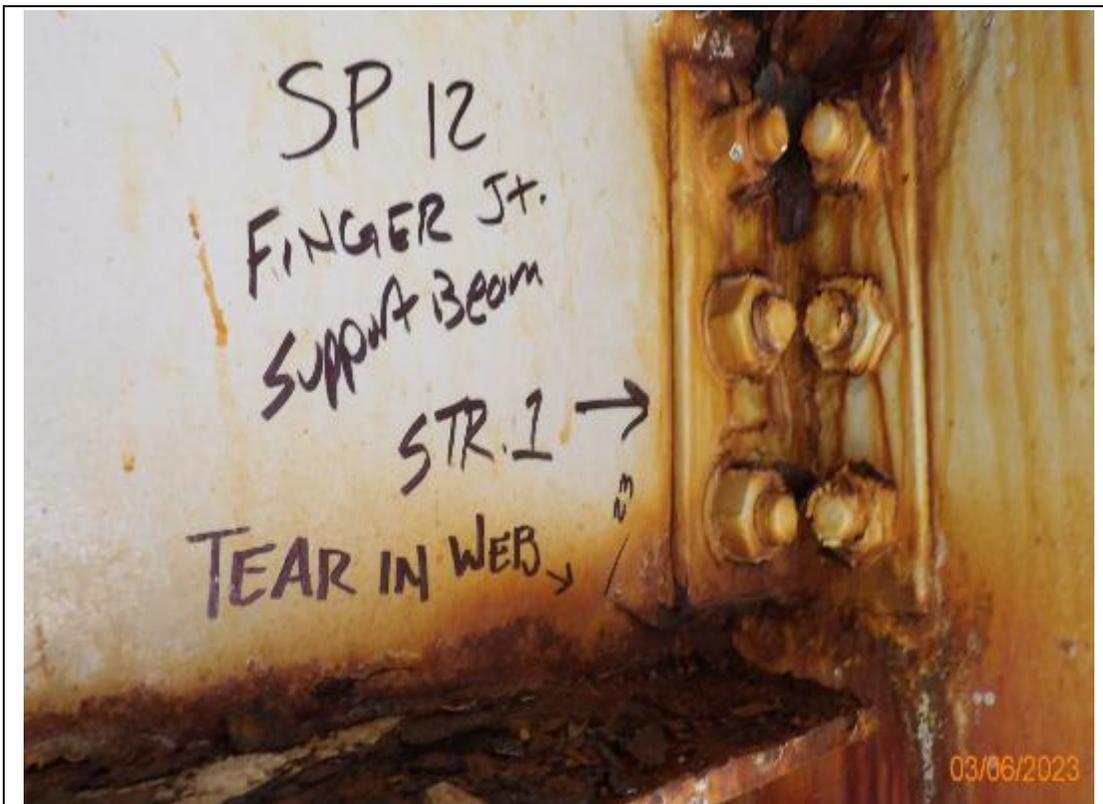
PHOTO 236 (Note: Photo mislabeled, this is Stringer 5.)
