RE: IL 53 Ramp Evaluation
IDOT Contract Number 62N91
IDOT Job Number D-91-144-21
Section 2018-100-BR
Cook County
District 1
PTB 203-021
Gonzalez Job No. 23-1003

SUBJECT: TECHNICAL MEMO

This memorandum was produced by Gonzalez Companies, LLC working as a sub-consultant to Strand Associates, Inc. and is part of a Phase II contract with the Illinois Department of Transportation (IDOT). The work is included as part of the IL 53 Bridge Rehabilitation Project from IL 62 (Algonquin Road) to Lake Cook Road. The results of the IL 53 ramp evaluation for Lake Cook Road and Dundee Road are presented herein.

Pavement Core Summary Table – PTB 203-021 62N91 IL 53 Supplement Coring in Cook County, IL
Core Photos Page 2 of 6

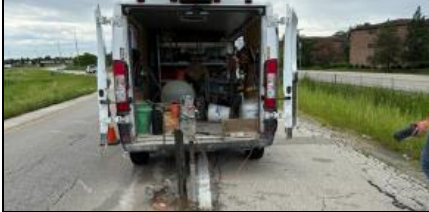
<u>Total Thickness = 10 ½ inches</u>

HMA Surface ₁ = 3 in.

Weathering & Deterioration

Broken Concrete = 7 ½ in.

Subbase Stone = 3 ½ inches

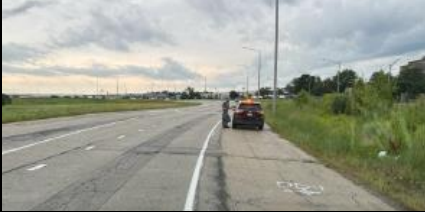
(Not Recovered)	<u>Total Thickness = 14 inches</u>

HMA Surface ₁ = 3 in.

NOT FULLY RECOVERED   Broken Concrete = 7 in.

Weathering & Deterioration

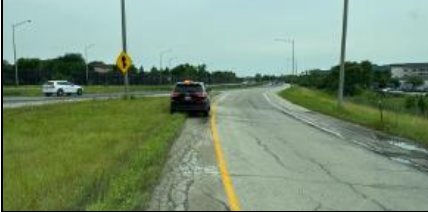
<p><u>Total Thickness = 16 inches</u></p> <ul style="list-style-type: none">

HMA Surface₁ = 1 ¼ in.

HMA Binder₁ = 1 in.

Weathering & Deterioration

HMA Binder₂ = 5 ¼ in.

HMA Binder₃ = 1 ½ in.

HMA Binder₄ = 3 ¾ in.

HMA Binder₅ = 3 ¼ in. Asphalt Grindings = 6 inches Core Barrel Reached Max Depth at 22 inches 	<p><u>Total Thickness = 15 inches</u></p> <ul style="list-style-type: none">

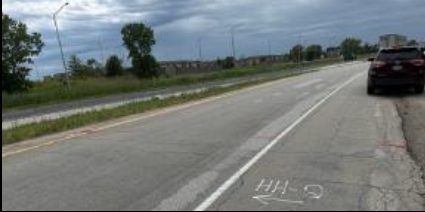
HMA Surface₁ = 2 in.

HMA Binder₁ = 2 in.

Weathering & Deterioration

Broken Concrete = 11 in. Subbase Stone = 7 inches Core Barrel Reached Max Depth at 22 inches 	<p><u>Total Thickness = 17 inches</u></p> <ul style="list-style-type: none">

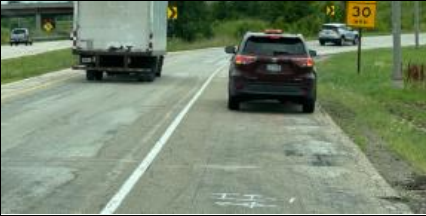
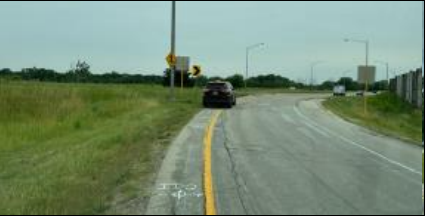
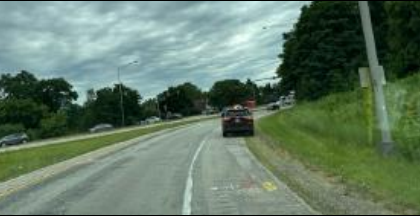
II-1 (NB Off Ramp from 53 to Lake Cook Rd)	II-2 (NB Off Ramp from 53 to Lake Cook Rd)	JJ-1 (NB Off Ramp to WB Lake Cook Rd)

<p><u>Total Thickness = 20 inches</u></p> <ul style="list-style-type: none"> HMA Surface₁ = 2 in. HMA Binder₁ = 2 ½ in. Weathering & Deterioration Broken Concrete = 12 ½ in. HMA Binder₂ = 3 in. NOT FULLY RECOVERED Possible Asphalt Grindings = 2 inches (Not Recovered) Core Barrel Reached Max Depth at 22 inches 	<p><u>Total Thickness = 20 inches</u></p> <ul style="list-style-type: none"> HMA Surface₁ = 2 ½ in. Weathering & Deterioration HMA Surface₂ = 2 ½ in. Weathering & Deterioration HMA Binder₁ = 2 ½ in. Weathering & Deterioration HMA Binder₂ = 9 in. Weathering & Deterioration HMA Layer₅ = 3 ½ in. NOT FULLY RECOVERED Possible Asphalt Grindings = 2 inches (Not Recovered) Core Barrel Reached Max Depth at 22 inches 	<p><u>Total Thickness = 17 inches</u></p> <ul style="list-style-type: none"> Possible SMA Surface₁ = 2 in. HMA Binder₁ = 3 ½ in. NOT FULLY RECOVERED Concrete = 11 ½ in. Asphalt Grindings = 5 inches Core Barrel Reached Max Depth at 22 inches

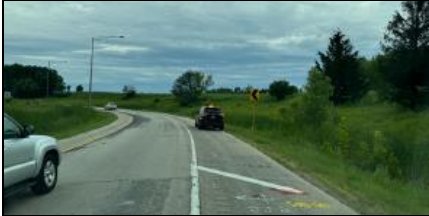
<p><u>Total Thickness = 17 inches</u></p> <p>

Possible SMA Surface₁ = 2 in. Weathering & Deterioration

HMA Binder₁ = 2 in.

HMA Leveling Binder₂ = ½ in.

Concrete = 12 ½ in.

Asphalt Grindings = 4 inches</p>	<p><u>Total Thickness = 18 inches</u></p> <p>

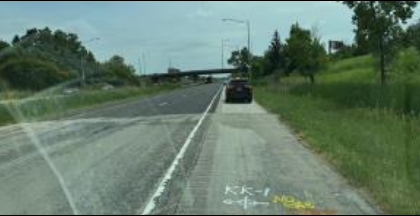
Possible SMA Surface₁ = 2 in.

HMA Binder₁ = 2 ½ in. Weathering & Deterioration

HMA Leveling Binder₂ = ¾ in.

Broken Concrete = 12 ¾ in.

Possible Asphalt Grindings = 4 inches (Not Recovered) <p align="center">Core Barrel Reached Max Depth at 22 inches</p> </p>	<p><u>Total Thickness = 16 inches</u></p> <p>

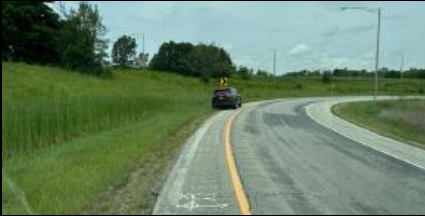
Possible SMA Surface₁ = 2 ½ in. Weathering & Deterioration

HMA Binder₁ = 1 ¾ in.

HMA Leveling Binder₂ = ¾ in.

Broken Concrete = 11 in.

Asphalt Grindings = 6 inches <p align="center">Core Barrel Reached Max Depth at 22 inches</p> </p>
