RE: IL 53 Mainline and Shoulder Evaluation  
IDOT Contract Number 62N91  
IDOT Job Number D-91-144-21  
Section 2018-100-BR  
Cook County  
District 1  
PTB 203-021  
Gonzalez Job No. 23-1003

SUBJECT: TECHNICAL MEMO

IDOT Project Number 62N91  
 IDOT Job Number D-91-144-21  
 Route IL 53 (FAP 342) Supplement Coring - I-90 to Lake Cook Road  
 Section 2018-100-BR  
 County Cook  
 District 1  
 PTB 203-021

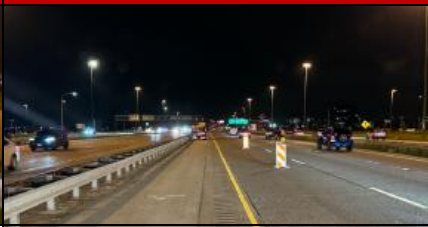
| <b>A-00</b><br><b>(SB Outside Shoulder)</b> | <b>B - 00</b><br><b>(SB Inside Shoulder)</b> | <b>C - 00</b><br><b>(NB Inside Shoulder)</b> |
|---|---|---|
| <p><b><u>Total Thickness = 17 inches</u></b></p> <ul style="list-style-type: none"> <li> HMA Surface<sub>1</sub> = 1 ¼ in.</li> <li> HMA Binder<sub>1</sub> = 2 ½ in.</li> <li> HMA Binder<sub>2</sub> = 1 ¼ in.</li> <li> <b>Weathering &amp; Deterioration</b></li> <li> HMA Binder<sub>3</sub> = 6 in.</li> <li> <b>Weathering &amp; Deterioration</b></li> <li> HMA Binder<sub>4</sub> = 6 in.</li> <li> <b>NOT FULLY RECOVERED</b></li> <li> Subbase Stone Not Observed</li> <li> <b>Subbase Type: Gravelly CLAY</b></li> <li> DCP Start Depth: 17 inches</li> <li> DCP Blows (per 6-inches):</li> <li> 4 – 7, 4 – 3, 9 – 18</li> </ul> | <p><b><u>Total Thickness = 18 inches</u></b></p> <ul style="list-style-type: none"> <li> HMA Surface<sub>1</sub> = 1 ½ in.</li> <li> HMA Binder<sub>1</sub> = 1 ¾ in.</li> <li> <b>Weathering &amp; Deterioration</b></li> <li> HMA Binder<sub>2</sub> = 5 ¾ in.</li> <li> <b>Weathering &amp; Deterioration</b></li> <li> HMA Binder<sub>3</sub> = 5 ¾ in.</li> <li> <b>Weathering &amp; Deterioration</b></li> <li> HMA Binder<sub>4</sub> = 3 ¾ in.</li> <li> Subbase Stone Not Observed</li> <li> <b>Subbase Type: Gravelly CLAY</b></li> <li> DCP Start Depth: 18 inches</li> <li> DCP Blows (per 6-inches):</li> <li> 4 – 5, 7 – 7, 6 – 9, 10</li> </ul> | <p><b><u>Total Thickness = 20 inches</u></b></p> <ul style="list-style-type: none"> <li> HMA Surface<sub>1</sub> = 1 ½ in.</li> <li> HMA Binder<sub>1</sub> = 3 in.</li> <li> HMA Binder<sub>2</sub> = 1 ½ in.</li> <li> <b>Weathering &amp; Deterioration</b></li> <li> HMA Layer<sub>4</sub> = 2 ½ in.</li> <li> <b>NOT FULLY RECOVERED</b></li> <li> HMA Binder<sub>3</sub> = 2 ½ in.</li> <li> <b>Weathering &amp; Deterioration</b></li> <li> HMA Binder<sub>4</sub> = 3 in.</li> <li> <b>Weathering &amp; Deterioration</b></li> <li> HMA Binder<sub>5</sub> = 6 in.</li> <li> Subbase Stone Not Observed</li> <li> <b>Subbase Type: Gravelly CLAY</b></li> <li> DCP Start Depth: 20 inches</li> <li> DCP Blows (per 6-inches):</li> <li> 4 – 4, 3 – 4, 12 – 10</li> </ul> |

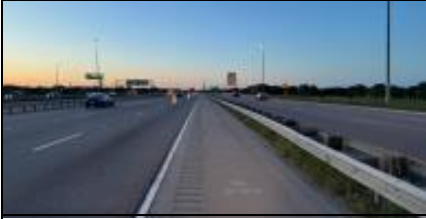
| <b>D - 00</b><br><b>(NB Outside Shoulder)</b> | <b>A - 13</b><br><b>(SB Outside Shoulder)</b> | <b>A - 14</b><br><b>(SB Outside Shoulder)</b> |
|---|---|---|
| <p><b><u>Total Thickness = 20 inches</u></b></p> <ul style="list-style-type: none"> <li> HMA Surface<sub>1</sub> = 1 in.</li> <li> HMA Binder<sub>1</sub> = 3 ¼ in.</li> <li> HMA Binder<sub>2</sub> = 2 ¼ in.</li> <li> HMA Binder<sub>3</sub> = 1 ½ in.</li> <li> <b>Weathering &amp; Deterioration</b></li> <li> HMA Binder<sub>4</sub> = 4 in.</li> <li> HMA Binder<sub>5</sub> = 8 in.</li> <li> <b>NOT FULLY RECOVERED</b></li> <li> Subbase Stone = 2 inches</li> <li> Subbase Type: Gravelly CLAY</li> <li> DCP Start Depth: 22 inches</li> <li> DCP Blows (per 6-inches):<br/>1 – 5, 5 – 5, 4 – 10</li> </ul> | <p><b><u>Total Thickness = 10 inches</u></b></p> <ul style="list-style-type: none"> <li> HMA Surface<sub>1</sub> = 2 in.</li> <li> HMA Binder<sub>1</sub> = 2 in.</li> <li> <b>Weathering &amp; Deterioration</b></li> <li> HMA Binder<sub>2</sub> = 3 ½ in.</li> <li> <b>Weathering &amp; Deterioration</b></li> <li> HMA Binder<sub>3</sub> = 2 ½ in.</li> <li> <b>NOT FULLY RECOVERED</b></li> <li> Subbase Stone = 6 inches</li> <li> Subbase Type: Gravelly CLAY</li> <li> DCP Start Depth: 16 inches</li> <li> DCP Blows (per 6-inches):<br/>5 – 9, 7 – 4, 5 – 5, 7</li> </ul> | <p><b><u>Total Thickness = 18 inches</u></b></p> <ul style="list-style-type: none"> <li> HMA Surface<sub>2</sub> = 2 in.</li> <li> HMA Binder<sub>1</sub> = 3 in.</li> <li> <b>Weathering &amp; Deterioration</b></li> <li> Concrete = 8 ½ in.</li> <li> HMA Binder<sub>2</sub> = 4 ½ in.</li> <li> <b>NOT FULLY RECOVERED</b></li> <li> Subbase Stone Not Observed</li> <li> Subbase Type: sand and gravel</li> <li> DCP Start Depth: 18 inches</li> <li> DCP Blows (per 6-inches):<br/>10 – 14, 21 – 17, 25/2" (DCP Refusal)</li> </ul> |

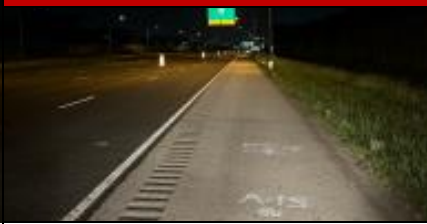
| <b>A - 15</b><br><b>(SB Outside Shoulder)</b> | <b>A - 16</b><br><b>(SB Outside Shoulder)</b> | <b>B - 13</b><br><b>(SB Inside Shoulder)</b> |
|---|---|---|
| <p><b><u>Total Thickness = 14 inches</u></b></p> <ul style="list-style-type: none"> <li> HMA Surface<sub>1</sub> = 1 ½ in.</li> <li> HMA Binder<sub>1</sub> = 3 ¼ in.</li> <li> HMA Binder<sub>2</sub> = 2 ½ in.</li> <li> <b>Weathering &amp; Deterioration</b></li> <li> HMA Binder<sub>3</sub> = 2 ½ in.</li> <li> <b>Weathering &amp; Deterioration</b></li> <li> HMA Binder<sub>4</sub> = 4 ¼ in.</li> <li> <b>NOT FULLY RECOVERED</b></li> <li> Subbase Stone = 8 inches</li> <li> <b>Subbase Type: sand and gravel</b></li> <li> DCP Start Depth: 22 inches</li> <li> DCP Blows (per 6-inches):<br/>25/0" (DCP Refusal)</li> </ul> | <p><b><u>Total Thickness = 13 ½ inches</u></b></p> <ul style="list-style-type: none"> <li> HMA Surface<sub>1</sub> = 2 ¼ in.</li> <li> <b>Weathering &amp; Deterioration</b></li> <li> HMA Binder<sub>1</sub> = 3 in.</li> <li> HMA Binder<sub>2</sub> = 2 ¾ in.</li> <li> <b>Weathering &amp; Deterioration</b></li> <li> HMA Binder<sub>3</sub> = 5 ½ in.</li> <li> Subbase Stone = 13 ½ inches</li> <li> <b>Subbase Type: sand and gravel</b></li> <li> DCP Start Depth: 27 inches</li> <li> DCP Blows (per 6-inches):<br/>25/0" (DCP Refusal)</li> </ul> | <p><b><u>Total Thickness = 10 inches</u></b></p> <ul style="list-style-type: none"> <li> HMA Surface<sub>1</sub> = 1 ½ in.</li> <li> HMA Surface<sub>2</sub> = 2 ¼ in.</li> <li> <b>Weathering &amp; Deterioration</b></li> <li> HMA Binder<sub>1</sub> = 6 ¼ in.</li> <li> <b>NOT FULLY RECOVERED</b></li> <li> Subbase Stone = 4 inches</li> <li> <b>Subbase Type: Gravelly CLAY</b></li> <li> DCP Start Depth: 14 inches</li> <li> DCP Blows (per 6-inches):<br/>5 – 11, 10 – 8, 9 – 9</li> </ul> |

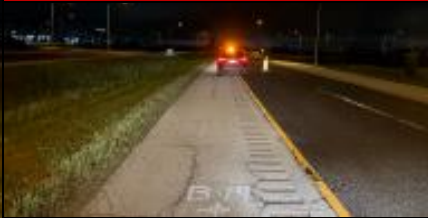
| <b>B - 14</b><br><b>(SB Inside Shoulder)</b> | <b>B - 15</b><br><b>(SB Inside Shoulder)</b> | <b>B - 16</b><br><b>(SB Inside Shoulder)</b> |
|---|---|---|
| <p><u><b>Total Thickness = 11 inches</b></u></p> <ul style="list-style-type: none"> <li> HMA Surface<sub>1</sub> = 1 ¾ in.</li> <li> HMA Binder<sub>1</sub> = 2 ¾ in.</li> <li> <b>Weathering &amp; Deterioration</b></li> <li> HMA Binder<sub>2</sub> = 3 in.</li> <li> <b>Weathering &amp; Deterioration</b></li> <li> HMA Binder<sub>3</sub> = 3 ½ in.</li> <li> Subbase Stone = 3 inches</li> <li> Subbase Type: Gravelly CLAY</li> <li> DCP Start Depth: 14 inches</li> <li> DCP Blows (per 6-inches):<br/>16 – 20, 21 – 10, 7 – 6</li> </ul> | <p><u><b>Total Thickness = 12 inches</b></u></p> <ul style="list-style-type: none"> <li> Possible SMA Surface<sub>1</sub> = 1 ½ in.</li> <li> <b>Weathering &amp; Deterioration</b></li> <li> HMA Binder<sub>1</sub> = 2 ¾ in.</li> <li> <b>Weathering &amp; Deterioration</b></li> <li> HMA Binder<sub>2</sub> = 2 ½ in.</li> <li> <b>Weathering &amp; Deterioration</b></li> <li> HMA Binder<sub>3</sub> = 5 ½ in.</li> <li> <b>NOT FULLY RECOVERED</b></li> <li> Subbase Stone = 14 inches</li> <li> Subbase Type: sand and gravel</li> <li> DCP Start Depth: 26 inches</li> <li> DCP Blows (per 6-inches):<br/>25/0" (DCP Refusal)</li> </ul> | <p><u><b>Total Thickness = 13 inches</b></u></p> <ul style="list-style-type: none"> <li> Possible SMA Surface<sub>1</sub> = 2 in.</li> <li> <b>Weathering &amp; Deterioration</b></li> <li> HMA Binder<sub>1</sub> = 2 ½ in.</li> <li> <b>Weathering &amp; Deterioration</b></li> <li> HMA Surface<sub>2</sub> = 2 ¾ in.</li> <li> <b>Weathering &amp; Deterioration</b></li> <li> HMA Surface<sub>3</sub> = 5 ¾ in.</li> <li> Subbase Stone = 13 inches</li> <li> Subbase Type: Gravelly CLAY</li> <li> DCP Start Depth: 26 inches</li> <li> DCP Blows (per 6-inches):<br/>7 – 4, 6 – 5</li> </ul> |

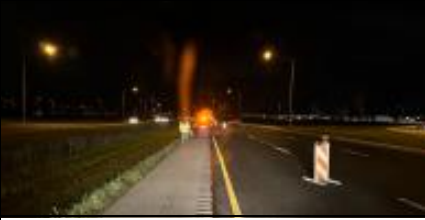
| C - 13<br>(NB Inside Shoulder) | C - 14<br>(NB Inside Shoulder) | C - 15<br>(NB Inside Shoulder) |
|---|---|---|
| <p><u>Total Thickness = 9 inches</u></p> <ul style="list-style-type: none"> <li>HMA Surface<sub>1</sub> = 1 ¾ in.</li> <li>HMA Leveling Binder<sub>1</sub> = ¼ in.</li> <li>HMA Binder<sub>2</sub> = 1 ½ in.</li> <li><b>Weathering &amp; Deterioration</b></li> <li>HMA Binder<sub>3</sub> = 2 ¼ in.</li> <li><b>Weathering &amp; Deterioration</b></li> <li>HMA Binder<sub>4</sub> = 3 ¼ in.</li> <li>Subbase Stone = 4 inches</li> <li>Subbase Type: Gravelly CLAY</li> <li>DCP Start Depth: 13 inches</li> <li>DCP Blows (per 6-inches):<br/>5 – 6, 7 – 8, 7 – 7</li> </ul> | <p><u>Total Thickness = 11 inches</u></p> <ul style="list-style-type: none"> <li>HMA Surface<sub>1</sub> = 1 ½ in.</li> <li><b>Weathering &amp; Deterioration</b></li> <li>HMA Binder<sub>1</sub> = 2 ½ in.</li> <li><b>Weathering &amp; Deterioration</b></li> <li>HMA Binder<sub>2</sub> = 7 in.</li> <li><b>NOT FULLY RECOVERED</b></li> <li>Subbase Stone = 3 inches</li> <li>Subbase Type: Gravelly CLAY</li> <li>DCP Start Depth: 14 inches</li> <li>DCP Blows (per 6-inches):<br/>12 – 19, 17 – 16, 13 – 12</li> </ul> | <p><u>Total Thickness = 14 ½ inches</u></p> <ul style="list-style-type: none"> <li>HMA Surface<sub>1</sub> = 1 in.</li> <li>HMA Surface<sub>2</sub> = 1 in.</li> <li><b>Weathering &amp; Deterioration</b></li> <li>HMA Binder<sub>1</sub> = 2 ¼ in.</li> <li>HMA Binder<sub>2</sub> = 3 ¼ in.</li> <li><b>Weathering &amp; Deterioration</b></li> <li>HMA Binder<sub>3</sub> = 7 in.</li> <li>Asphalt Grindings = 2 ½ inches (Not Recovered)</li> <li>Subbase Type: sand and gravel</li> <li>DCP Start Depth: 17 inches</li> <li>DCP Blows (per 6-inches):<br/>25/2" (DCP Refusal)</li> </ul> |

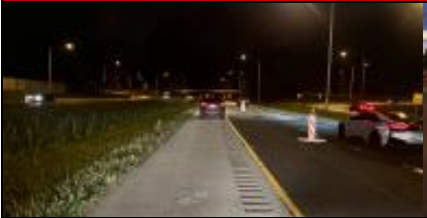
| <b>C - 16</b><br><b>(NB Inside Shoulder)</b> | <b>D - 13</b><br><b>(NB Outside Shoulder)</b> | <b>D - 14</b><br><b>(NB Outside Shoulder)</b> |
|---|---|---|
| <p><u><b>Total Thickness = 13 ½ inches</b></u></p> <ul style="list-style-type: none"> <li> HMA Surface<sub>1</sub> = 1 in.</li> <li> HMA Surface<sub>2</sub> = 1 in.</li> <li> <b>Weathering &amp; Deterioration</b></li> <li> HMA Binder<sub>1</sub> = 2 ½ in.</li> <li> HMA Binder<sub>2</sub> = 4 in.</li> <li> <b>Weathering &amp; Deterioration</b></li> <li> HMA Binder<sub>3</sub> = 5 in.</li> <li> Subbase Stone = 8 ½ inches</li> <li><b>Subbase Type: sand and gravel</b></li> <li><b>DCP Start Depth: 22 inches</b></li> <li><b>DCP Blows (per 6-inches):</b><br/><b>25/3" (DCP Refusal)</b></li> </ul> | <p><u><b>Total Thickness = 10 inches</b></u></p> <ul style="list-style-type: none"> <li> HMA Surface<sub>1</sub> = 1 ¼ in.</li> <li> HMA Binder<sub>1</sub> = 1 ¾ in.</li> <li> <b>Weathering &amp; Deterioration</b></li> <li> HMA Binder<sub>2</sub> = 7 in.</li> <li> <b>NOT FULLY RECOVERED</b></li> <li> Subbase Stone<sub>1</sub> = 3 inches</li> <li> Subbase Stone<sub>2</sub> = 5 inches</li> <li><b>Subbase Type: Gravelly CLAY</b></li> <li><b>DCP Start Depth: 18 inches</b></li> <li><b>DCP Blows (per 6-inches):</b><br/><b>15 – 23, 11 – 11, 13 – 15, 12</b></li> </ul> | <p><u><b>Total Thickness = 12 inches</b></u></p> <ul style="list-style-type: none"> <li> HMA Surface<sub>1</sub> = 1 ½ in.</li> <li> HMA Binder<sub>1</sub> = 3 ½ in.</li> <li> HMA Binder<sub>2</sub> = 2 ½ in.</li> <li> <b>Weathering &amp; Deterioration</b></li> <li> HMA Binder<sub>3</sub> = 4 ½ in.</li> <li> Subbase Stone = 4 inches</li> <li><b>Subbase Type: Gravelly CLAY</b></li> <li><b>DCP Start Depth: 16 inches</b></li> <li><b>DCP Blows (per 6-inches):</b><br/><b>6 – 14, 17 – 24, 22 – 16, 10</b></li> </ul> |

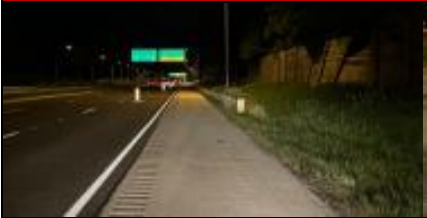
| <b>D - 15</b><br><b>(NB Outside Shoulder)</b> | <b>D - 16</b><br><b>(NB Outside Shoulder)</b> | <b>PN - 00</b><br><b>(NB Inside Lane)</b> |
|---|---|---|
| <p><u><b>Total Thickness = 17 inches</b></u></p> <ul style="list-style-type: none"> <li> HMA Surface<sub>1</sub> = 1 ¾ in.</li> <li> <b>Weathering &amp; Deterioration</b></li> <li> HMA Binder<sub>1</sub> = 3 in.</li> <li> HMA Surface<sub>2</sub> = 2 ½ in.</li> <li> <b>Weathering &amp; Deterioration</b></li> <li> HMA Binder<sub>2</sub> = 5 ¼ in.</li> <li> HMA Binder<sub>3</sub> = 4 ½ in.</li> <li> <b>Weathering &amp; Deterioration</b></li> <li> <b>NOT FULLY RECOVERED</b></li> <li> Subbase Stone = 5 inches</li> <li> Subbase Type: sand and gravel</li> <li> DCP Start Depth: 22 inches</li> <li> DCP Blows (per 6-inches):<br/><b>25/1"</b></li> </ul> | <p><u><b>Total Thickness = 12 ½ inches</b></u></p> <ul style="list-style-type: none"> <li> HMA Surface<sub>1</sub> = 1 ¾ in.</li> <li> HMA Binder<sub>1</sub> = 2 ¼ in.</li> <li> HMA Binder<sub>2</sub> = 2 ¾ in.</li> <li> <b>Weathering &amp; Deterioration</b></li> <li> HMA Binder<sub>3</sub> = 5 ¾ in.</li> <li> Subbase Stone = 9 ½ inches</li> <li> Subbase Type: sand and gravel</li> <li> DCP Start Depth: 22 inches</li> <li> DCP Blows (per 6-inches):<br/><b>25/2"</b></li> </ul> | <p><u><b>Total Thickness = 20 inches</b></u></p> <ul style="list-style-type: none"> <li> Possible SMA Surface<sub>1</sub> = 2 in.</li> <li> HMA Binder<sub>1</sub> = 2 ¾ in.</li> <li> <b>Weathering &amp; Deterioration</b></li> <li> HMA Layer<sub>3</sub> = 2 ¼ in.</li> <li> <b>Weathering &amp; Deterioration</b></li> <li> Broken Concrete = 13 in.</li> <li> Subbase Stone Not Observed</li> </ul> |

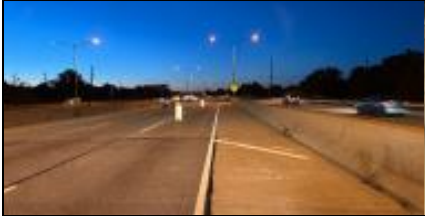
| PN - 01<br>(NB Outside Lane) | PN - 02<br>(NB Inside Lane) | PN - 03<br>(NB Inside Lane) |
|---|---|---|
| <p><u>Total Thickness = 14 ½ inches</u></p> <ul style="list-style-type: none"> <li>Possible SMA Surface<sub>1</sub> = 2 in.</li> <li>HMA Binder<sub>1</sub> = 2 ¼ in.</li> <li><b>Weathering &amp; Deterioration</b></li> <li>HMA Binder<sub>2</sub> = 2 ¾ in.</li> <li><b>Weathering &amp; Deterioration</b></li> <li>Concrete = 7 ½ in.</li> <li>Subbase Stone = 7 ½ inches</li> </ul> <p>Core Barrel Reached Max Depth at 22 inches</p> | <p><u>Total Thickness = 15 ½ inches</u></p> <ul style="list-style-type: none"> <li>Possible SMA Surface<sub>1</sub> = 2 ¼ in.</li> <li>HMA Binder<sub>1</sub> = 2 ½ in.</li> <li><b>Weathering &amp; Deterioration</b></li> <li>HMA Binder<sub>2</sub> = 2 ¼ in.</li> <li><b>Weathering &amp; Deterioration</b></li> <li>Concrete = 8 ½ in.</li> <li>Subbase Stone = 6 ½ inches</li> </ul> <p>Core Barrel Reached Max Depth at 22 inches</p> | <p><u>Total Thickness = 14 inches</u></p> <ul style="list-style-type: none"> <li>Possible SMA Surface<sub>1</sub> = 2 ¼ in.</li> <li>HMA Binder<sub>1</sub> = 2 ½ in.</li> <li><b>Weathering &amp; Deterioration</b></li> <li>HMA Layer<sub>3</sub> = 1 ¼ in.</li> <li><b>NOT FULLY RECOVERED</b></li> <li>Concrete = 8 in.</li> <li>Subbase Stone = 8 inches</li> </ul> <p>Core Barrel Reached Max Depth at 22 inches</p> |

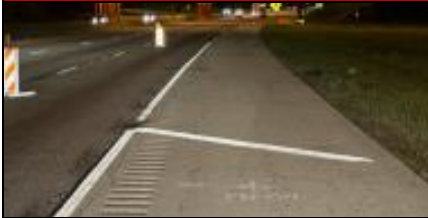
| PN - 04<br>(NB Outside Lane) | PN - 05<br>(NB Inside Lane) | PN - 06<br>(NB Inside Lane) |
|---|---|---|
| <p><u>Total Thickness = 15 inches</u></p> <p> Possible SMA Surface<sub>1</sub> = 4 ¼ in.</p> <p> HMA Binder<sub>1</sub> = ¾ in.</p> <p> Weathering &amp; Deterioration</p> <p> HMA Binder<sub>2</sub> = 2 in.</p> <p> Weathering &amp; Deterioration</p> <p> Broken Concrete = 8 in.</p> <p> Subbase Stone = 7 inches</p> <p>Core Barrel Reached Max Depth at 22 inches</p> | <p><u>Total Thickness = 13 inches</u></p> <p> Possible SMA Surface<sub>1</sub> = 2 in.</p> <p> HMA Binder<sub>1</sub> = 2 in.</p> <p> Weathering &amp; Deterioration</p> <p> Broken Concrete = 9 in.</p> <p> Subbase Stone = 9 inches</p> <p>Core Barrel Reached Max Depth at 22 inches</p> | <p><u>Total Thickness = 14 ½ inches</u></p> <p> Possible SMA Surface<sub>1</sub> = 2 in.</p> <p> HMA Binder<sub>1</sub> = 2 ½ in.</p> <p> Weathering &amp; Deterioration</p> <p> HMA Binder<sub>2</sub> = 1 in.</p> <p> Weathering &amp; Deterioration</p> <p> Broken Concrete = 9 in.</p> <p> Subbase Stone = 7 ½ inches</p> <p>Core Barrel Reached Max Depth at 22 inches</p> |

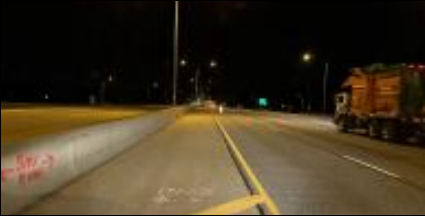
| PN - 07<br>(NB Inside Lane) | PN - 08<br>(NB Inside Lane) | PN - 09<br>(NB Inside Lane) |
|---|---|---|
| <p><u>Total Thickness = 15 inches</u></p> <p> Possible SMA Surface<sub>1</sub> = 1 ½ in.<br/><b>Weathering &amp; Deterioration</b></p> <p> HMA Binder<sub>1</sub> = 6 ½ in.<br/><b>NOT FULLY RECOVERED</b></p> <p> Broken Concrete = 7 in.<br/>Subbase Stone = 7 inches</p> <p>Core Barrel Reached Max Depth at 22 inches</p> | <p><u>Total Thickness = 15 ½ inches</u></p> <p> Possible SMA Surface<sub>1</sub> = 2 in.<br/><b>Weathering &amp; Deterioration</b></p> <p> HMA Binder<sub>1</sub> = 2 ¼ in.<br/><b>Weathering &amp; Deterioration</b></p> <p> HMA Binder<sub>2</sub> = 3 ¼ in.<br/><b>NOT FULLY RECOVERED</b></p> <p> Broken Concrete = 8 in.<br/>Subbase Stone = 6 ½ inches</p> <p>Core Barrel Reached Max Depth at 22 inches</p> | <p><u>Total Thickness = 15 inches</u></p> <p> Possible SMA Surface<sub>1</sub> = 2 in.<br/>HMA Binder<sub>1</sub> = 2 in.<br/><b>Weathering &amp; Deterioration</b></p> <p> HMA Binder<sub>2</sub> = 2 ½ in.<br/><b>NOT FULLY RECOVERED</b></p> <p> Broken Concrete = 8 ½ in.<br/>Subbase Stone = 7 inches</p> <p>Core Barrel Reached Max Depth at 22 inches</p> |

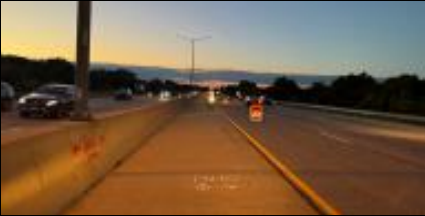
| PN - 10<br>(NB Inside Lane) | PN - 11<br>(NB Inside Lane) | PN - 12<br>(NB Inside Lane) |
|---|---|---|
| <p><u>Total Thickness = 16 inches</u></p> <p> Possible SMA Surface<sub>1</sub> = 1 ¾ in.</p> <p> HMA Binder<sub>1</sub> = 2 ½ in.</p> <p> HMA Binder<sub>2</sub> = 2 ¾ in.</p> <p> Weathering &amp; Deterioration</p> <p> Broken Concrete = 9 in.</p> <p> Subbase Stone = 2 inches</p> | <p><u>Total Thickness = 18 inches</u></p> <p> Possible SMA Surface<sub>1</sub> = 2 in.</p> <p> HMA Binder<sub>1</sub> = 2 ½ in.</p> <p> HMA Binder<sub>2</sub> = 1 in.</p> <p> Weathering &amp; Deterioration</p> <p> Broken Concrete = 8 ½ in.</p> <p> Weathering &amp; Deterioration</p> <p> HMA Binder<sub>3</sub> = 4 in.</p> <p> Subbase Stone Not Observed</p> | <p><u>Total Thickness = 15 inches</u></p> <p> Possible SMA Surface<sub>1</sub> = 1 ¾ in.</p> <p> HMA Binder<sub>1</sub> = 2 ½ in.</p> <p> HMA Binder<sub>2</sub> = ¾ in.</p> <p> Weathering &amp; Deterioration</p> <p> Concrete = 10 ½ in.</p> <p> Subbase Stone Not Observed</p> |

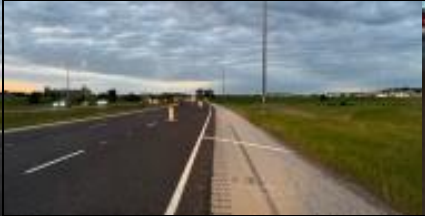
| PN - 13<br>(NB Outside Lane) | PN - 14<br>(NB Outside Lane) | PN - 15<br>(NB Outside Lane) |
|---|---|---|
| <p><u>Total Thickness = 14 inches</u></p> <p> Possible SMA Surface<sub>1</sub> = 1 ½ in.<br/> HMA Binder<sub>1</sub> = 1 ½ in.<br/> <b>Weathering &amp; Deterioration</b><br/> Concrete = 8 in.<br/> HMA Binder<sub>2</sub> = 3 in.<br/> Subbase Stone Not Observed</p> | <p><u>Total Thickness = 14 ½ inches</u></p> <p> Possible SMA Surface<sub>1</sub> = 2 in.<br/> HMA Binder<sub>1</sub> = 2 in.<br/> HMA Leveling Binder<sub>2</sub> = 1 in.<br/> HMA Binder<sub>3</sub> = 9 ½ in.<br/> Fabric Interlayer<br/> Subbase Stone = 7 ½ inches<br/> Core Barrel Reached Max Depth at 22 inches</p> | <p><u>Total Thickness = 15 inches</u></p> <p> Possible SMA Surface<sub>1</sub> = 1 ¾ in.<br/> HMA Binder<sub>1</sub> = 1 ½ in.<br/> Longitudinal Joint Sealing<br/> HMA Leveling Binder<sub>2</sub> = 1 in.<br/> Broken Concrete = 10 ¾ in.<br/> Subbase Stone = 7 inches<br/> Core Barrel Reached Max Depth at 22 inches</p> |

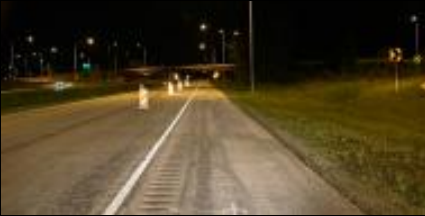
| PN - 16<br>(NB Outside Lane) | PS - 00<br>(SB Inside Lane) | PS - 01<br>(SB Outside Lane) |
|---|---|---|
| <p><u>Total Thickness = 21 inches</u></p> <p> Possible SMA Surface<sub>1</sub> = 2 in.<br/> HMA Binder<sub>1</sub> = 2 ½ in.<br/> <b>Weathering &amp; Deterioration</b><br/> HMA Leveling Binder<sub>2</sub> = ¾ in.<br/> Concrete = 12 ¼ in.<br/> HMA Surface<sub>3</sub> = 3 ½ in.<br/> Subbase Stone Not Observed </p> | <p><u>Total Thickness = 13 ½ inches</u></p> <p> Possible SMA Surface<sub>1</sub> = 1 ¾ in.<br/> HMA Binder<sub>1</sub> = 2 ½ in.<br/> <b>Weathering &amp; Deterioration</b><br/> Concrete = 9 ¼ in.<br/> Subbase Stone = 4 ½ inches </p> | <p><u>Total Thickness = 16 inches</u></p> <p> Possible SMA Surface<sub>1</sub> = 2 ½ in.<br/> HMA Binder<sub>1</sub> = 1 ½ in.<br/> HMA Binder<sub>2</sub> = 1 ¼ in.<br/> <b>Weathering &amp; Deterioration</b><br/> HMA Binder<sub>3</sub> = 2 in.<br/> <b>Weathering &amp; Deterioration</b><br/> Concrete = 8 ¾ in.<br/> Subbase Stone = 6 inches<br/> Core Barrel Reached Max Depth at 22 inches </p> |

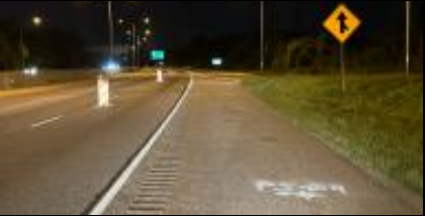
| PS - 02<br>(SB Inside Lane) | PS - 03<br>(SB Inside Lane) | PS - 04<br>(SB Outside Lane) |
|---|---|---|
| <p><u>Total Thickness = 14 ½ inches</u></p> <ul style="list-style-type: none"> <li>Possible SMA Surface<sub>1</sub> = 2 ¼ in.</li> <li>HMA Binder<sub>1</sub> = 2 ¾ in.</li> <li><b>Weathering &amp; Deterioration</b></li> <li>HMA Binder<sub>2</sub> = 1 ½ in.</li> <li><b>Weathering &amp; Deterioration</b></li> <li>Concrete = 8 in.</li> <li>Subbase Stone = 7 ½ inches</li> </ul> <p>Core Barrel Reached Max Depth at 22 inches</p> | <p><u>Total Thickness = 14 inches</u></p> <ul style="list-style-type: none"> <li>Possible SMA Surface<sub>1</sub> = 1 ½ in.</li> <li>HMA Binder<sub>1</sub> = 2 ½ in.</li> <li><b>Weathering &amp; Deterioration</b></li> <li>HMA Binder<sub>2</sub> = 2 in.</li> <li><b>NOT FULLY RECOVERED</b></li> <li>Concrete = 8 in.</li> <li>Subbase Stone = 8 inches</li> </ul> <p>Core Barrel Reached Max Depth at 22 inches</p> | <p><u>Total Thickness = 14 ½ inches</u></p> <ul style="list-style-type: none"> <li>Possible SMA Surface<sub>1</sub> = 1 ½ in.</li> <li>HMA Binder<sub>1</sub> = 1 ½ in.</li> <li>HMA Binder<sub>2</sub> = 1 ¼ in.</li> <li><b>Weathering &amp; Deterioration</b></li> <li>HMA Binder<sub>3</sub> = 1 ¾ in.</li> <li><b>Weathering &amp; Deterioration</b></li> <li>Broken Concrete = 8 ½ in.</li> <li>Subbase Stone = 7 ½ inches</li> </ul> <p>Core Barrel Reached Max Depth at 22 inches</p> |

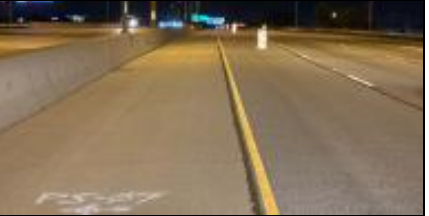
| PS - 05<br>(SB Inside Lane) | PS - 06<br>(SB Inside Lane) | PS - 07<br>(SB Inside Lane) |
|---|---|---|
| <p><u>Total Thickness = 16 inches</u></p> <ul style="list-style-type: none"> <li>Possible SMA Surface<sub>1</sub> = 2 in.</li> <li>HMA Binder<sub>1</sub> = 2 in.</li> <li>HMA Binder<sub>2</sub> = 3 ½ in.</li> <li><b>Weathering &amp; Deterioration</b></li> <li>Concrete = 8 ½ in.</li> <li>Subbase Stone = 6 inches</li> </ul> <p>Core Barrel Reached Max Depth at 22 inches</p> | <p><u>Total Thickness = 16 inches</u></p> <ul style="list-style-type: none"> <li>Possible SMA Surface<sub>1</sub> = 2 in.</li> <li><b>Weathering &amp; Deterioration</b></li> <li>HMA Binder<sub>1</sub> = 3 ½ in.</li> <li><b>Weathering &amp; Deterioration</b></li> <li>HMA Binder<sub>2</sub> = 2 in.</li> <li><b>Weathering &amp; Deterioration</b></li> <li>Broken Concrete = 8 ½ in.</li> <li>Subbase Stone = 6 inches</li> </ul> <p>Core Barrel Reached Max Depth at 22 inches</p> | <p><u>Total Thickness = 15 inches</u></p> <ul style="list-style-type: none"> <li>Possible SMA Surface<sub>1</sub> = 2 in.</li> <li>HMA Binder<sub>1</sub> = 2 in.</li> <li>HMA Binder<sub>2</sub> = 1 ½ in.</li> <li><b>Weathering &amp; Deterioration</b></li> <li>HMA Binder<sub>3</sub> = 1 ½ in.</li> <li><b>Weathering &amp; Deterioration</b></li> <li>Broken Concrete = 8 in.</li> <li>Subbase Stone = 7 inches</li> </ul> <p>Core Barrel Reached Max Depth at 22 inches</p> |

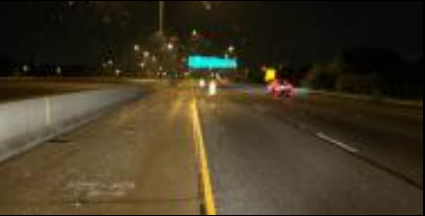
| PS - 08<br>(SB Inside Lane) | PS - 09<br>(SB Inside Lane) | PS - 10<br>(SB Inside Lane) |
|---|---|---|
| <p><u>Total Thickness = 15 inches</u></p> <ul style="list-style-type: none"> <li>Possible SMA Surface<sub>1</sub> = 2 in.</li> <li>HMA Binder<sub>1</sub> = 2 ¼ in.</li> <li>HMA Binder<sub>2</sub> = 1 ¼ in.</li> <li><b>Weathering &amp; Deterioration</b></li> <li>HMA Binder<sub>3</sub> = 2 in.</li> <li><b>Weathering &amp; Deterioration</b></li> <li>Broken Concrete = 7 ½ in.</li> <li>Subbase Stone = 7 inches</li> <li>Core Barrel Reached Max Depth at 22 inches</li> </ul> | <p><u>Total Thickness = 16 ½ inches</u></p> <ul style="list-style-type: none"> <li>Possible SMA Surface<sub>1</sub> = 2 in.</li> <li>HMA Binder<sub>1</sub> = 1 in.</li> <li><b>Weathering &amp; Deterioration</b></li> <li>HMA Binder<sub>2</sub> = 3 ½ in.</li> <li><b>Weathering &amp; Deterioration</b></li> <li>HMA Binder<sub>3</sub> = 2 in.</li> <li><b>Weathering &amp; Deterioration</b></li> <li>Broken Concrete = 8 in.</li> <li>Subbase Stone = 5 ½ inches</li> <li>Core Barrel Reached Max Depth at 22 inches</li> </ul> | <p><u>Total Thickness = 14 inches</u></p> <ul style="list-style-type: none"> <li>Possible SMA Surface<sub>1</sub> = 2 ¼ in.</li> <li>HMA Binder<sub>1</sub> = 1 ¾ in.</li> <li>HMA Binder<sub>2</sub> = 2 in.</li> <li><b>Weathering &amp; Deterioration</b></li> <li>Broken Concrete = 8 in.</li> <li>Subbase Stone = 8 inches</li> <li>Core Barrel Reached Max Depth at 22 inches</li> </ul> |

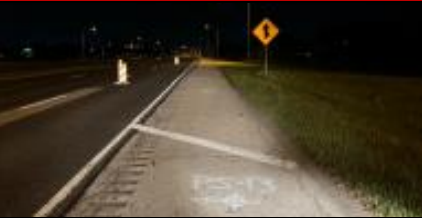
| PS - 11<br>(SB Inside Lane) | PS - 12<br>(SB Inside Lane) | PS - 13<br>(SB Outside Lane) |
|---|---|---|
| <p><u>Total Thickness = 20 inches</u></p> <ul style="list-style-type: none"> <li>HMA Surface<sub>1</sub> = 2 in.</li> <li>HMA Binder<sub>1</sub> = 3 ½ in.</li> <li>HMA Binder<sub>2</sub> = 1 ¾ in.</li> <li><b>Weathering &amp; Deterioration</b></li> <li>Concrete = 9 ¼ in.</li> <li><b>Weathering &amp; Deterioration</b></li> <li>HMA Binder<sub>3</sub> = 3 ½ in.</li> <li>Subbase Stone Not Observed</li> </ul> | <p><u>Total Thickness = 20 ½ inches</u></p> <ul style="list-style-type: none"> <li>Possible SMA Surface<sub>1</sub> = 1 ½ in.</li> <li>HMA Binder<sub>1</sub> = 2 ¾ in.</li> <li>HMA Surface<sub>1</sub> = ¾ in.</li> <li><b>Weathering &amp; Deterioration</b></li> <li>HMA Surface<sub>2</sub> = ¾ in.</li> <li>HMA Binder<sub>3</sub> = ¾ in.</li> <li><b>Weathering &amp; Deterioration</b></li> <li>Concrete = 8 ½ in.</li> <li><b>Weathering &amp; Deterioration</b></li> <li>HMA Binder<sub>4</sub> = 5 ½ in.</li> <li>Subbase Stone Not Observed</li> </ul> | <p><u>Total Thickness = 16 inches</u></p> <ul style="list-style-type: none"> <li>Possible SMA Surface<sub>1</sub> = 2 in.</li> <li><b>Weathering &amp; Deterioration</b></li> <li>HMA Binder<sub>1</sub> = 2 in.</li> <li><b>Weathering &amp; Deterioration</b></li> <li>Broken Concrete = 9 in.</li> <li>HMA Surface<sub>3</sub> = 3 in.</li> <li>Subbase Stone Not Observed</li> </ul> |

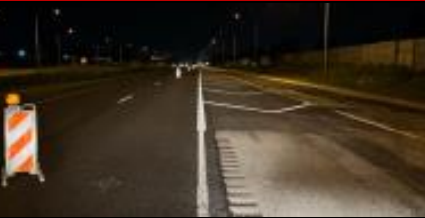
| PS - 14<br>(SB Outside Lane) | PS - 15<br>(SB Outside Lane) | PS - 16<br>(SB Outside Lane) |
|---|---|---|
| <p><u>Total Thickness = 16 inches</u></p> <ul style="list-style-type: none"> <li>Possible SMA Surface<sub>1</sub> = 2 in.</li> <li><b>Weathering &amp; Deterioration</b></li> <li>HMA Binder<sub>1</sub> = 2 in.</li> <li>HMA Layer<sub>3</sub> = 3 in.</li> <li><b>Weathering &amp; Deterioration</b></li> <li>Broken Concrete = 9 in.</li> <li>Subbase Stone = 2 inches</li> </ul> | <p><u>Total Thickness = 17 ½ inches</u></p> <ul style="list-style-type: none"> <li>Possible SMA Surface<sub>1</sub> = 1 ¾ in.</li> <li>HMA Binder<sub>1</sub> = 1 ¾ in.</li> <li><b>Weathering &amp; Deterioration</b></li> <li>Broken Concrete = 11 ½ in.</li> <li><b>Weathering &amp; Deterioration</b></li> <li>HMA Binder<sub>2</sub> = 2 ½ in.</li> <li>Subbase Stone = 4 ½ inches</li> <li>Core Barrel Reached Max Depth at 22 inches</li> </ul> | <p><u>Total Thickness = 18 ½ inches</u></p> <ul style="list-style-type: none"> <li>Possible SMA Surface<sub>1</sub> = 2 ¼ in.</li> <li><b>Weathering &amp; Deterioration</b></li> <li>HMA Binder<sub>1</sub> = 2 ¼ in.</li> <li><b>Weathering &amp; Deterioration</b></li> <li>Broken Concrete = 11 in.</li> <li><b>Weathering &amp; Deterioration</b></li> <li>HMA Binder<sub>2</sub> = 2 ½ in.</li> <li>Subbase Stone = 3 ½ inches</li> <li>Core Barrel Reached Max Depth at 22 inches</li> </ul> |
