### STATE OF ILLINOIS DEPARTMENT OF TRANSPORTATION

Contract: 76906

REP-1 1-14-2005

> BEAM STRAIGHTENING F.A.I. RT 64 ST. CLAIR COUNTY SN 082-0150

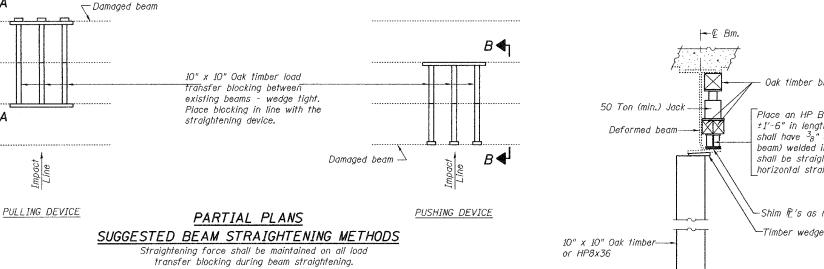
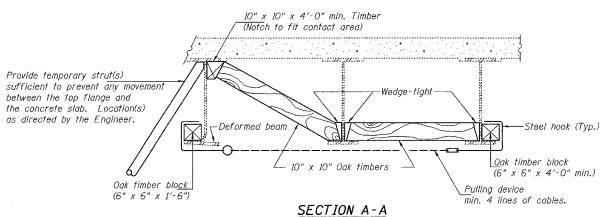
### EXISTING DEFORMATION TO BE STRAIGHTENED

# Oak timber blocks Place an HP Beam or a 6" I-Beam (Min.) $\pm 1'$ -6" in length on bottom flange. Beam shall have 38" stiffeners (3 each side of beam) welded in place. Bent bottom flange shall be straightened before starting any horizontal straightening operation. -Shim Æ's as req'd. `\_Timber wedae .3⊿" Bra. P 50 Ton (min.) jack -Timber block-

### SUGGESTED VERTICAL STRAIGHTENING DETAIL

(To correct flange rotation.)

## GRINDING DETAIL

Grind existing nicks, gouges and shallow cracks in the damaged beams as detailed. Ground surfaces shall be inspected for cracks using magnetic particle testing prior to initiating any beam straightening operations. Any cracks that cannot be removed by grinding approximately  $l_4$ " deep shall be identified and reported to the Bureau of Bridges and Structures for further disposition. Ground surfaces shall be spot cleaned and painted with an aluminum epoxy mastic primer followed by a finish coat to match the color of the existing beam. Cost of grinding, testing and spot painting included with Beam Straightening.
