CONTRACT 98939 U.S. RTE. 60 & U.E. RTE. 62 (138D-BR) P-1 ALEXANDER COUNTY SHEET &S OF &S

REPAIR 15 & 16

BRIDGE REPAIRS OLD CAIRO BRIDGE OVER MISSISSIPPI RIVER FAS RTE. 944 (US 60 & 62) SEC. (138D-BR)1-5 ALEXANDER COUNTY SN 002-0005

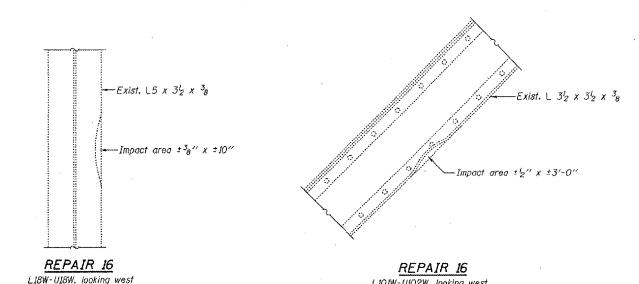
REPAIR 16 FB34, looking north

REPAIR 16 Horiz. sway brace @ PP 39, looking north

Impacted areas shall be straightened. See special provision Straighten Bent Members. Cost included with Straighten Bent Members. Typical for repair 16.

| | | STRUCTURAL STE | EL REPAIR | |
|---|---|---|---|---|
| <i>1</i> 6 | FB 34 | B'twn. Str. B & C | Bent bottom flange | Straighten & grind |
| 16 | Horiz. sway brace | PP 39 | Damaged angle | Straighten & grind |
