## DRAINAGE STRUCTURE IMPROVEMENT DETAIL LOCATION #6 STA. 858 + 38 S.N. 057–8556

FILE NAME =	USER NAME = hoganbj	DESIGNED - BJM	REVISED -		DRAINAGE STRUCTURE IMPROVEMENT DETAIL LOCATION #6 STA. 858 + 38		F.A.I.	SECTION	COUNTY	TOTAL	SHEET
c:\pw_work\pwidot\hoganbj\dØl5834Ø\D57Ø	550-sht-sm struct det.dgn	DRAWN -	REVISED -	STATE OF ILLINOIS			74	(57-20(1),21,22)RS-3	McLean	150	56
	PLOT SCALE = 40.00000 '/ IN.	CHECKED -	REVISED -	DEPARTMENT OF TRANSPORTATION	LUCATION #0 51A. 838 + 38						70550
	PLOT DATE = 10/21/2010	DATE - 09/23/10	REVISED -		SCALE: 1" = 20'	SHEET NO. OF SHEETS STA. TO STA.		ILLINOIS FED. A	ID PROJECT		
			•	•			•

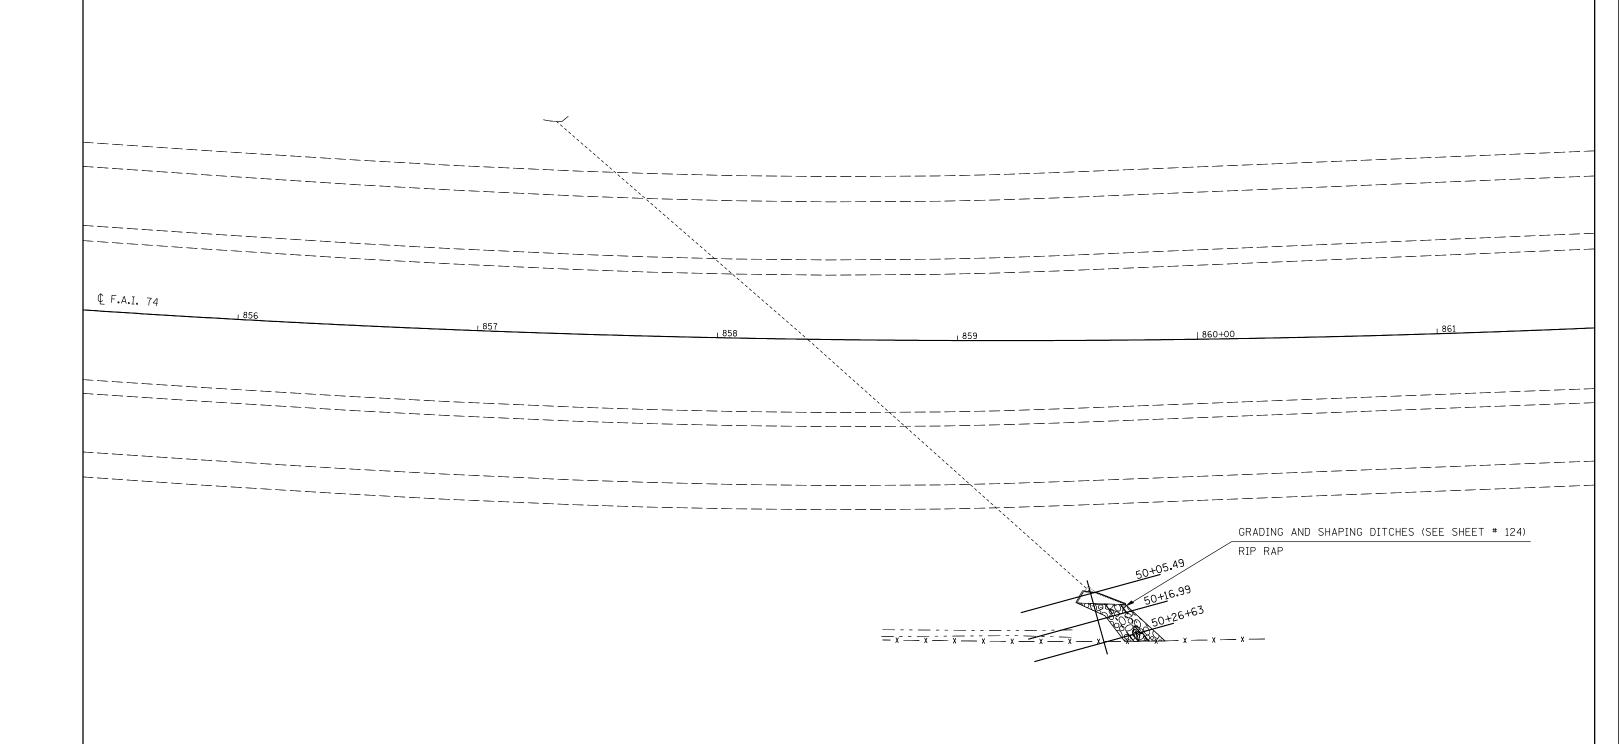
THE EXISTING STRUCTURE AT STATION 858+38 CONSISTS OF A 36" R.C.C.P. WITH CAST IN PLACE END SECTIONS. THE STRUCTURE IS IN GOOD CONDITION BUT THE DOWNSTREAM CHANNEL HAS EXPERIENCED SCOUR AND THE TOEWALL IS EXPOSED.

THE PROPOSED SCOPE OF WORK IS TO REGRADE THE DOWNSTREAM CHANNEL AND PROTECT IT WITH A TREATMENT OF RIPRAP WITHIN THE R.O.W.
