STRUCTURAL REPAIR L
FLOORBEAM 7 AT PIER 19
(Looking South)

MISCELLANEOUS STEEL
REPAIR DETAILS - 8
I-80 OVER
MISSISSIPPI RIVER
STRUCTURE NO. 081-0011

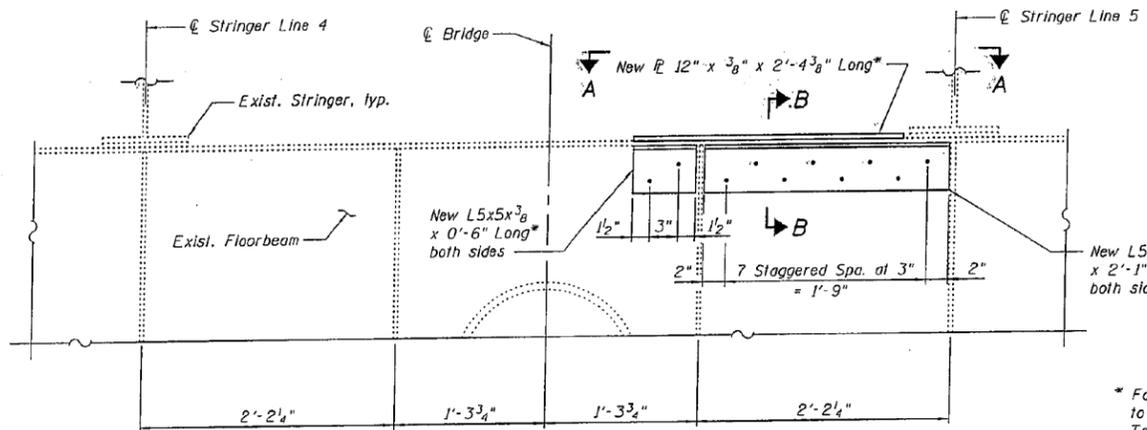
Note:
After mechanically straightening flange any gaps between the existing steel and the new steel angles and/or cover plates shall be sealed with an approval polyurethane sealant. The sealant shall be compatible with the proposed paint system and shall be submitted to the Engineer for approval prior to use.

* Fabricate new plate and angles for top flange repair to match existing top flange profile. See Floorbeam Top Flange Profile detail.

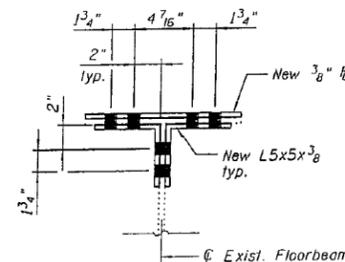
SECTION B-B

Notes:
Clip (1/2" x 1/2") heels of new angles to clear existing floorbeam flange to web weld.
Field drill holes in existing floorbeams and new plate using new angles as templates.
Open holes in new angles to be 15/16" φ for 7/8" φ H.S. A325 bolts.
