STATE OF ILLINOIS  
DEPARTMENT OF TRANSPORTATION

ROUTE NO.	SECTION	COUNTY	JOBS	SHEET	SHEET NO. 9
FAP 840	*	IROQUOIS	39	21	14 SHEETS
FED. ROAD DIST. NO.	ILLINOIS	FED. AID PROJECT			
66647				123-BR-1

**NORTH ABUTMENT  
IL 49 OVER PIGEON CREEK  
FAP ROUTE 840 - SECTION 123-BR-1  
IROQUOIS COUNTY  
STATION 135+74.00  
STRUCTURE NO. 038-0174**

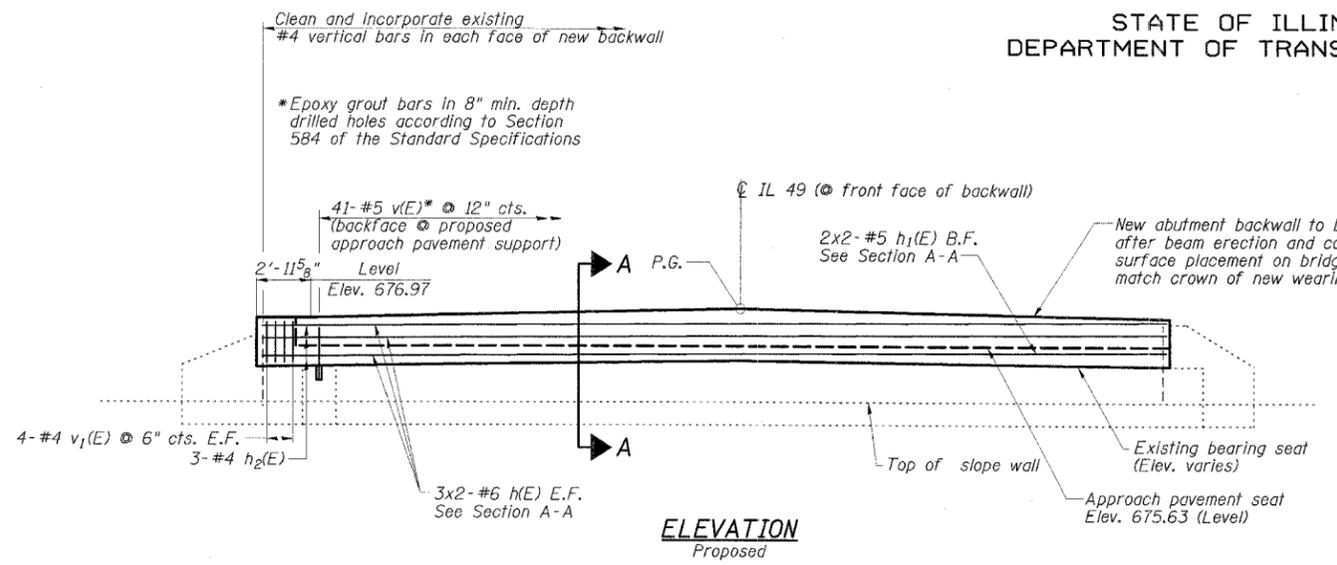
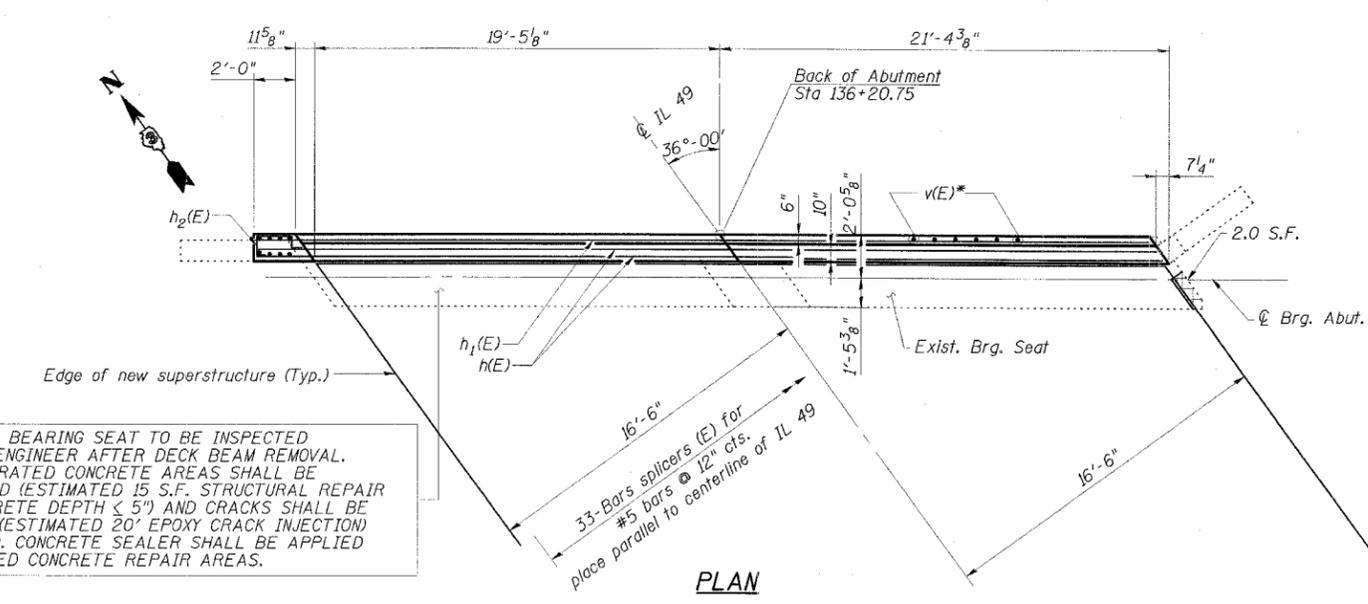
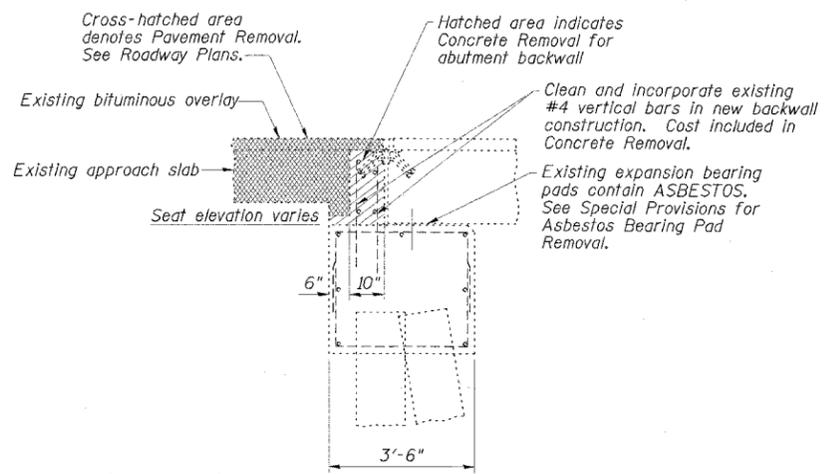
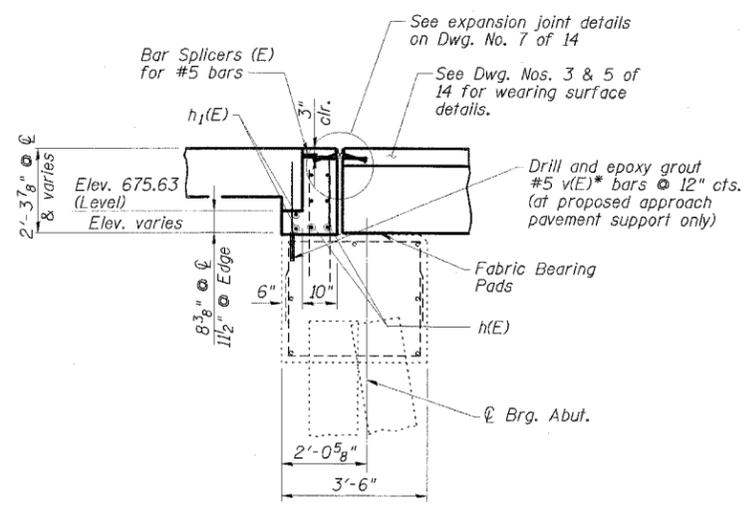
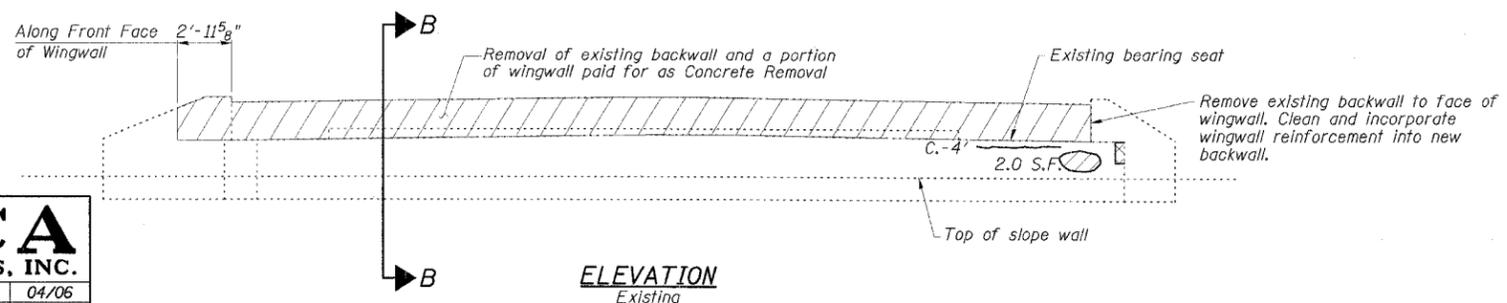
EXISTING BEARING SEAT TO BE INSPECTED BY THE ENGINEER AFTER DECK BEAM REMOVAL. DETERIORATED CONCRETE AREAS SHALL BE REPAIRED (ESTIMATED 15 S.F. STRUCTURAL REPAIR OF CONCRETE DEPTH < 5") AND CRACKS SHALL BE SEALED (ESTIMATED 20" EPOXY CRACK INJECTION IF FOUND. CONCRETE SEALER SHALL BE APPLIED TO FORMED CONCRETE REPAIR AREAS.
