INDEX OF SHEETS

- 1 TITLE SHEET/INDEX OF SHEETS
- 2 SUMMARY OF QUANTITIES AND GENERAL NOTES
- 3 DAM SCOUR REPAIR PLAN
- 4 CHANNEL PROFILES
- 5 PRECAST BLOCK DETAILS
- 6 CROSS SECTION

STATE OF ILLINOIS
DEPARTMENT OF NATURAL RESOURCES
OFFICE OF WATER RESOURCES
VERMILION RIVER
DAM SCOUR REPAIR
OGLESBY, ILLINOIS
LA SALLE COUNTY
FR-429
2010

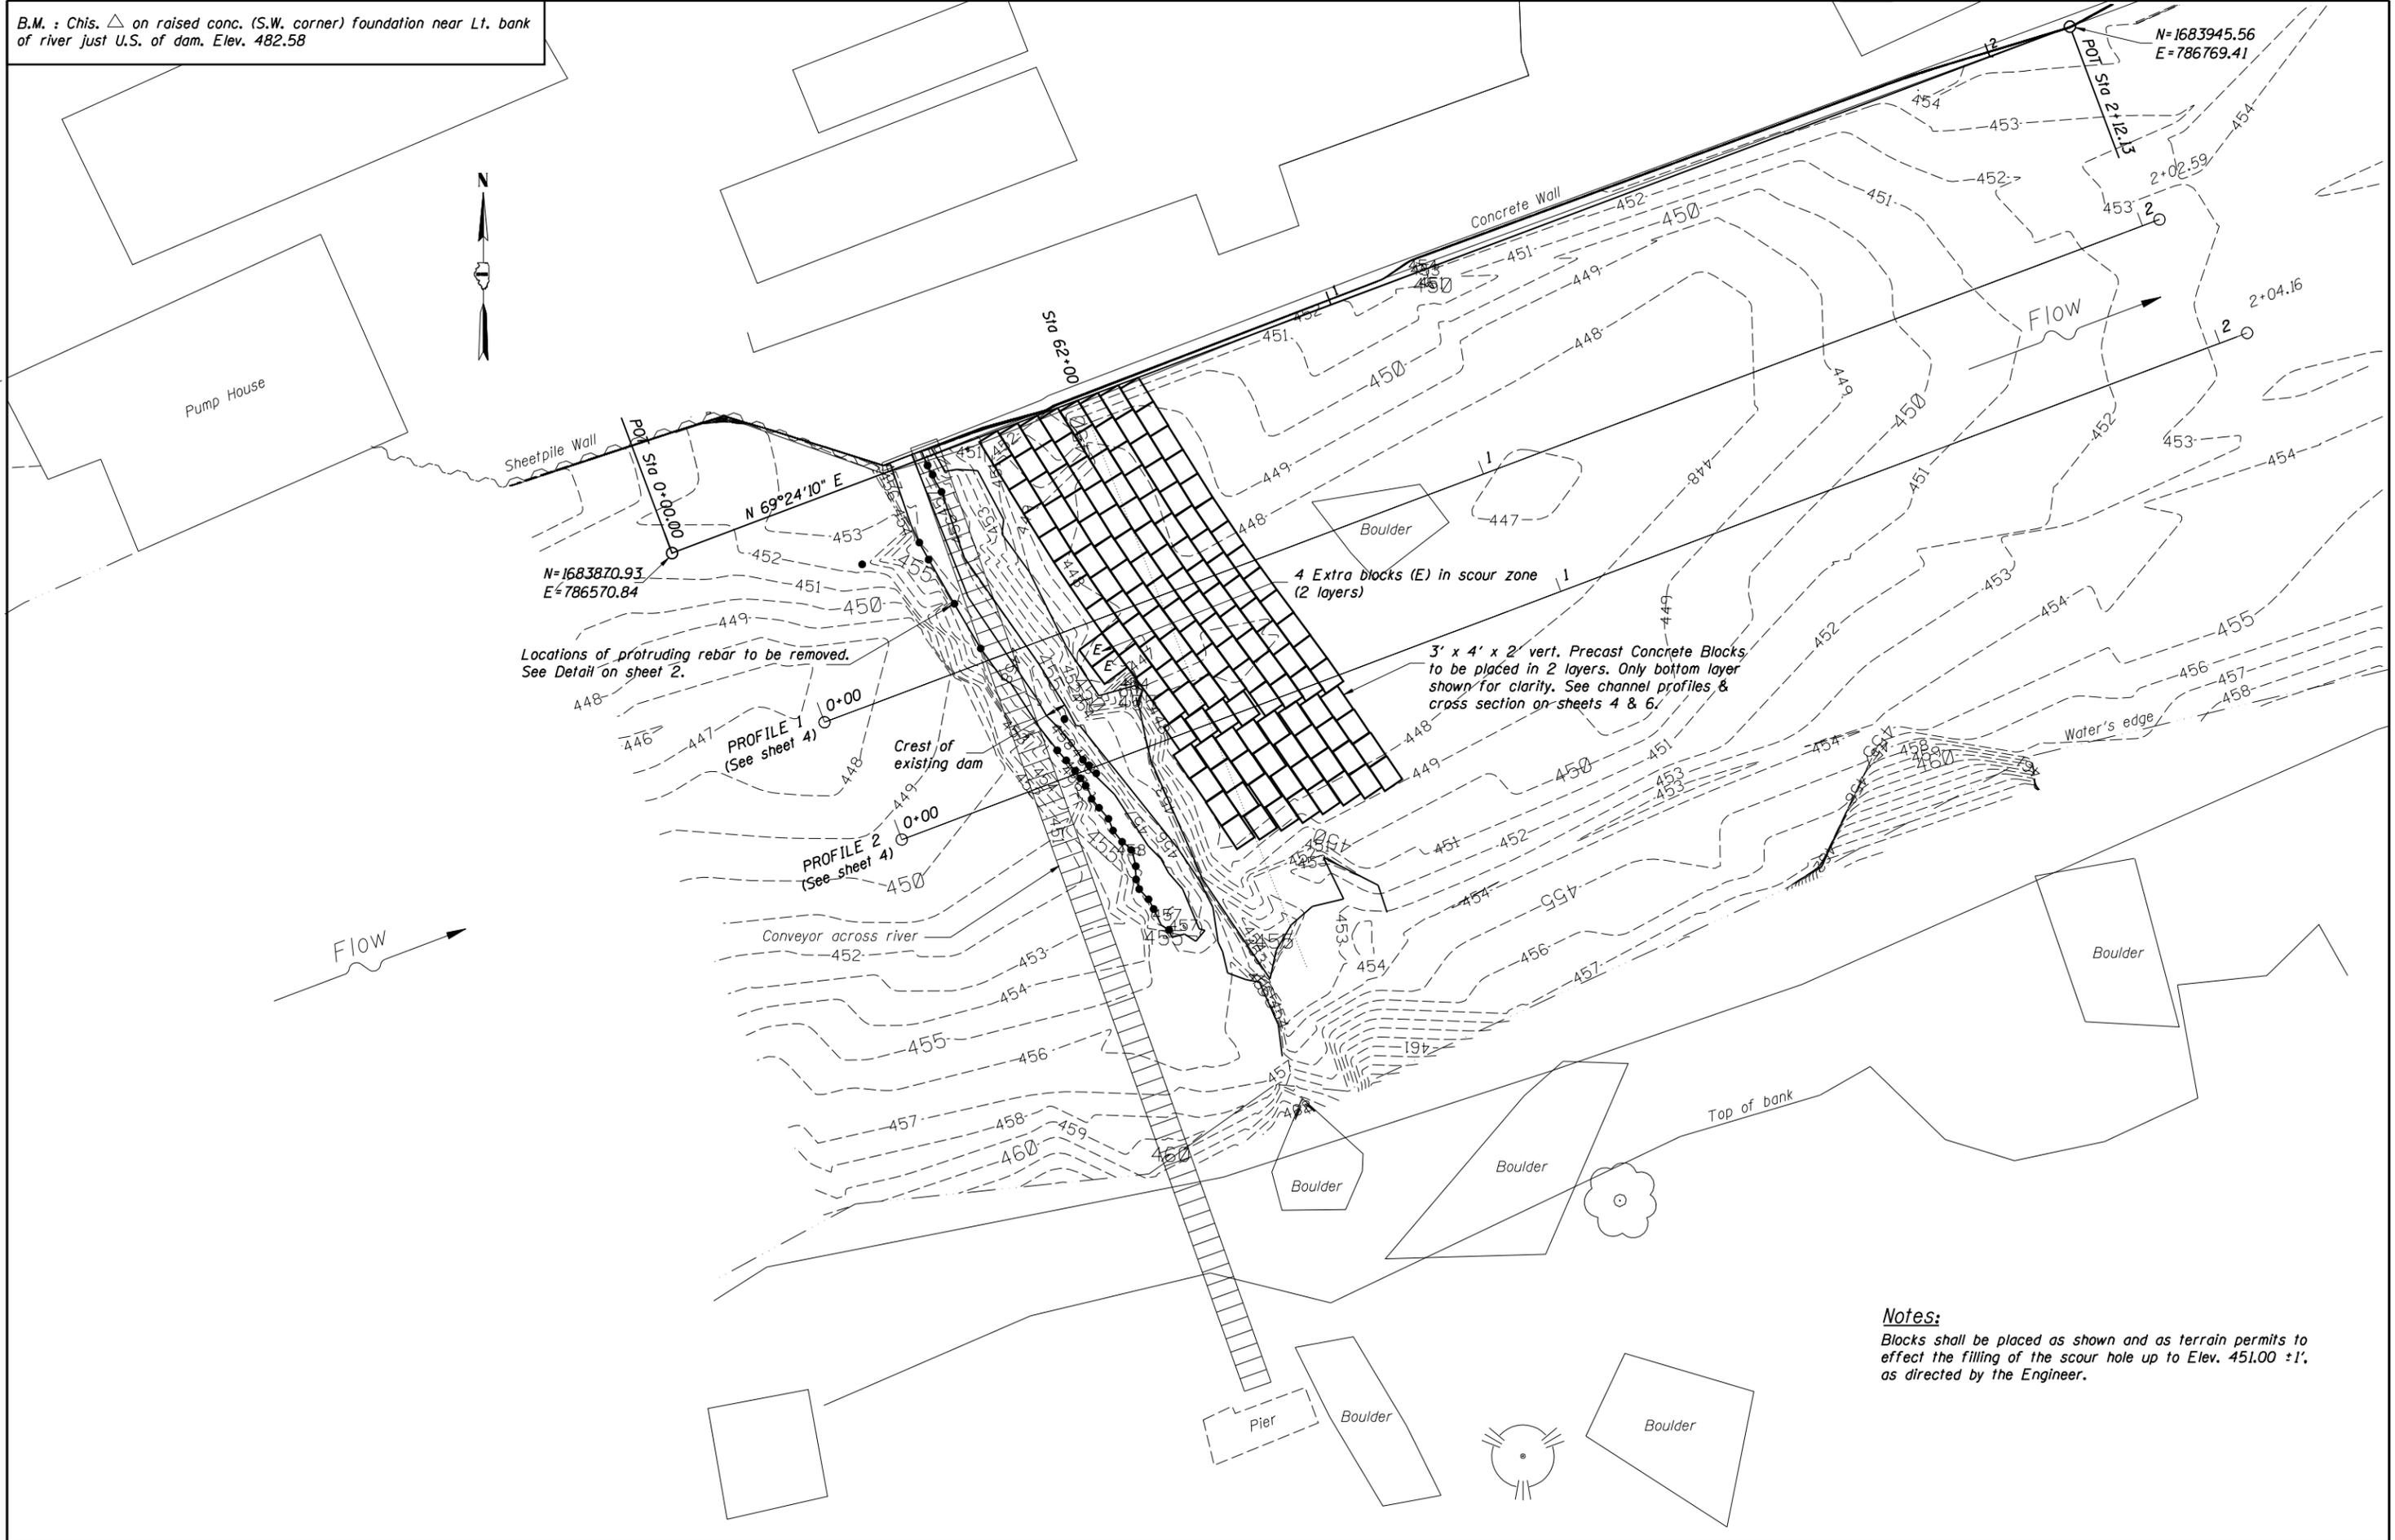
3' x 4' x 2' vert. Precast Concrete Blocks to be placed in 2 layers. Only bottom layer shown for clarity. See channel profiles & cross section on sheets 4 & 6.

Notes:
Blocks shall be placed as shown and as terrain permits to effect the filling of the scour hole up to Elev. 451.00 ±1', as directed by the Engineer.

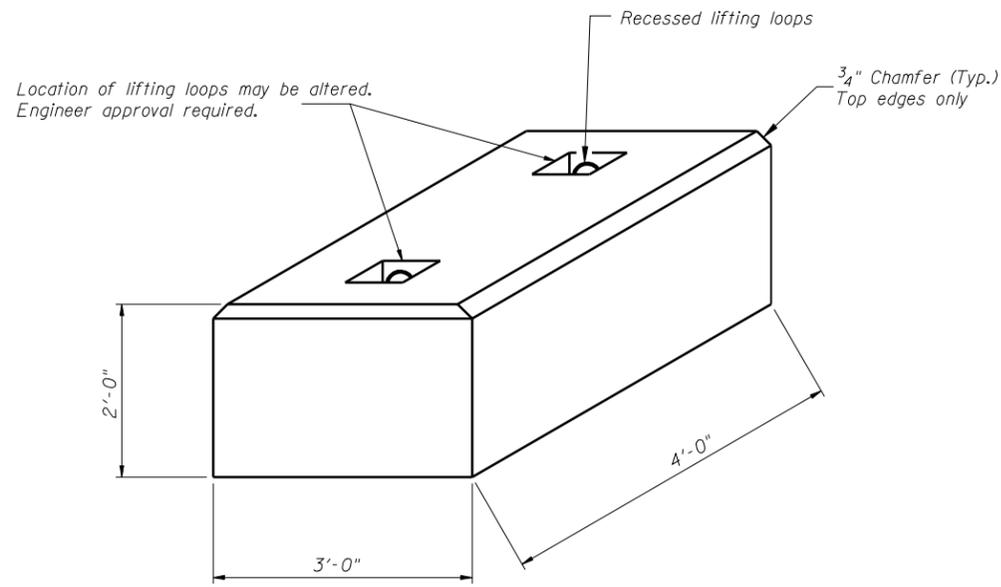
ISOMETRIC VIEW

Lifting loops shall be #4 epoxy coated reinforcing bars and shall conform to the requirements of ASTM A706, Grade 60. Cost included in Precast Concrete Blocks.

Spreader bar shall be used for pickup of blocks.

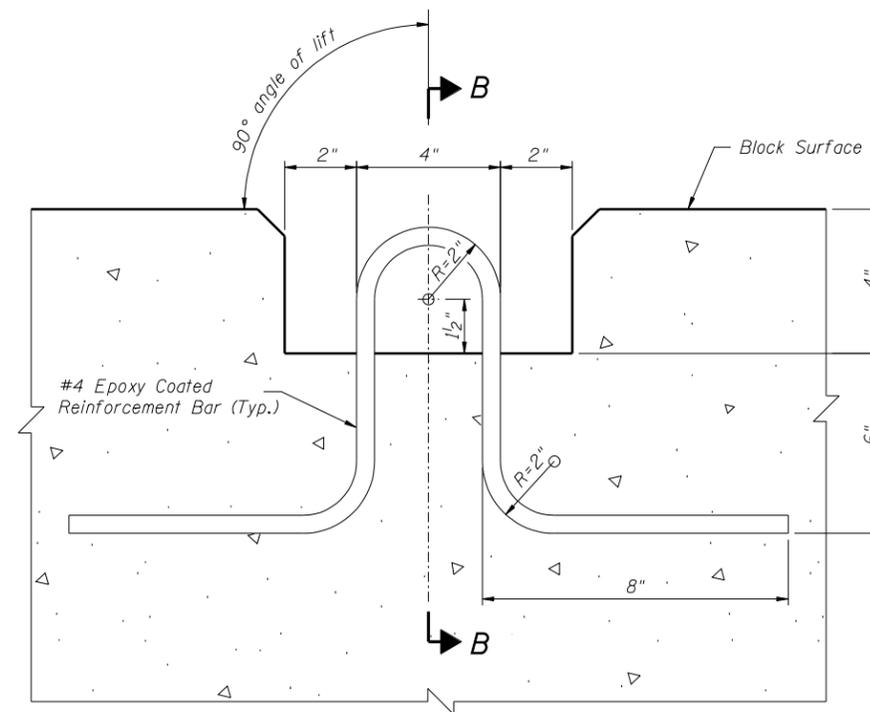
SECTION A-A

Precast Concrete Blocks to be unreinforced.

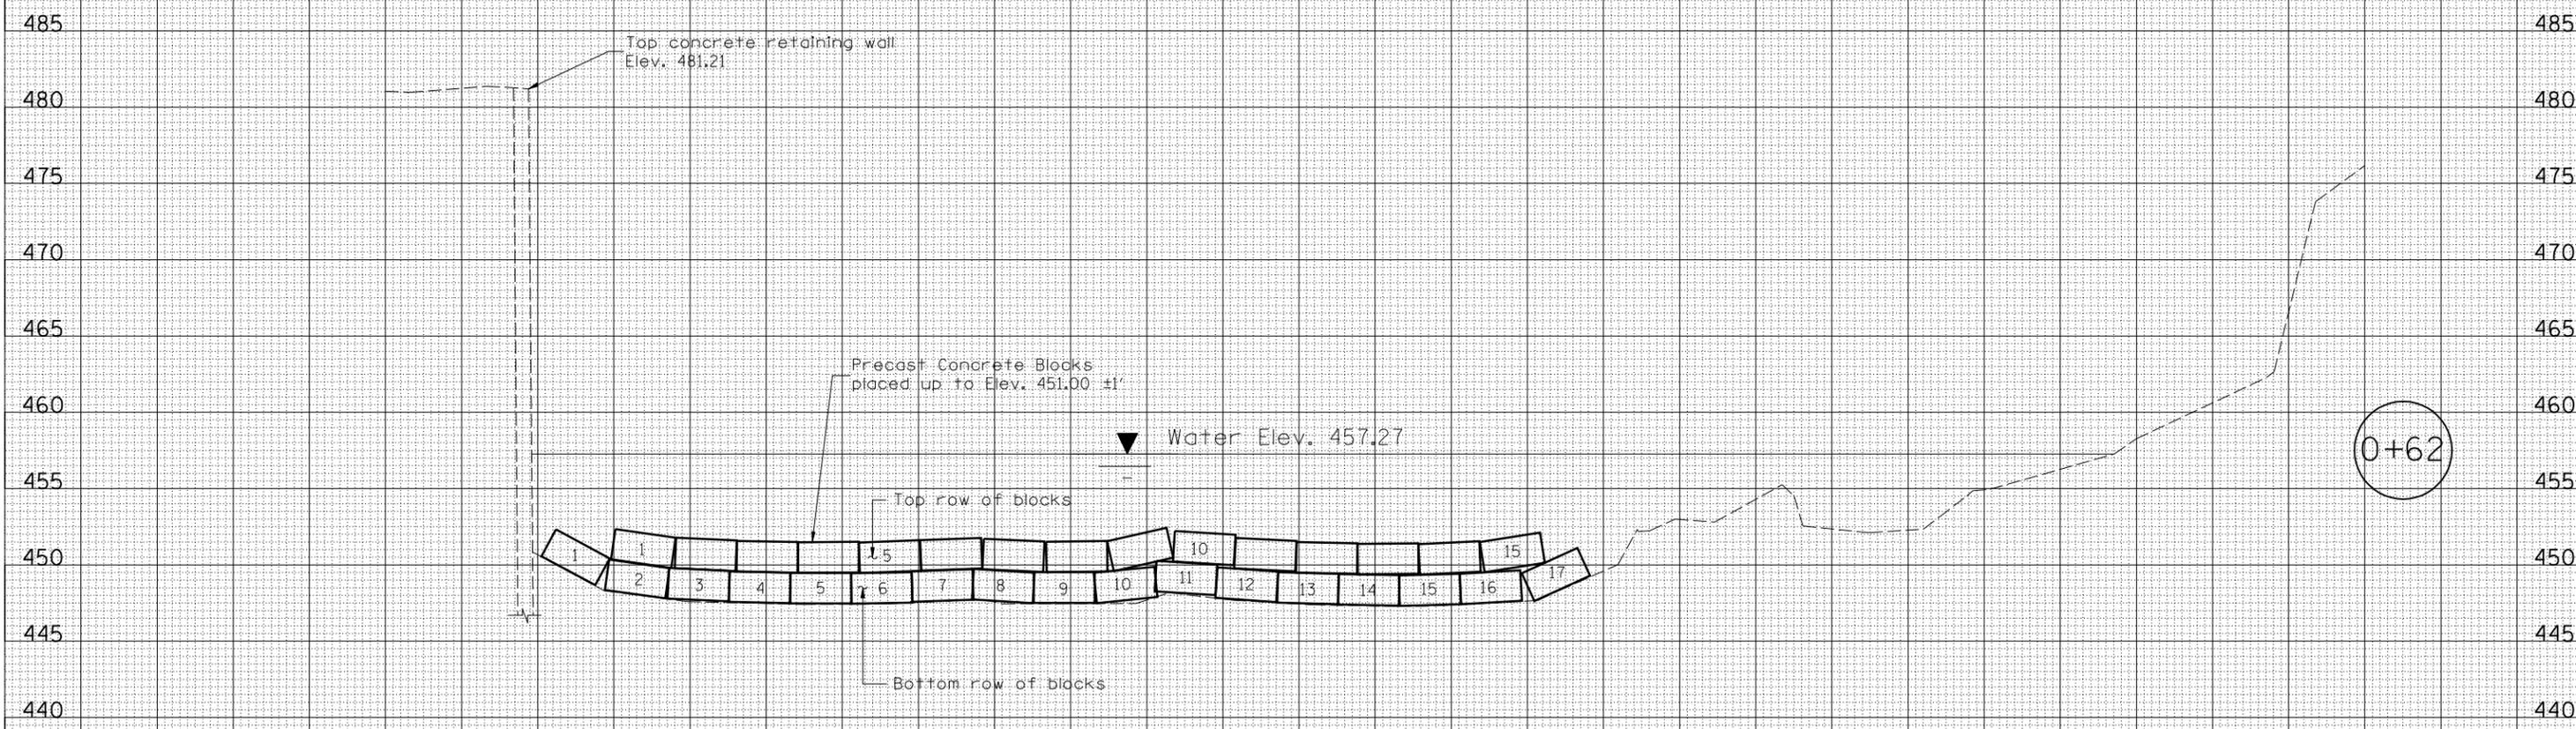
Top concrete retaining wall
Elev. 481.21

Precast Concrete Blocks
placed up to Elev. 451.00 ±1'
