STRUCTURAL STEEL REPAIR DETAILS, SHEET 2 STRUCTURE NO. 081-9905		SECTION
		(3BR)M
31110010HL NO. 001-3303		C-92-090-12
SHEET NO. 13 OF 33 SHEETS		ILLINOI

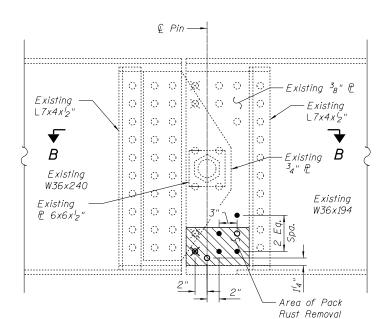
DETAIL 5

Span 21, Beam F North Pin, West Face

REPAIR SEQUENCE:

- 1. Drill out and remove designated flattened rivets.
- Remove pack rust from between ³₈" bearing plates and web of W36x194 using hand tool or power tool methods.
- 3. Clean out bolt holes and tap threads in plates and web of W36x194 at location where threaded rod will be installed.
- Install new ⁷₈ ["] A 325SC Bolts and Tighten to bring ³₈ " plates into contact with web of W36x194.
- 5. Install new 1" ϕ H.S. threaded rod. Threaded rod should be cut short to allow for l_g " of exposed threads on each 3g " bearing plate.
- Mar exposed threads on each ³8" bearing plate to prevent threaded rod from rotating out of hole.

SECTION B-B

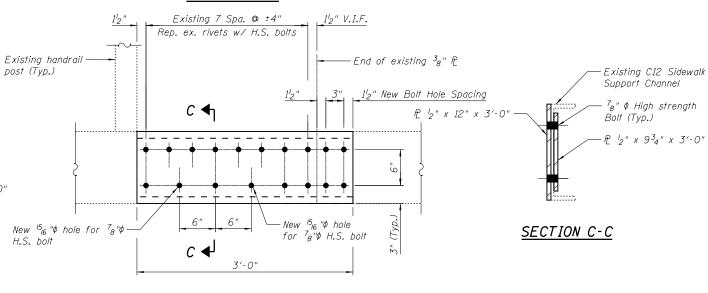
DETAIL 7

Span 25 West Sidewalk, 6' North from Bent 18 (Looking East)

Contractor to ensure support of sidewalk channel during splice plate exchange

New ¹⁵16 "\$\phi\$ hole

for 78"\$ H.S. bolt
