**STATE OF ILLINOIS
 DEPARTMENT OF TRANSPORTATION**

**DECK SLAB REPAIRS AND CONCRETE REMOVAL
 STRUCTURE NO. 054-0009**

SHEET NO. 4 OF 13 SHEETS

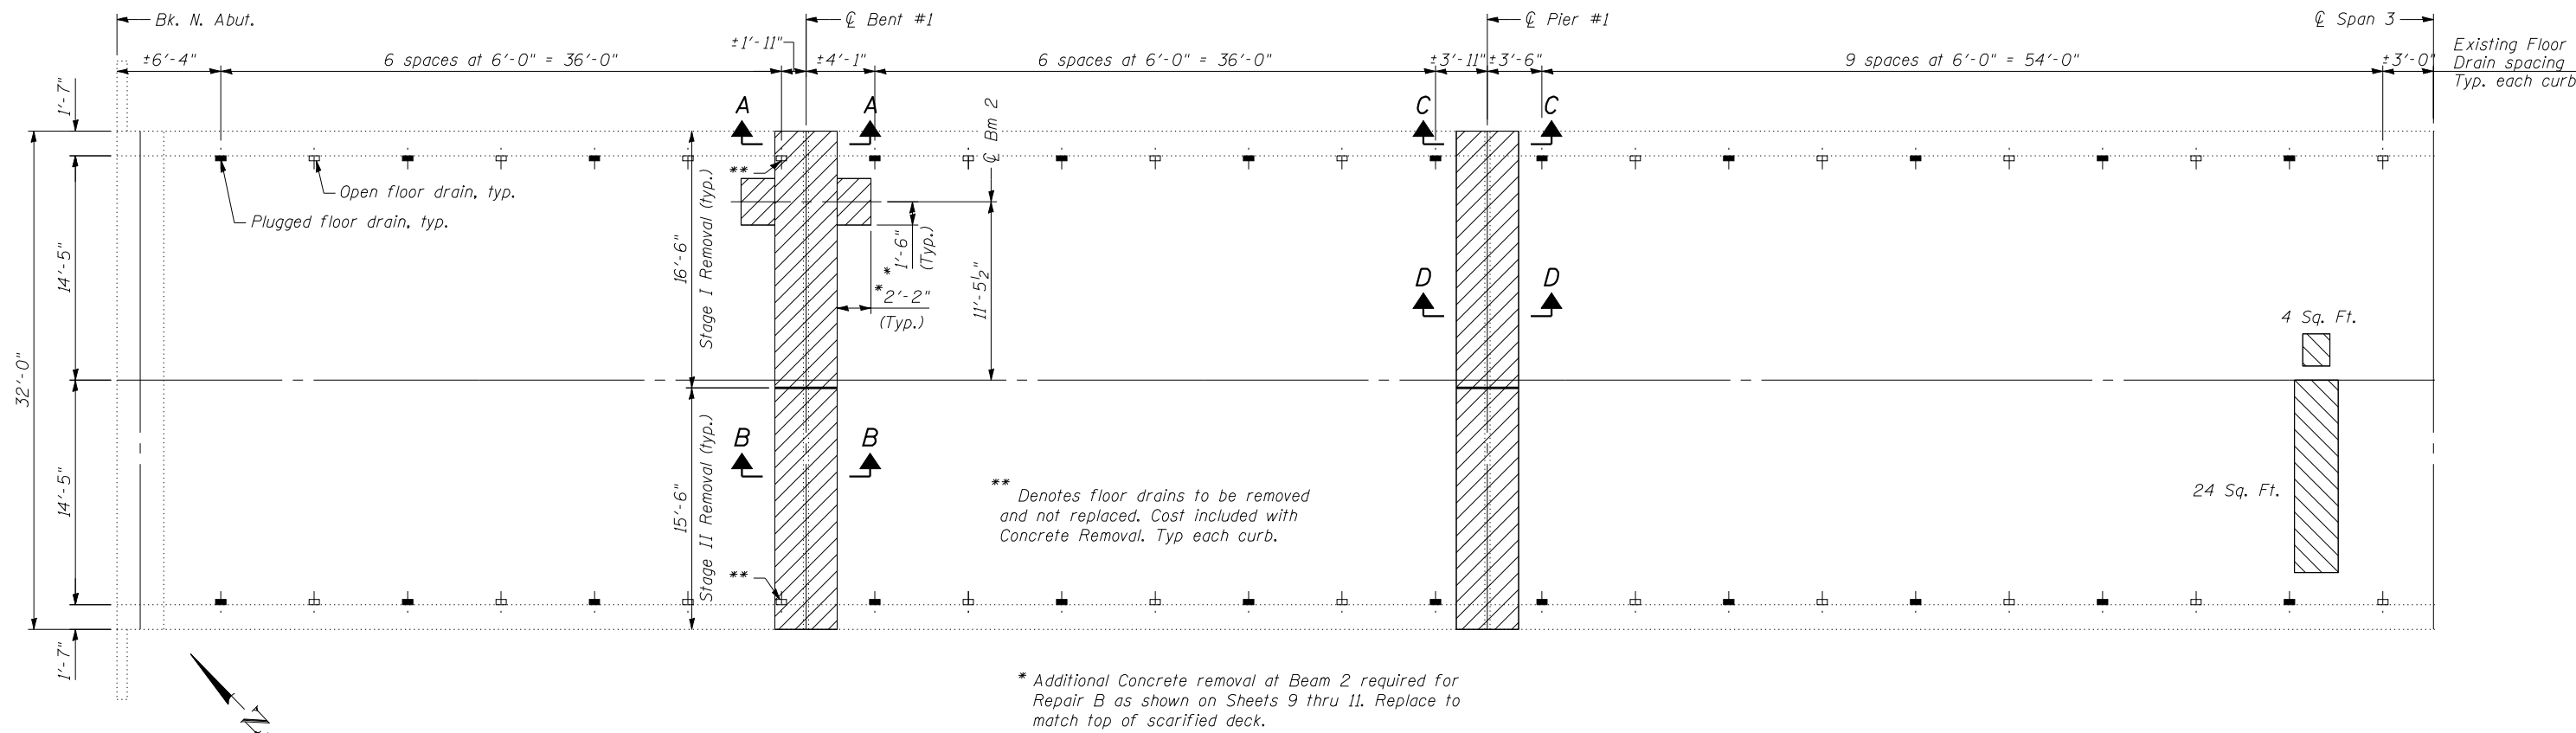
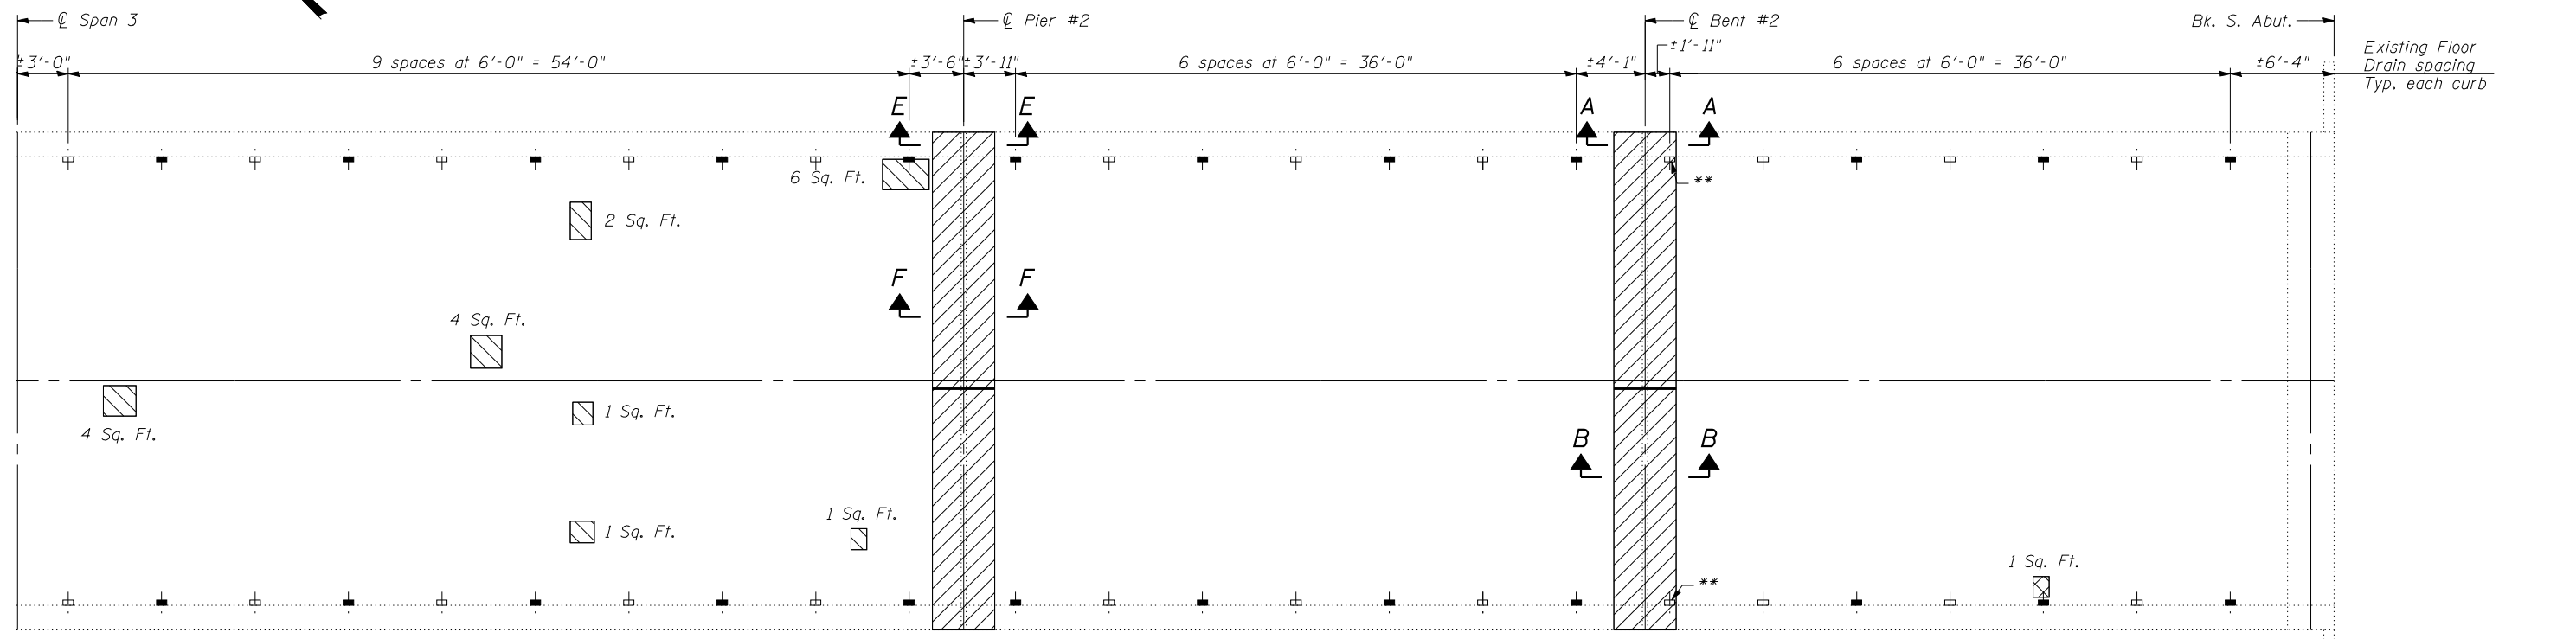
* Additional Concrete removal at Beam 2 required for Repair B as shown on Sheets 9 thru 11. Replace to match top of scarified deck.

Notes:
 The areas of Deck Slab Repair are based on visual inspection completed in 2009 and 2011. Actual repair areas and locations shall be determined by the Engineer and shown on As-Built Plans.
 See Sheet 5 of 13 for Sections A-A thru F-F.
 See Sheet 2 of 13 for Floor Drain Details.
