**MIDAMERICA ST. LOUIS AIRPORT  
ST. CLAIR COUNTY, ILLINOIS**

**RUNWAY AND TAXIWAY JOINT REPAIR**

**IL PROJECT: BLV-3886  
AIP PROJ: 3-17-0146-XX**

**JOINT REPAIR  
DETAILS**

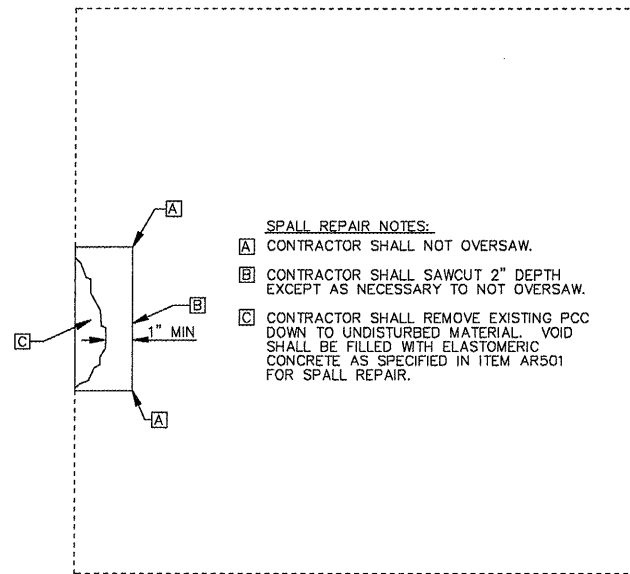
- SPALL REPAIR NOTES:**
- A** CONTRACTOR SHALL NOT OVERSAW.
  - B** CONTRACTOR SHALL SAWCUT 2" DEPTH EXCEPT AS NECESSARY TO NOT OVERSAW.
  - C** CONTRACTOR SHALL REMOVE EXISTING PCC DOWN TO UNDISTURBED MATERIAL. VOID SHALL BE FILLED WITH ELASTOMERIC CONCRETE AS SPECIFIED IN ITEM AR501 FOR SPALL REPAIR.

**SPALL REPAIR DETAIL**  
NOT TO SCALE

NOTE: FOR USE WITH SPALL WIDTHS GREATER THAN 0.5".

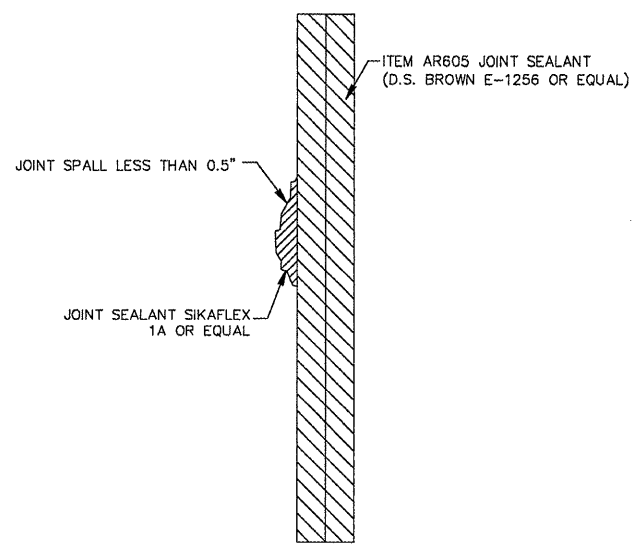
**MINOR SPALL REPAIR DETAIL**  
NOT TO SCALE

NOTE: FOR USE WITH SPALL WIDTHS LESS THAN 0.5".

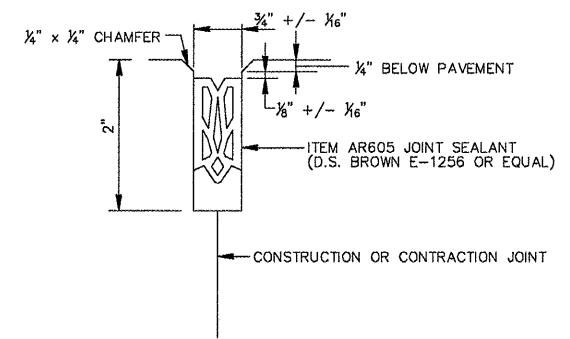
**JOINT SEALANT DETAIL**  
NOT TO SCALE

NOTE: RECORDS INDICATE THAT THE EXISTING JOINT WIDTH IS 0.5" FOR TAXIWAY G AND 0.375" FOR ALL OTHER PAVEMENTS.
