STATE OF ILLINOIS **DEPARTMENT OF TRANSPORTATION** SUPERSTRUCTURE REPAIR STRUCTURE NO. 045-0005 SHEET NO. 3 OF 4 SHEETS

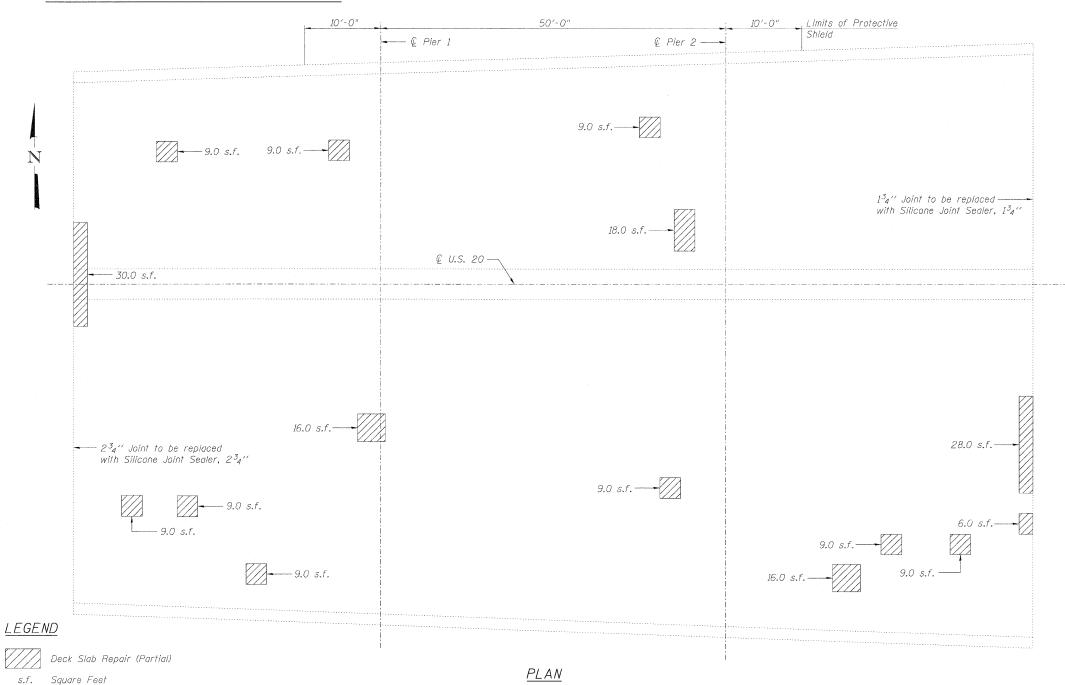
SILICONE JOINT SEALER END TREATMENT

Repair of the existing deck slab shall include but may not be limited to the areas shown. The actual area to be repaired will be determined by the Engineer at the time of construction. Cost of existing joint removal is included in the cost of Silicone Joint Sealer.

Limits of Protective Shield shall extend longitudinally as shown below and transversely from North to South fascia beams,
