DIXON MUNICIPAL, AIRPORT CHARLES R. WALGREEN FIELD

REPAIR AND OVERLAY PORTIONS OF RUNWAY 12-30

LIGHT ADJUSTMENT AND MARKING PLAN AND LIGHT ADJUSTMENT DETAILS RUNWAY 12-30 STA 199+49.16 THRU STA 209+50

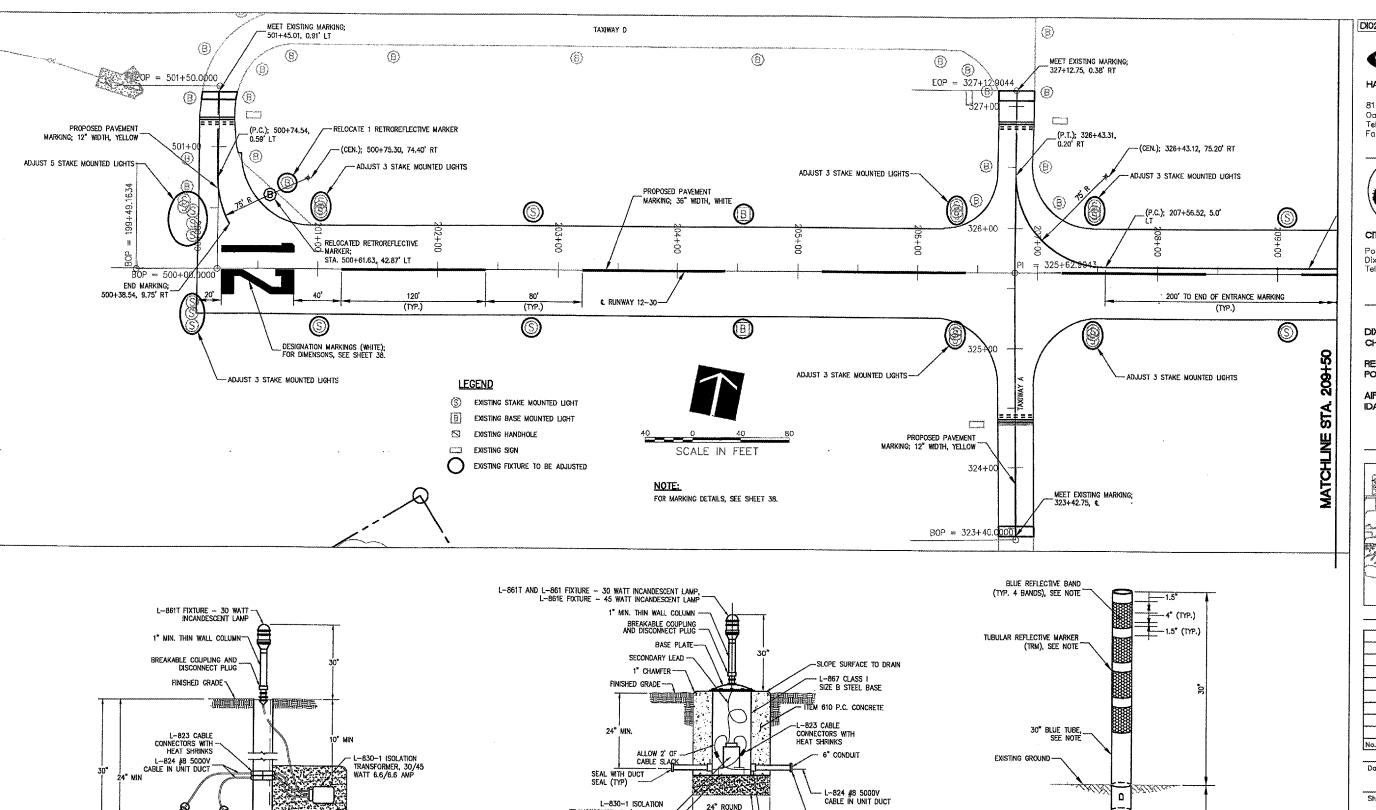
EXISTING STAKE - MOUNTED LIGHT L-861 AND L-861T

1. BREAKABLE COUPLING SHALL NOT BE OVER 1" ABOVE BASE PLATE.

CONDUIT BUSHING NO SQUEEZE

- TWO FEET OF SLACK CABLE IS TO BE LEFT AT EACH LIGHT. SLACK IS TO BE ON THE CABLE SIDE OF PRIMARY CONNECTORS AND SPLICES AND IS TO BE INCIDENTAL TO THE CABLE.
- 3. SEE SPECIAL PROVISIONS FOR ADDITIONAL REQUIREMENTS.

6.6/6.6 AMP

TRANSFORMER HOLDER

EXISTING BASE - MOUNTED LIGHT L-861, L-861E, L-861T

TUBULAR REFLECTIVE MARKER (TRM) TO BE CROUSE—HINDS (PART NO. 853S0-30-4B) OR EQUAL. TUBULAR REFLECTIVE MARKER TO BE INSTALLED PER MANUFACTURER'S INSTRUCTION.

TAXIWAY REFLECTIVE MARKER (TRM)
