**STATE OF ILLINOIS
DEPARTMENT OF TRANSPORTATION**

**DECK PATCHING DETAILS
SN 081-0016 (SB)**

SHEET NO. 2 OF 3 SHEETS

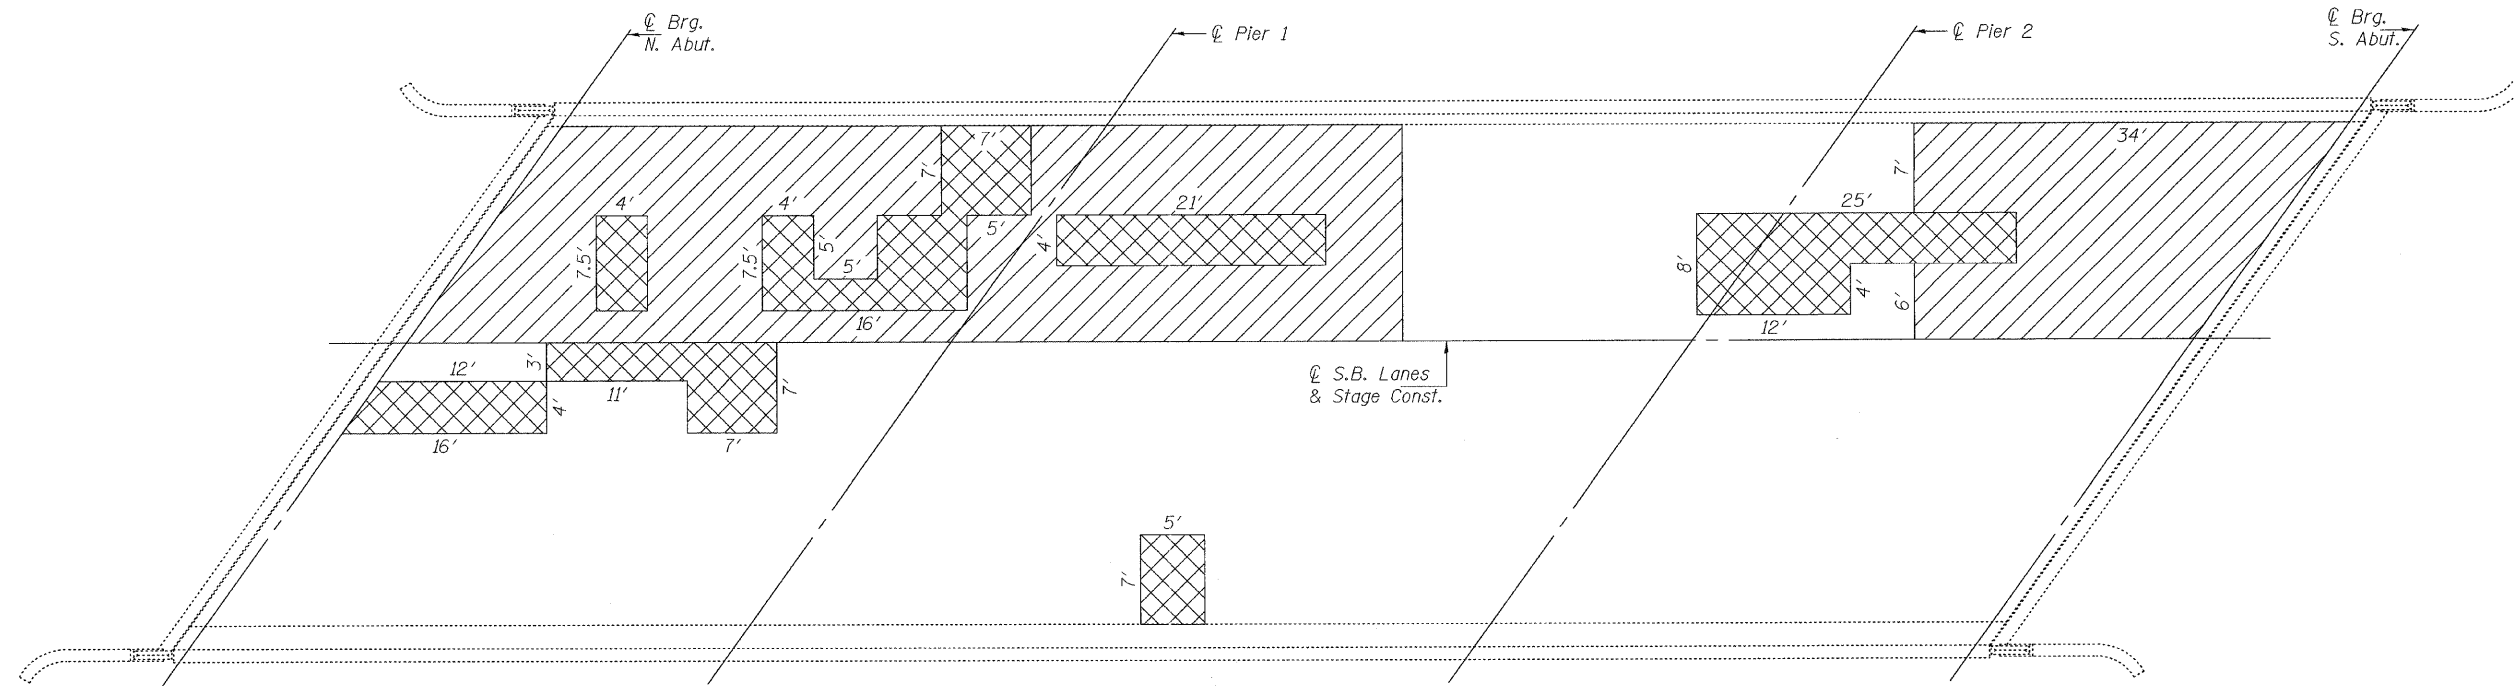
PLAN

Hatched areas indicate Deck Slab Repair (Partial)
Areas of deck repair are estimated. Actual locations shall be shown by the Engineer for As Built Plans.
