STATE OF ILLINOIS
DEPARTMENT OF TRANSPORTATION

-	DECK	PATCH	ING	DETAILS	·····
	SN	081-	0017	(NB)	
_	SHEET	F NO. 3	OF 3	SHEETS

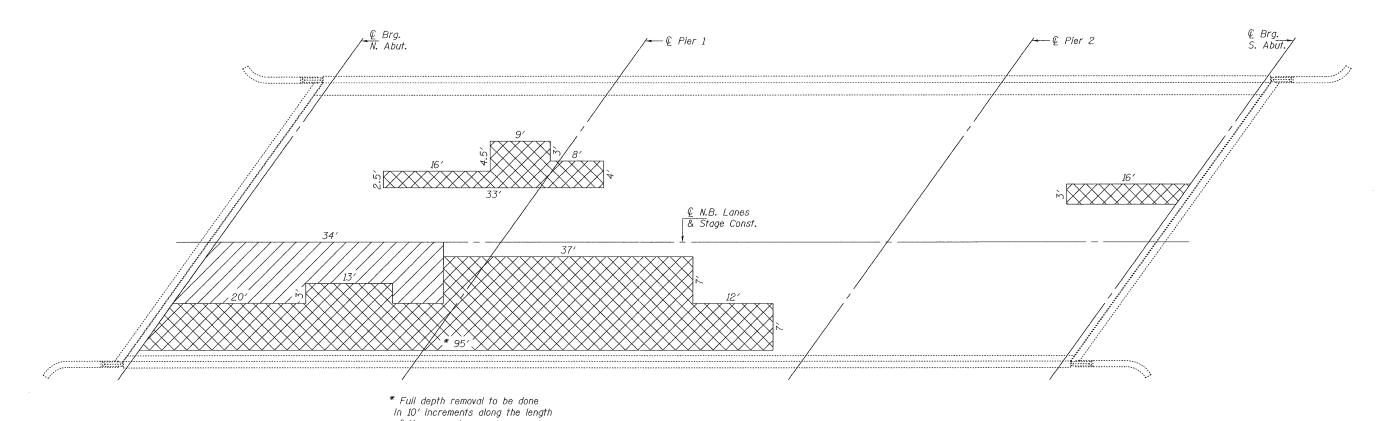
PLAN

Hatched areas indicate Deck Slab Repair (Partial) Areas of deck repair are estimated. Actual locations shall be shown by the Engineer for As Built Plans.

Cross hatched areas indicate Deck Slab Repair (Full Depth, Type II)
