STATE OF ILLINOIS  
DEPARTMENT OF TRANSPORTATION

DECK PATCHING DETAILS  
SN 037-0025 (SB)

SHEET NO. 2 OF 3 SHEETS

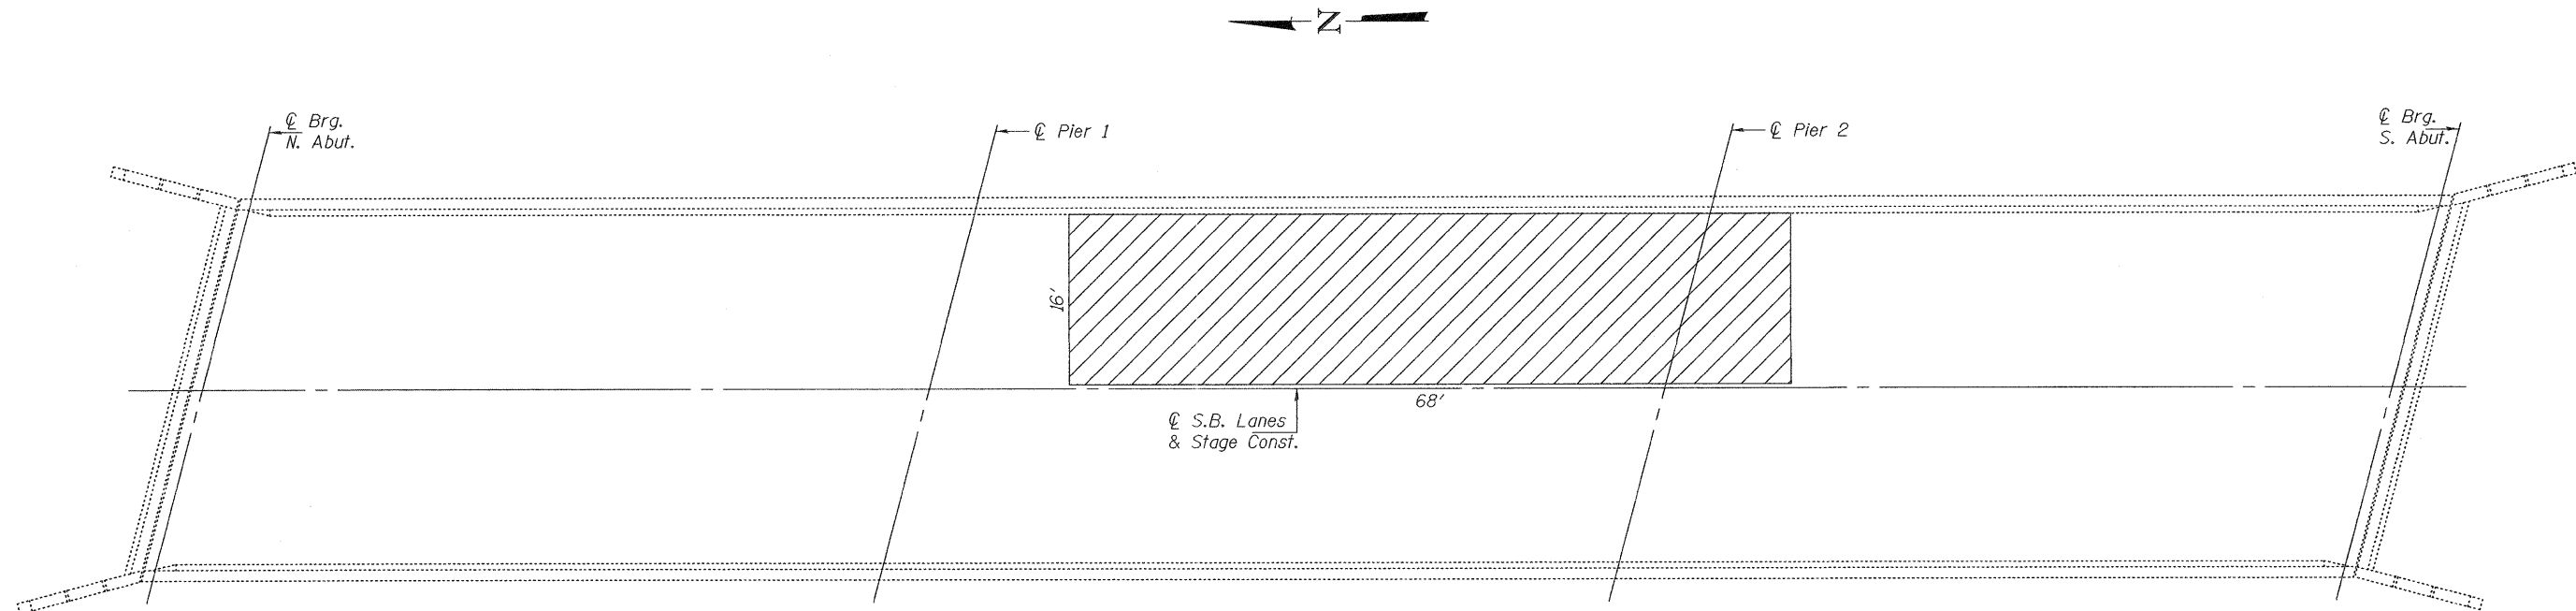
**PLAN**

Hatched areas indicate Deck Slab Repair (Partial)  
Areas of deck repair are estimated. Actual locations shall be shown by the Engineer for As Built Plans.
