**STATE OF ILLINOIS
 DEPARTMENT OF TRANSPORTATION**

**DETAILS
 STRUCTURE NO. 095-0036**

F.A.I. RTE.	SECTION	COUNTY	TOTAL SHEETS	SHEET NO.
64	95-1,21RS-1	WASHINGTON	126	95
CONTRACT NO. 76D20			ILLINOIS FED. AID PROJECT

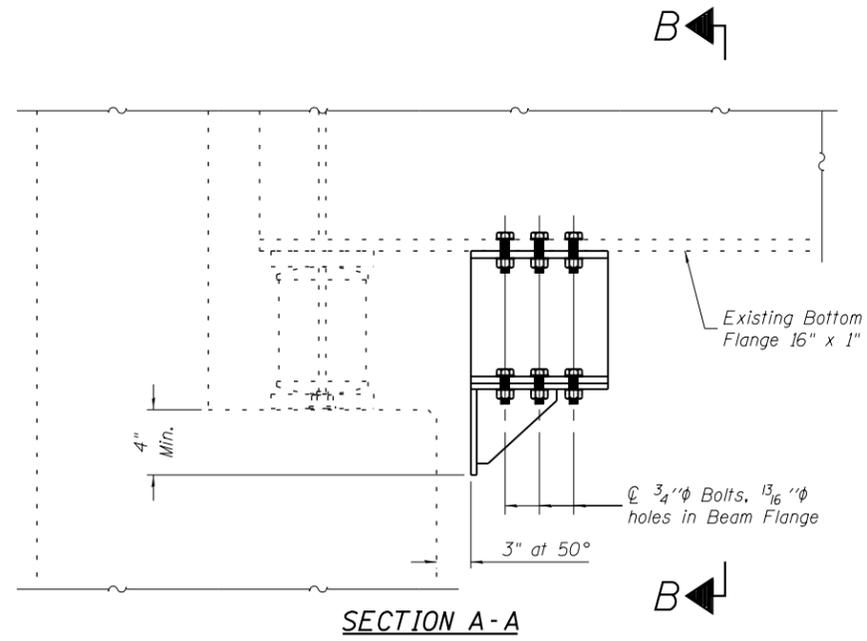
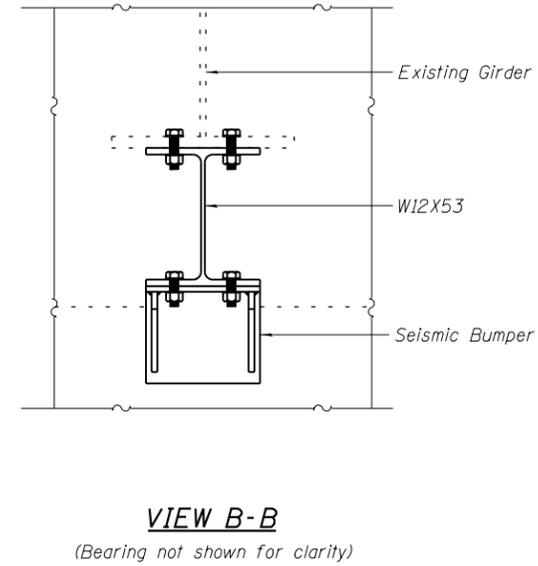
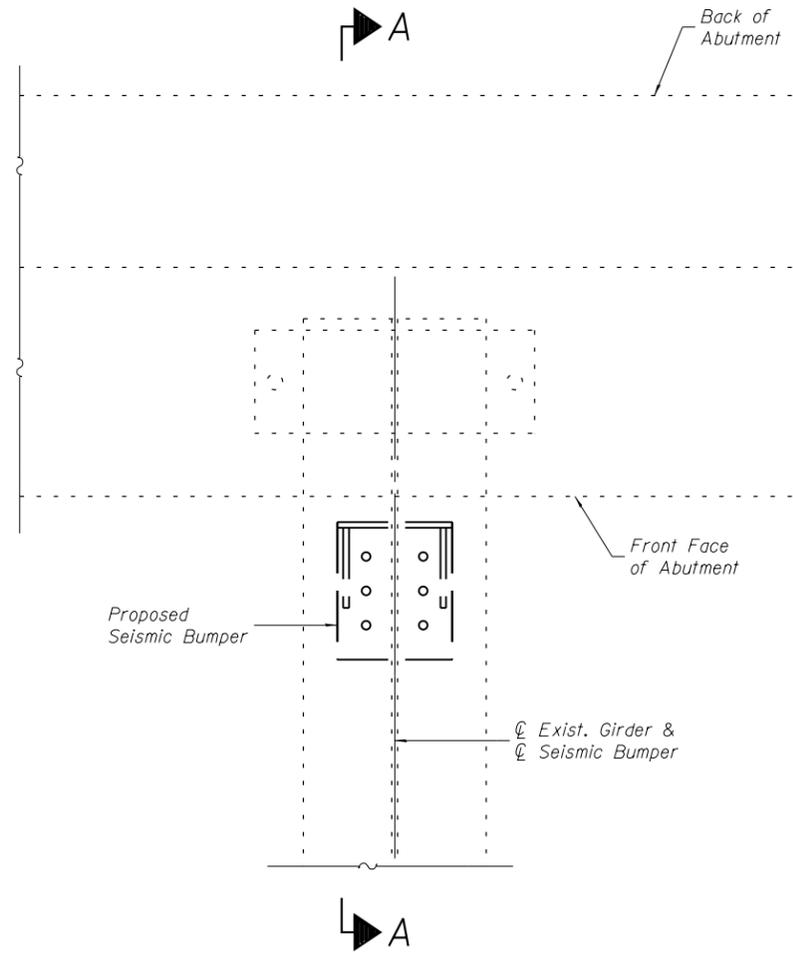
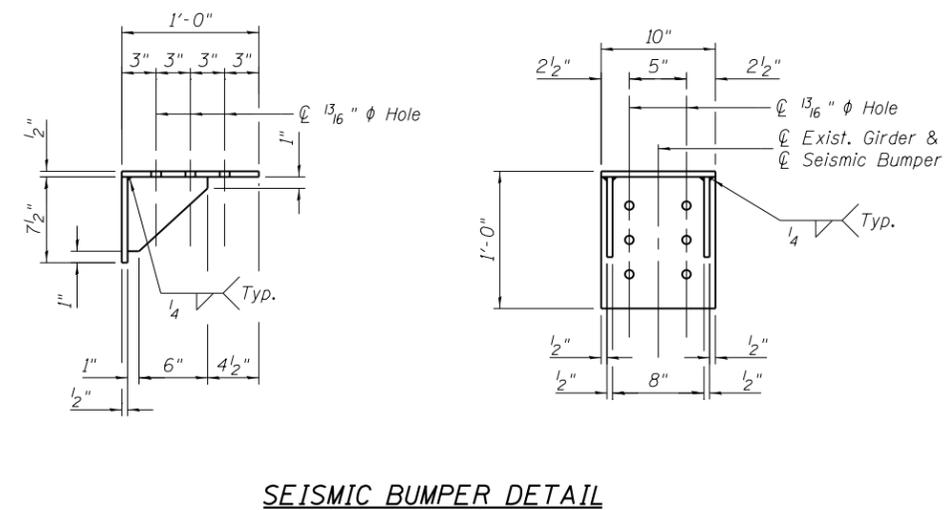
PART PLAN OF ABUTMENT AT SEISMIC BUMPER
(8 Locations - each girder at each abutment)

Note:
 New steel and connection bolts are included in Structural Steel Repair.
 Two hardened washers required for each set of oversized holes.
 Cost of drilling holes in bottom flange of existing girders shall be included in Structural Steel Repair.
 Seismic bumper shall be installed parallel to front face of abutment.
