STATE OF ILLINOIS DEPARTMENT OF TRANSPORTATION

STRINGER END REPAIR DETAILS - 1 I-80 OVER MISSISSIPPI RIVER

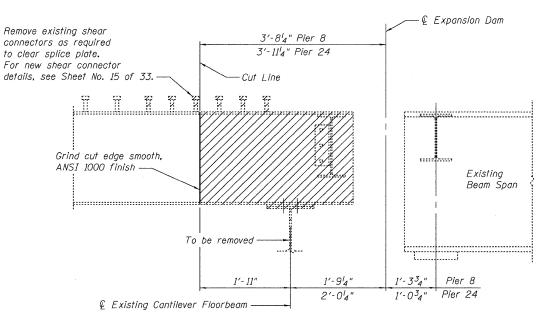
Note: Expansion Dams not shown for clarity.

STRINGER END REPAIR AT EXPANSION DAM PIER 8 AND 24 - STRINGER LINES 1 AND 8 TYPICAL REMOVAL ELEVATION

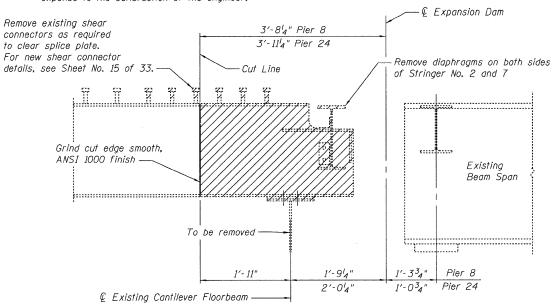
Remaining exposed shear connectors damaged as a result of construction shall be replaced, at the contractor's expense to the satisfaction of the engineer.

STRINGER END REPAIR AT EXPANSION DAM PIER 8 AND 24 - STRINGER LINES 2 AND 7 TYPICAL REMOVAL ELEVATION

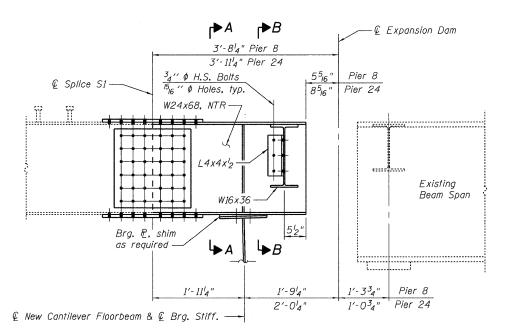
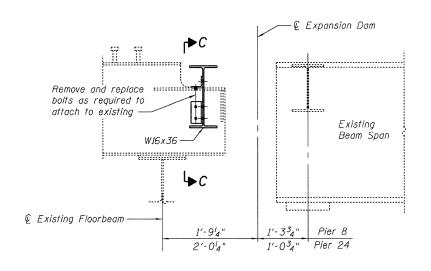
STRINGER END REPAIR AT EXPANSION DAM PIER 8 AND 24 - STRINGER LINES 1, 2, 7 AND 8 TYPICAL ELEVATION

Load carrying components designated "NTR" shall conform to the supplemental requirement for Notch Toughness, Zone 2.

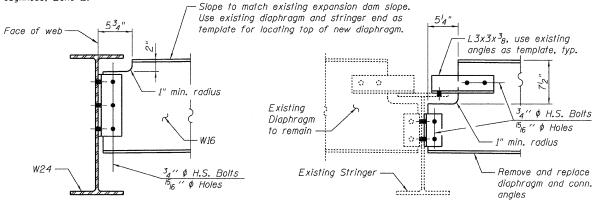
SECTION B-B Stringer No. 1 & 8 shown, Stringer No. 2 & 7 similar
