STATE OF ILLINOIS DEPARTMENT OF TRANSPORTATION

DECK REPAIR PLAN F.A.P. Route 303 & FAB 738 (IL 251) OVER Railroad SECTION (5VB, 5HB, 1-2HB)M WINNEBAGO COUNTY SN 101-0029

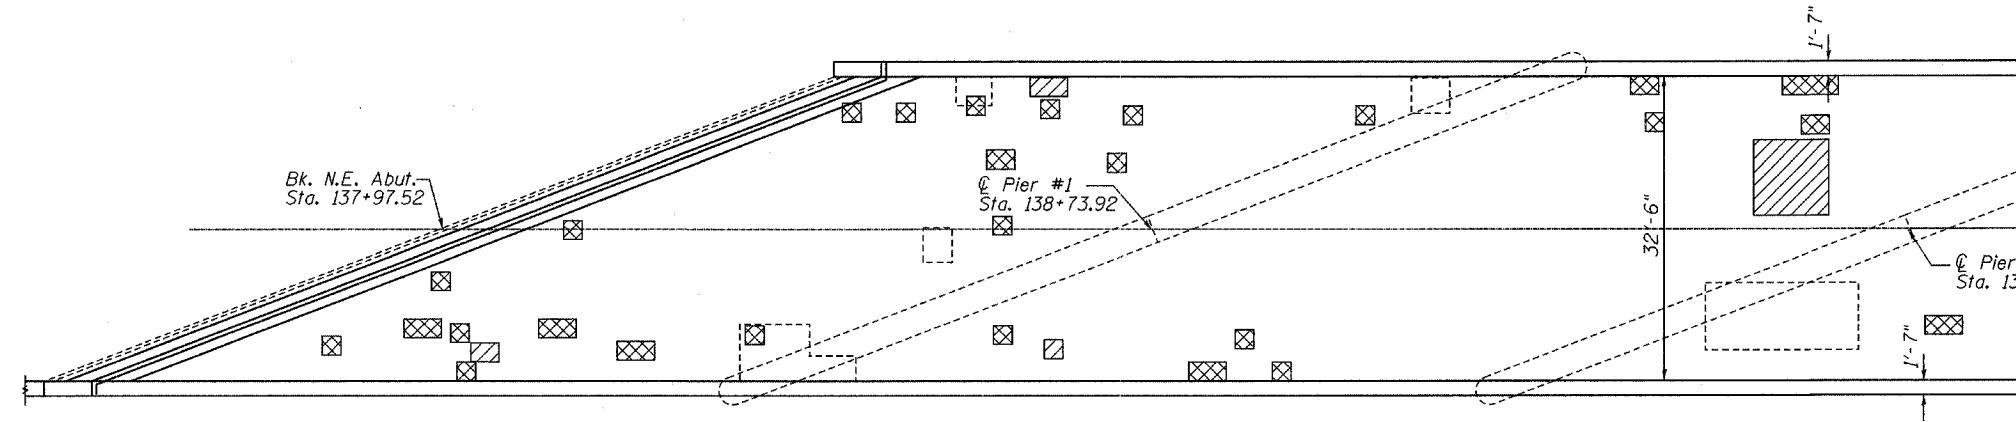
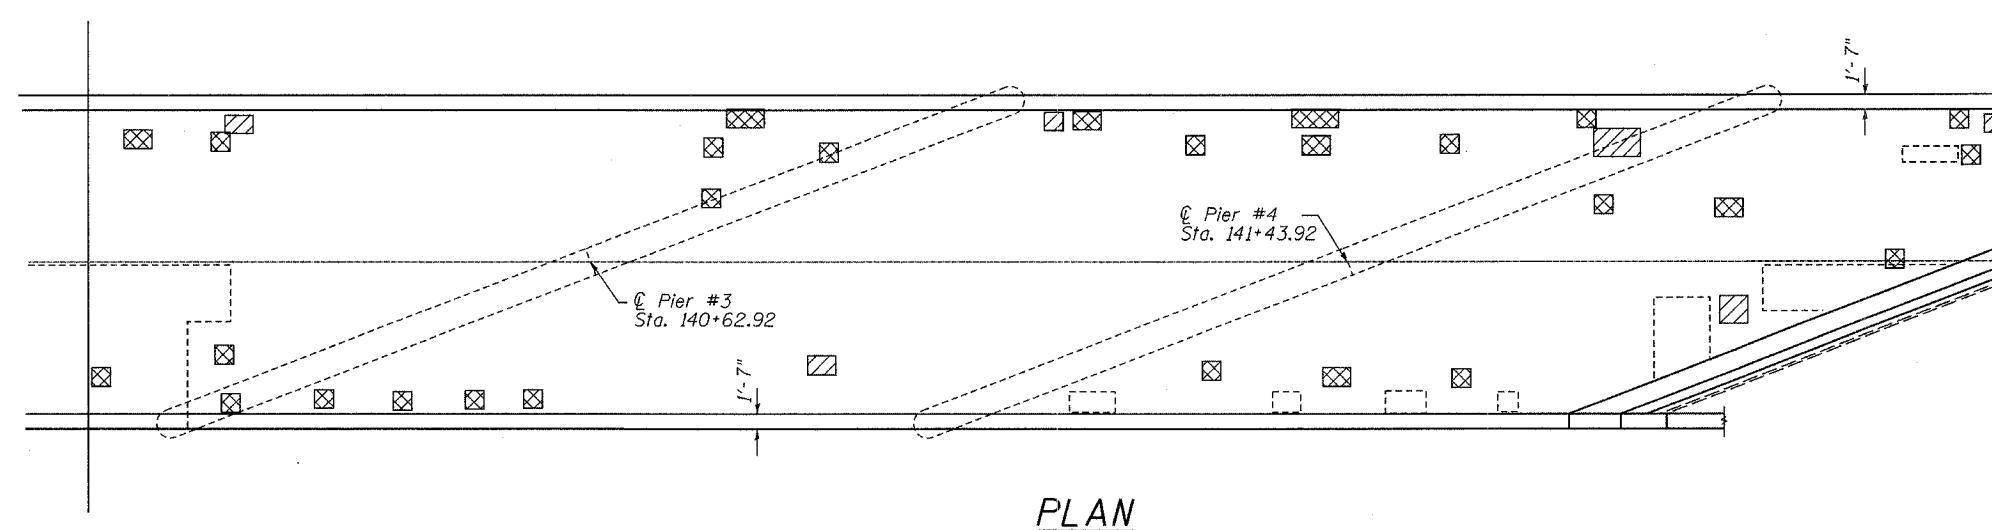
Existing Deck Slab Repair

Deck Survey Date: Octoboer 15, 2004

Deck Slab Repair (Partial) Deck Slab Repair (Full Depth)

The plan quantities for Deck Slab Repair (Partial and Full Depth) are estimated quantities from a deck survey provided by others. The areas shown on the deck repair plans for each structure are potential areas of Deck Slab Repair, The Deck Slab Repair quantities in Bills of Material are included as contingencies to be used as directed by the engineer during construction. The actual locations and quantity of Deck Slab Repair on all structures shall be determined by the resident engineer in the field after removal of the existing wearing surface. Actual repair locations shall be shown on the same as-built plans.
