**STATE OF ILLINOIS  
DEPARTMENT OF TRANSPORTATION**

**REPAIRS TO - SOUTH ABUTMENT  
STRUCTURE NO. 060-0255**

SHEET NO. 16 OF 48 SHEETS

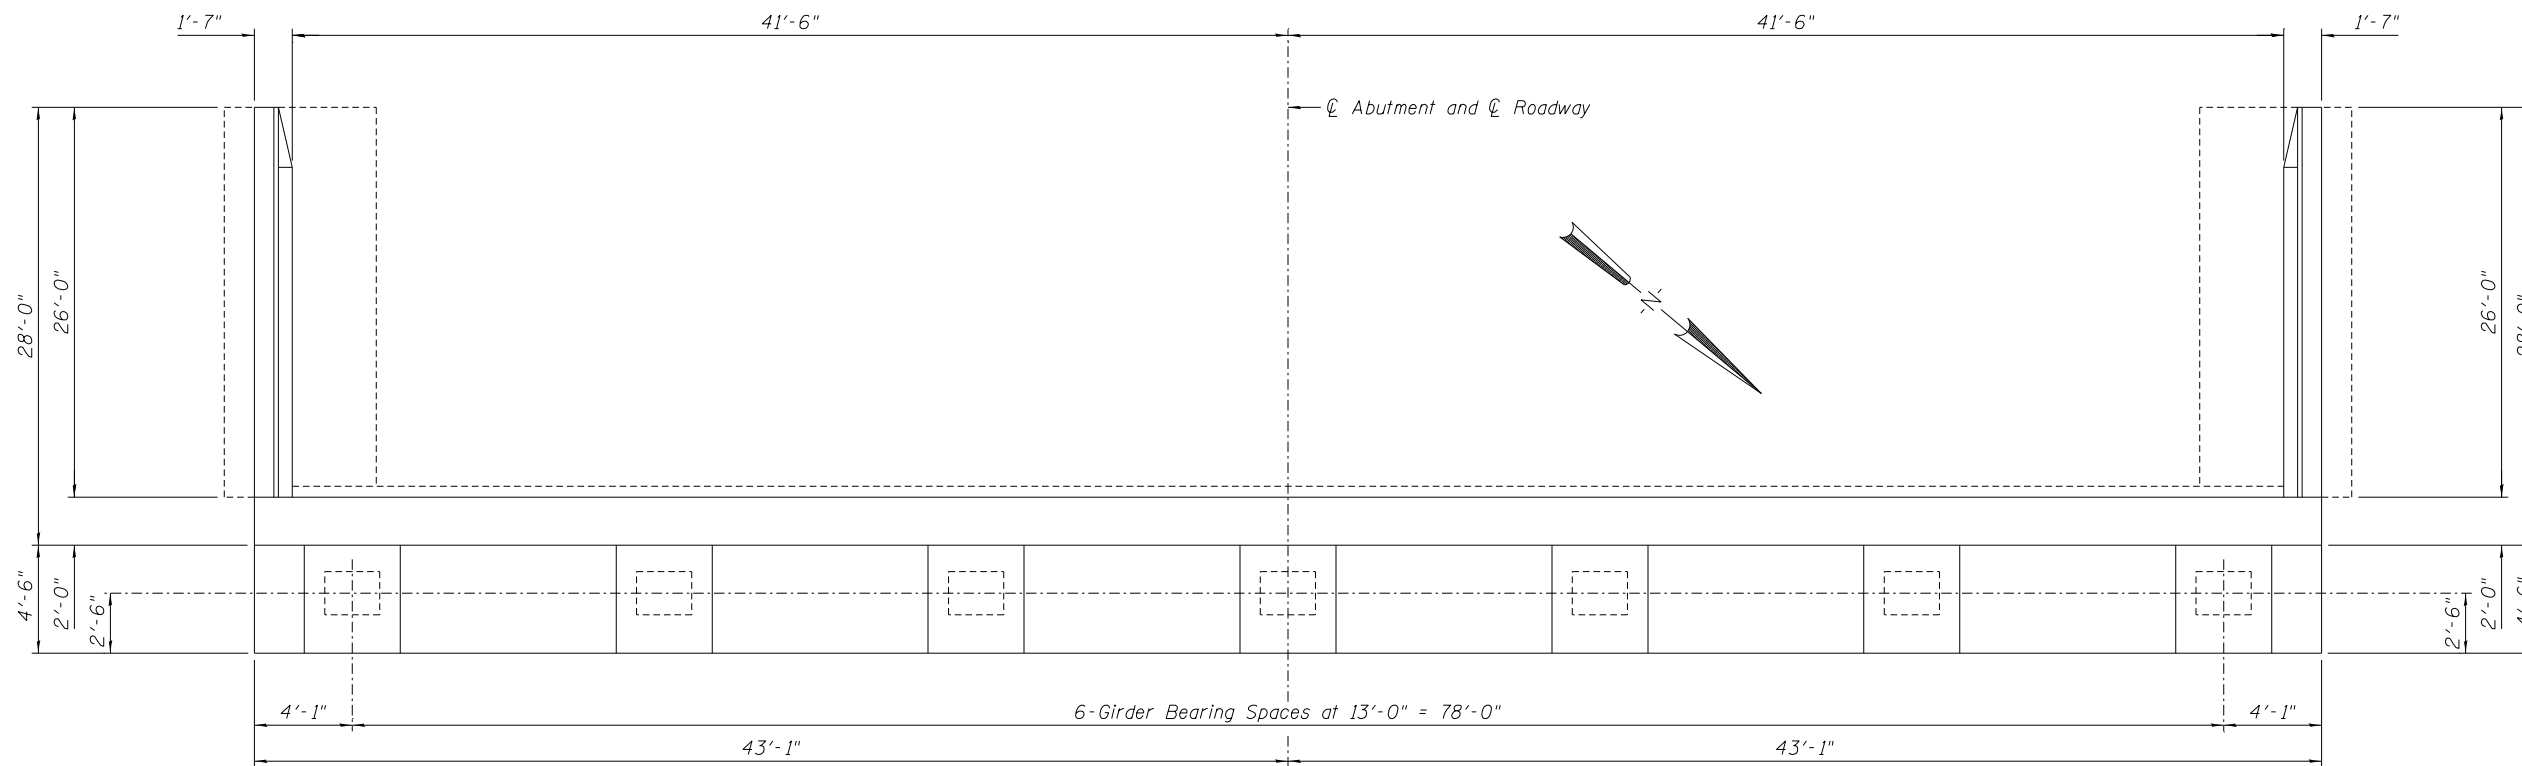
**TOP PLAN**

**GRAFFITI REMOVAL**

I.D.	Description	Pay Item	Units	Quantity
132	Beams 1-7, Each Web Face	Graffiti Removal	SQ. YD.	233.3
