STAGING
IL 106 OVER THE SNY RIVER
SN 075-0024

SHEET NO. 2 5 SHEETS	F.A.P. RTE.	SECTION	COUNTY	TOTAL SHEETS	SHEET NO.
	751	D6 BRIDGE REPAIR 2009	PIKE	22	14
FED. ROAD DIST. NO.			ILLINOIS FED. AID PROJECT		
CONTRACT NO. 72D44

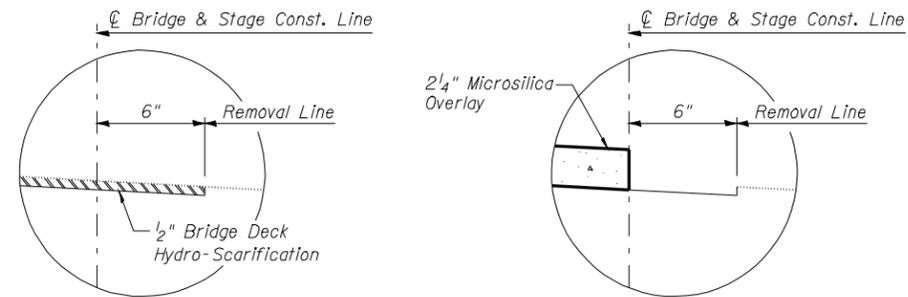
DETAIL A
(Showing Proposed)

Existing Formed 4"x6" Floor Drain
Coat the Interior with a Bonding Agent & Plug with Concrete
