**STATE OF ILLINOIS
DEPARTMENT OF TRANSPORTATION**

**NORTH AND SOUTH ABUTMENT REPAIRS
STRUCTURE NO. 060-0224NB**

SHEET NO. 11 OF 13 SHEETS

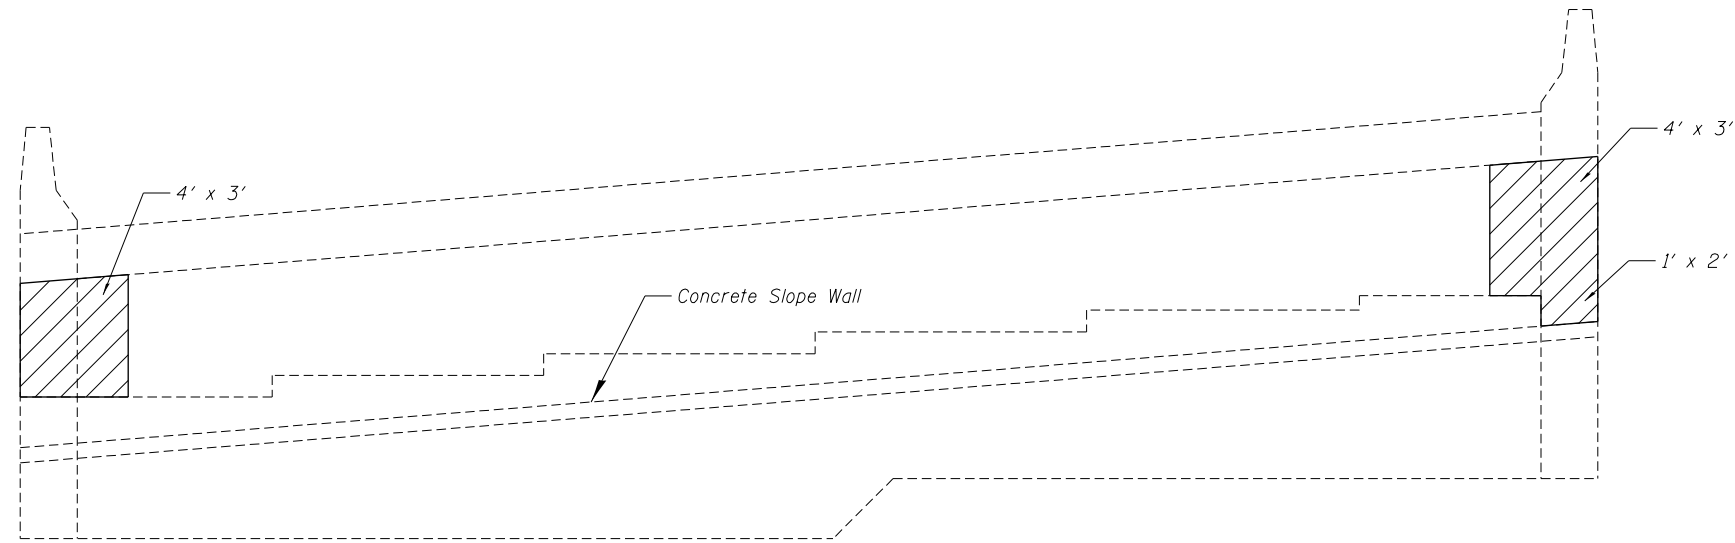
NORTH ABUTMENT ELEVATION
(Looking North)

Structural Repair of Concrete > 5"

Rope texture not required on repaired concrete surface.
