## STATE OF ILLINOIS DEPARTMENT OF TRANSPORTATION

CONTRACT NO. 66584

PIER 1 US 136 OVER BRANCH OF SALT CREEK FAP ROUTE 315 - SECTION 102X-BR-2 MCLEAN COUNTY STATION 616+99.00 STRUCTURE NO. 057-0185

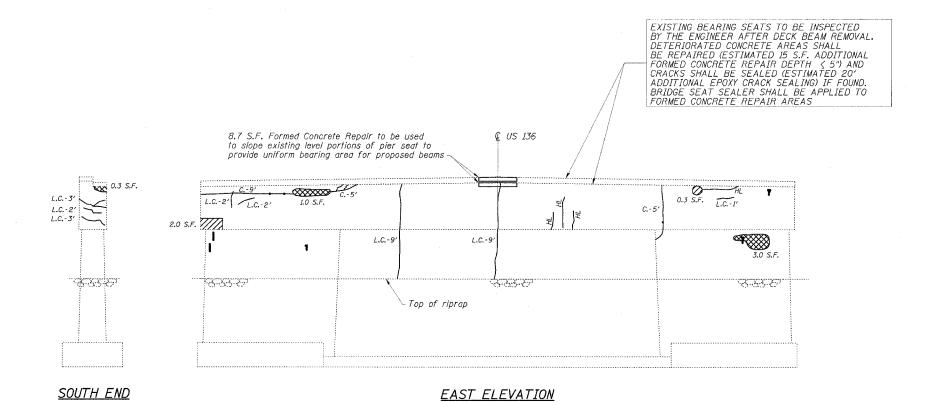
WEST ELEVATION

NOTE: PIER CRACK REPAIR LENGTHS AND FORMED CONCRETE REPAIR AREAS ARE ESTIMATED FROM II-15-01 SURVEY WORK. ACTUAL LOCATIONS AND OUANTITIES OF REPAIRS SHALL BE SHOWN BY THE ENGINEER ON THE AS-BUILT PLANS FOR THIS SECTION.

EPOXY CRACK SEALING

FORMED CONC. REPAIR
