SUPERSTRUCTURE
WEST BOUND LANES
STRUCTURE NO. 081-0019 (W.B.)
FAI ROUTE 280
Rock Island County
Sta. 232+86.50

STATE OF ILLINOIS
DEPARTMENT OF TRANSPORTATION

DISTRICT 2 BRIDGE PATCHING
SUPERSTRUCTURE
081-0019

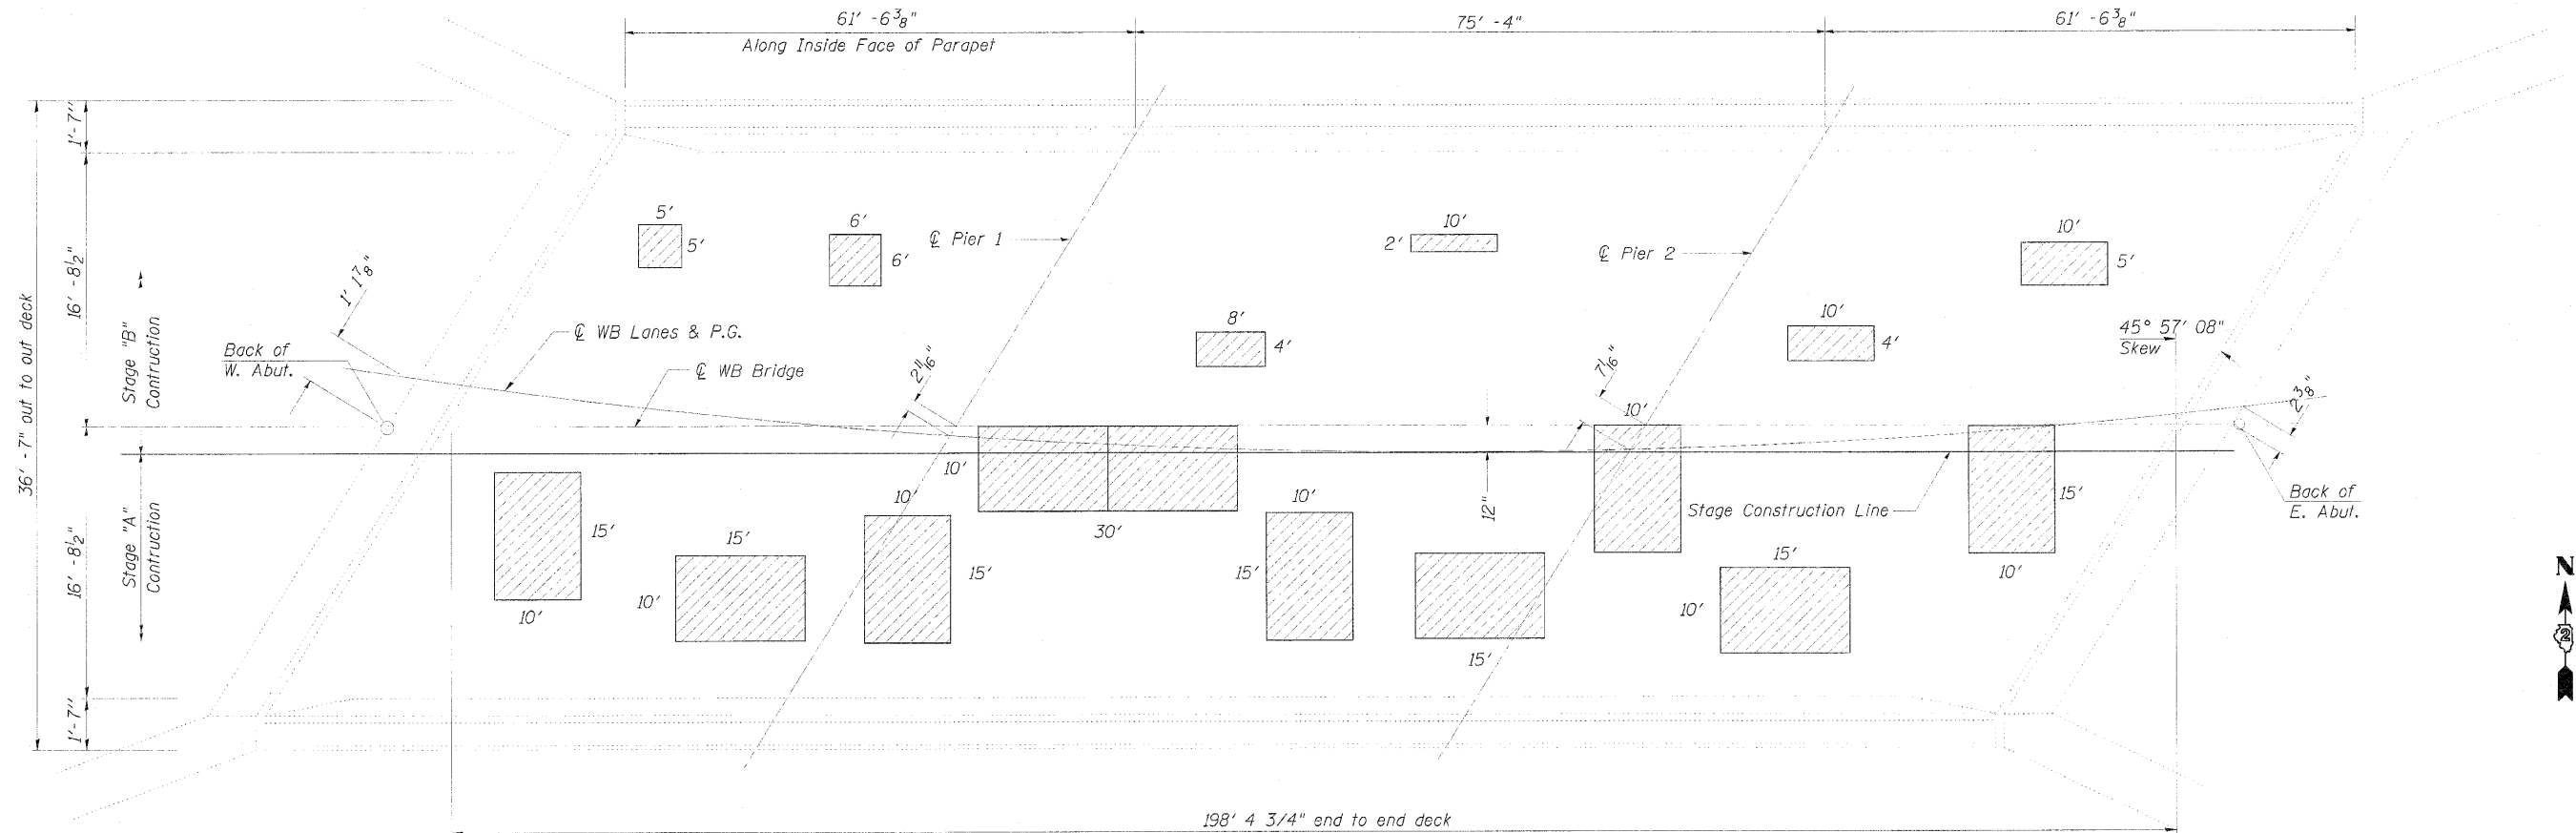
Legend
 Potential Deck Slab Repair (Partial)
Date of Survey 10/2009

PLAN
Areas shown for repair are potential areas of deck slab repair.
Actual locations and quantities to be determined in the field.
Resident Engineer to contact District Bridge Office for assistance
with locating patches.

SQ YD	
DECK SLAB REPAIR (FULL DEPTH, TYPE I)	26	
DECK SLAB REPAIR (FULL DEPTH, TYPE II)	14	
DECK SLAB REPAIR (PARTIAL)	128
