**SUPERSTRUCTURE**  
**WEST BOUND LANES**  
**STRUCTURE NO. 081-0021 (W.B.)**  
**FAI ROUTE 280**  
**Rock Island County**  
**Sta. 241+69.27**

| FILE NAME = | USER NAME = | DESIGNED = | REVISED = | <b>STATE OF ILLINOIS</b><br><b>DEPARTMENT OF TRANSPORTATION</b> | | <b>DISTRICT 2 BRIDGE PATCHING</b><br><b>SUPERSTRUCTURE</b><br><b>081-0021</b> | | F.A.I. RTE. | SECTION | COUNTY | TOTAL SHEETS | SHEET NO. |

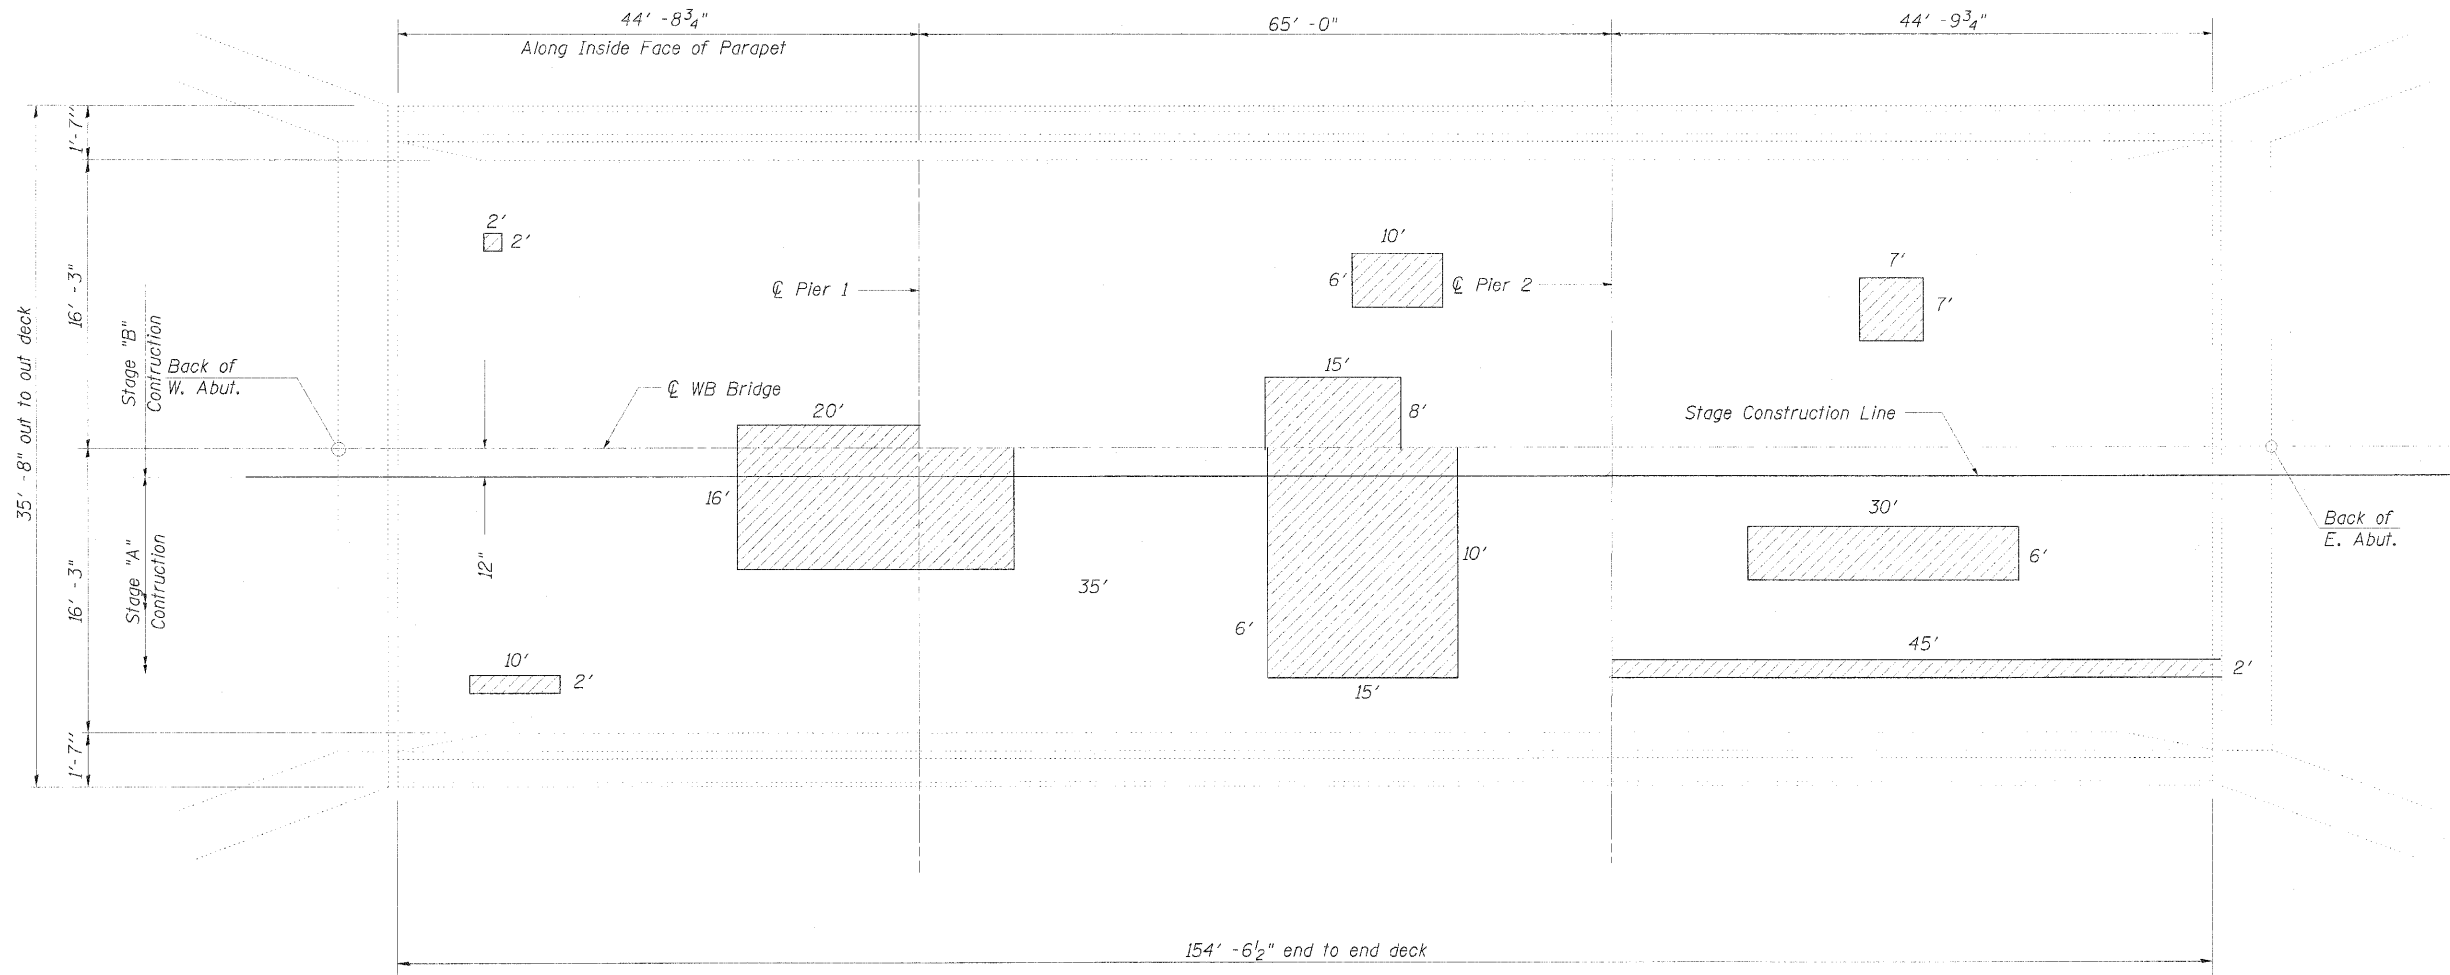
**PLAN**

Potential Deck Slab Repair (Partial)

Date of Survey 10/2009

Areas shown for repair are potential areas of deck slab repair. Actual locations and quantities to be determined in the field. Resident Engineer to contact District Bridge Office for assistance with locating patches.

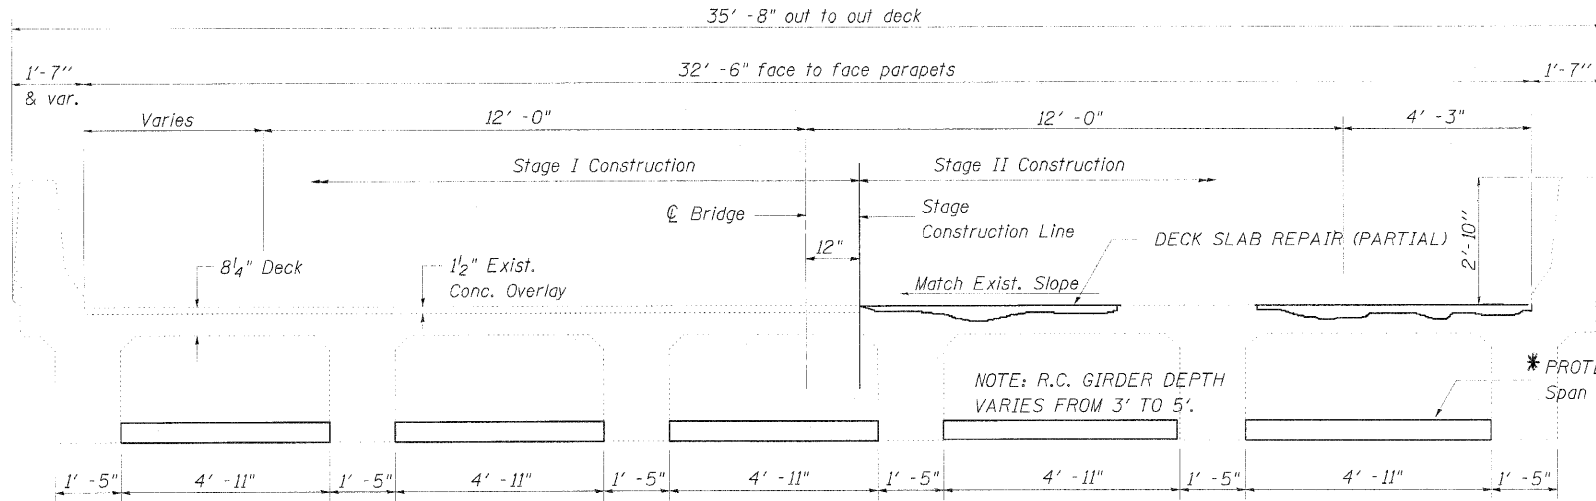
**CROSS SECTION**  
Looking East

\* Drilling into concrete T-girder's stem is not allowed.
