**SUPERSTRUCTURE**  
**WEST BOUND LANES**  
**STRUCTURE NO. 081-0023 (W.B.)**  
**FAI ROUTE 280**  
**Rock Island County**  
**Sta. 254+98.87**

| FILE NAME = | | USER NAME = bupul2241 | | DESIGNED | DPA | REVISED | - | STATE OF ILLINOIS<br>DEPARTMENT OF TRANSPORTATION | | | | DISTRICT 2 BRIDGE PATCHING<br>SUPERSTRUCTURE<br>081-0023 | | | | F.A.I.<br>RTE.<br>280 | | SECTION | | COUNTY | TOTAL SHEETS | SHEET NO. |

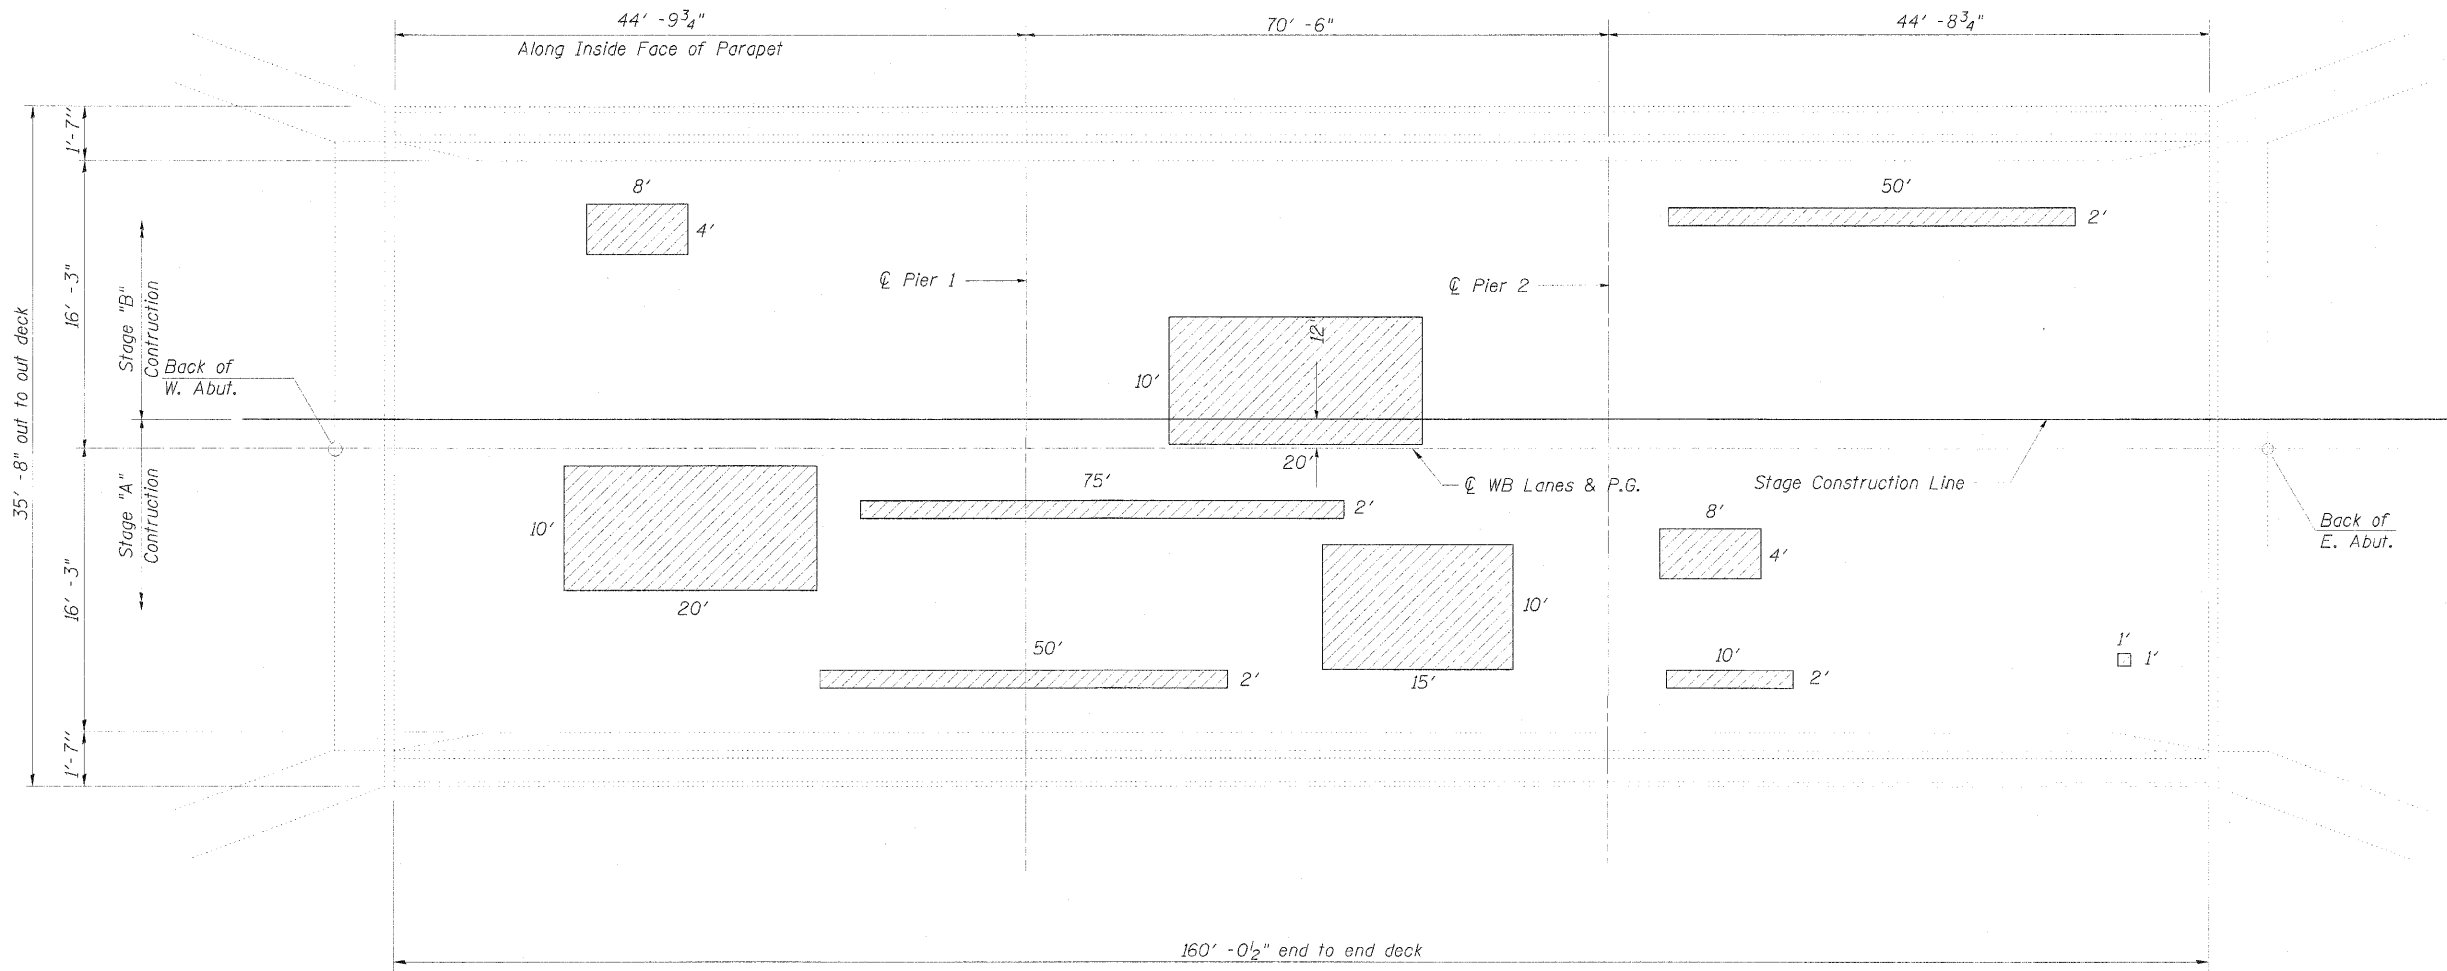
**PLAN**

**Legend**  
 Potential Deck Slab Repair (Partial)  
Date of Survey 10/2009

Areas shown for repair are potential areas of deck slab repair. Actual locations and quantities to be determined in the field. Resident Engineer to contact District Bridge Office for assistance with locating patches.

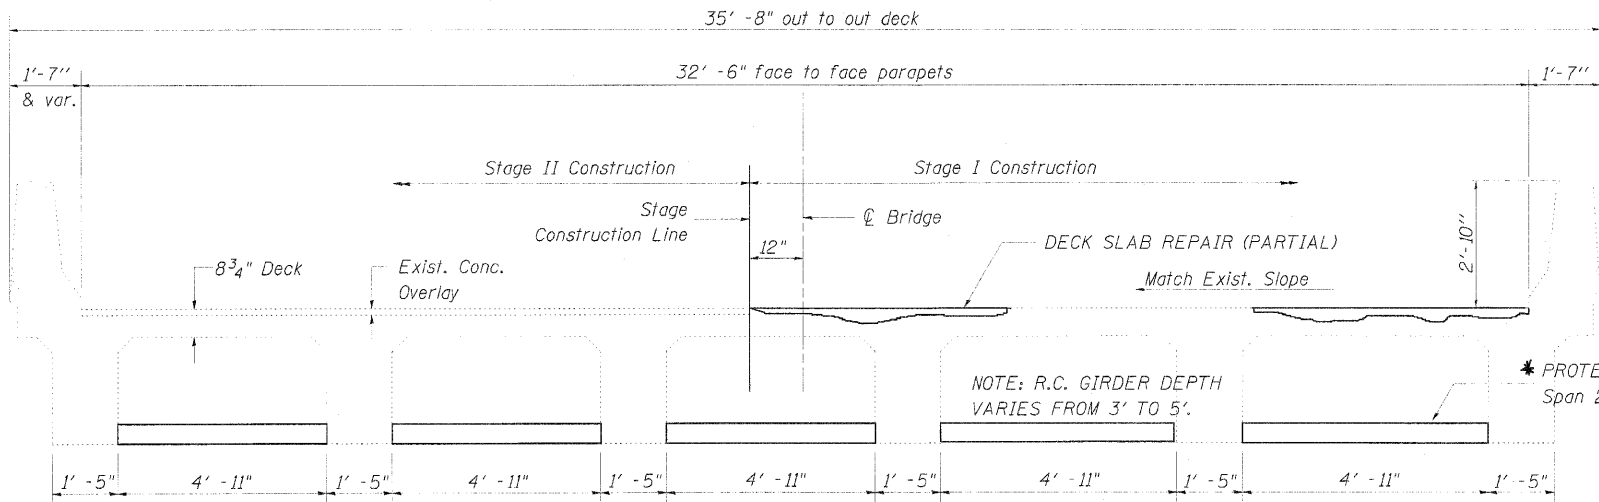
**CROSS SECTION**  
*Looking West*

\* Drilling into concrete T-girder's stem is not allowed.
