Date of Survey 10/2009

**SUPERSTRUCTURE**  
**WEST BOUND LANES**  
**STRUCTURE NO. 081-0027 (W.B.)**  
**FAI ROUTE 280**  
**Rock Island County**  
**Sta. 286+90**

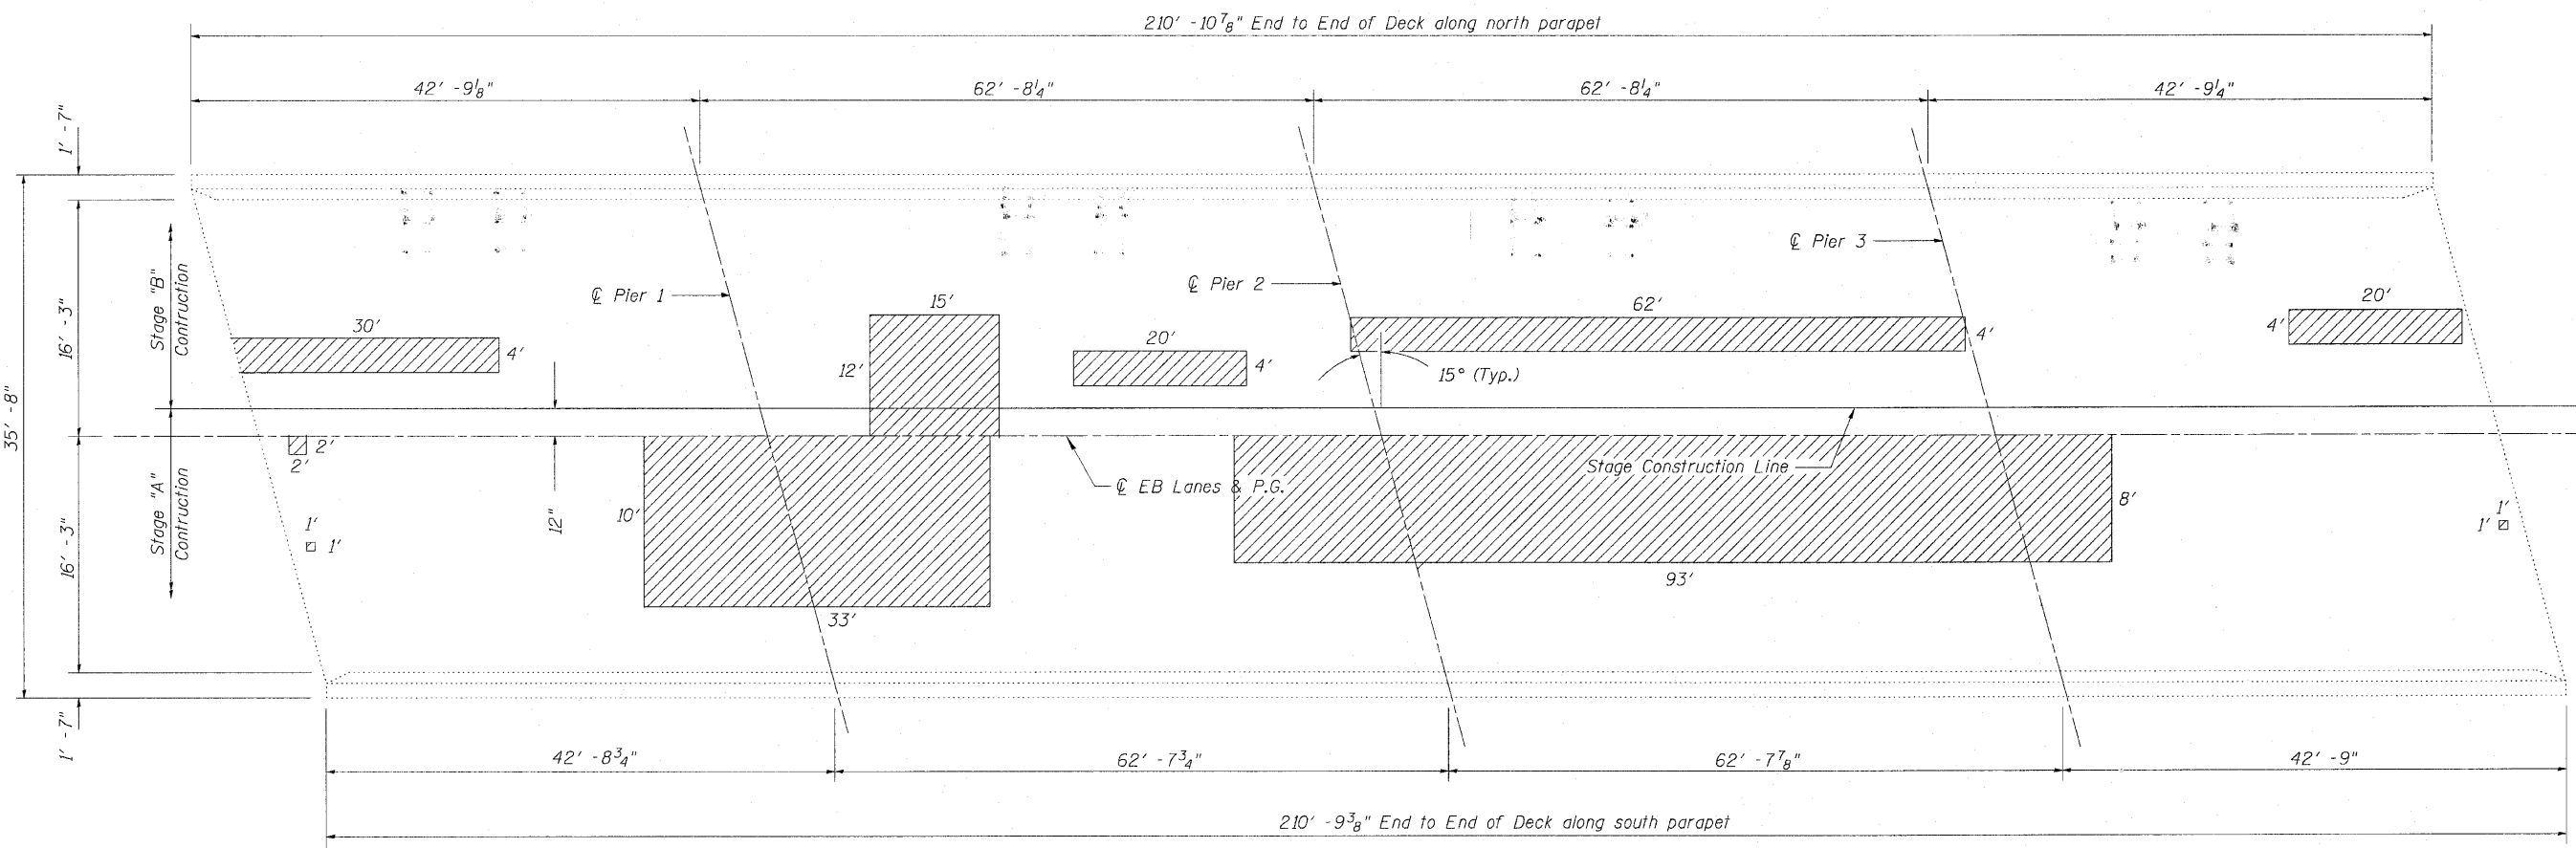
**PLAN**

Areas shown for repair are potential areas of deck slab repair.  
Actual locations and quantities to be determined in the field.  
Resident Engineer to contact District Bridge Office for assistance  
with locating patches.
