STATE OF ILLINOIS  
DEPARTMENT OF TRANSPORTATION

PIER 2 REPAIRS  
STRUCTURE NO. 081-0024 (W.B.)  
STRUCTURE NO. 081-0025 (E.B.)

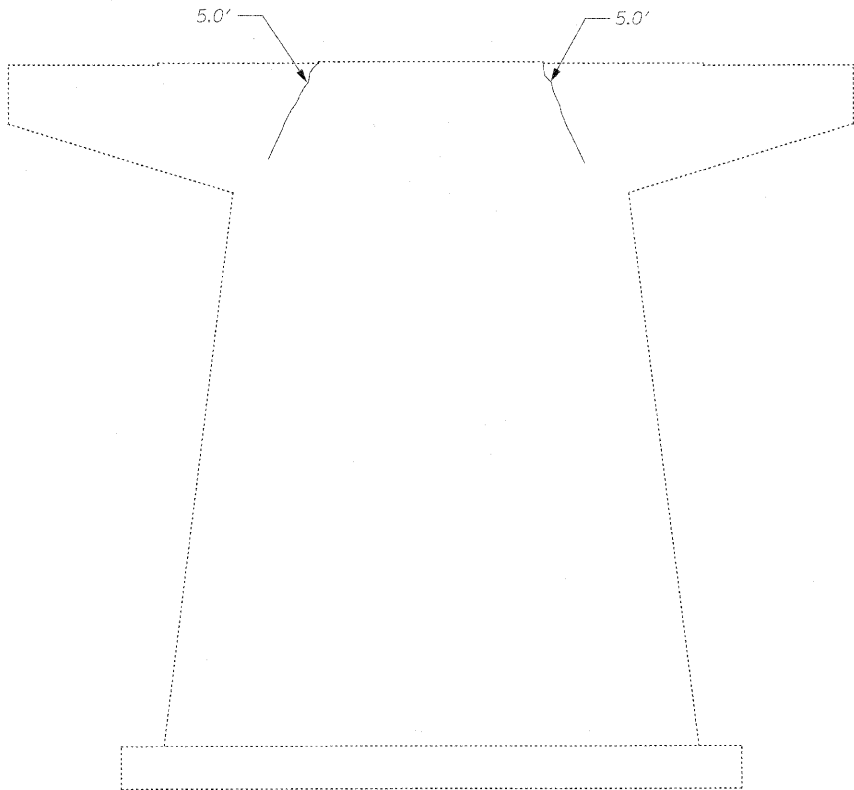
TOP PLAN

~~~~~ Indicates limits of Epoxy Crack Injection
