STATE OF ILLINOIS
DEPARTMENT OF TRANSPORTATION

PIER 5 REPAIRS
STRUCTURE NO. 081-0024 (W.B.)
STRUCTURE NO. 081-0025 (E.B.)

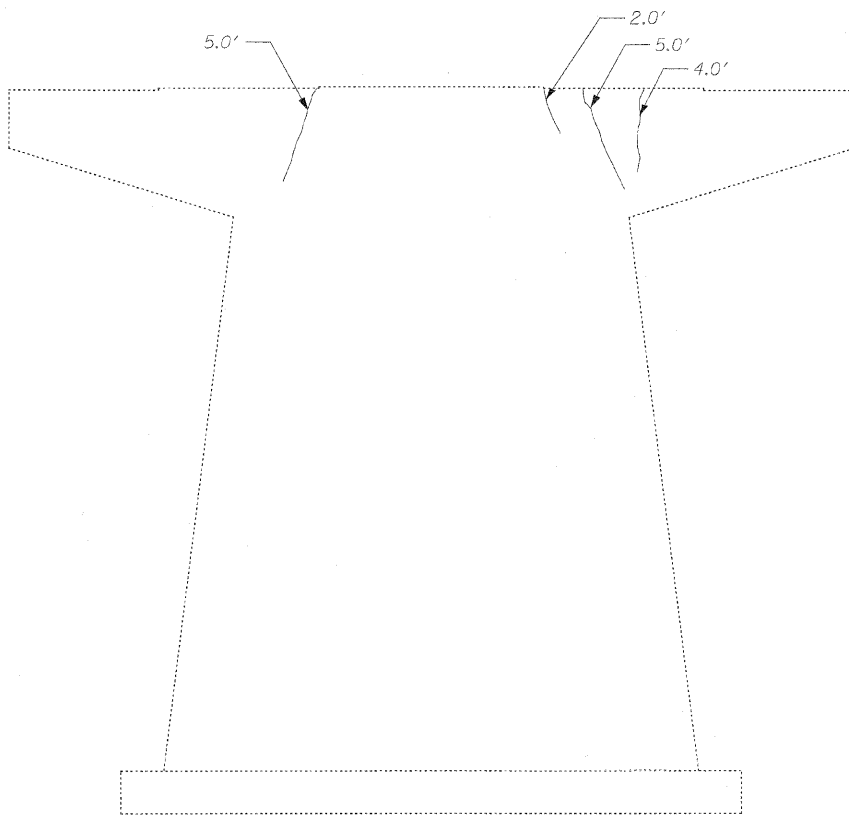
TOP PLAN

Note:
Repair of the existing pier shall include but not be limited to the areas shown. The actual areas to be repaired will be determined by the Engineer at the time of construction.

~~~~~ Indicates limits of Epoxy Crack Injection  
===== Indicates limits of Structural Repair of Concrete (Depth Equal to or Less Than 5 Inches)
