STATE OF ILLINOIS  
DEPARTMENT OF TRANSPORTATION

PIER 6 REPAIRS  
STRUCTURE NO. 081-0024 (W.B.)  
STRUCTURE NO. 081-0025 (E.B.)

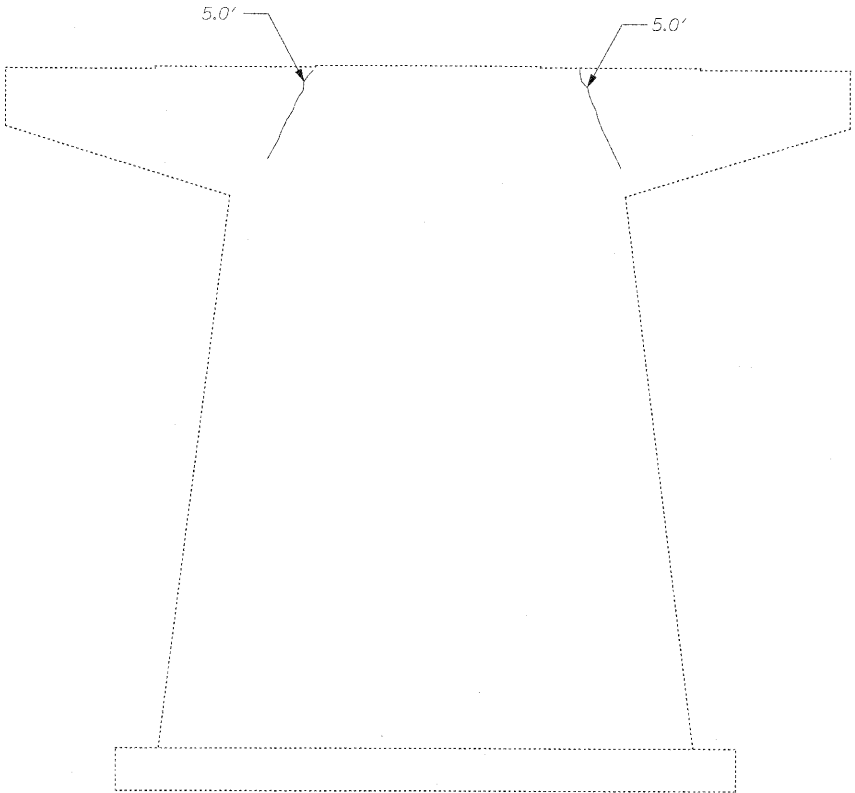
TOP PLAN

~~~~~ Indicates limits of Epoxy Crack Injection

Note:  
Repair of the existing pier shall include but not be limited to the areas shown. The actual areas to be repaired will be determined by the Engineer at the time of construction.
