F.A.I. RTE.	SECTION	COUNTY	TOTAL SHEETS	SHEET NO.
70	60-10B	MADISON	156	109
FED. ROAD DIST. NO.	ILLINOIS	FED. AID PROJECT		
			CONTRACT NO. 76857

Deck Condition Survey performed 8/15/2006.

**DECK PLAN**  
FAI 70 (WB) OVER  
WENDELL BRANCH  
FAI ROUTE 70 SECTION 60-10B  
MADISON COUNTY  
STATION 996+66.15  
STRUCTURE NO. 060-0024

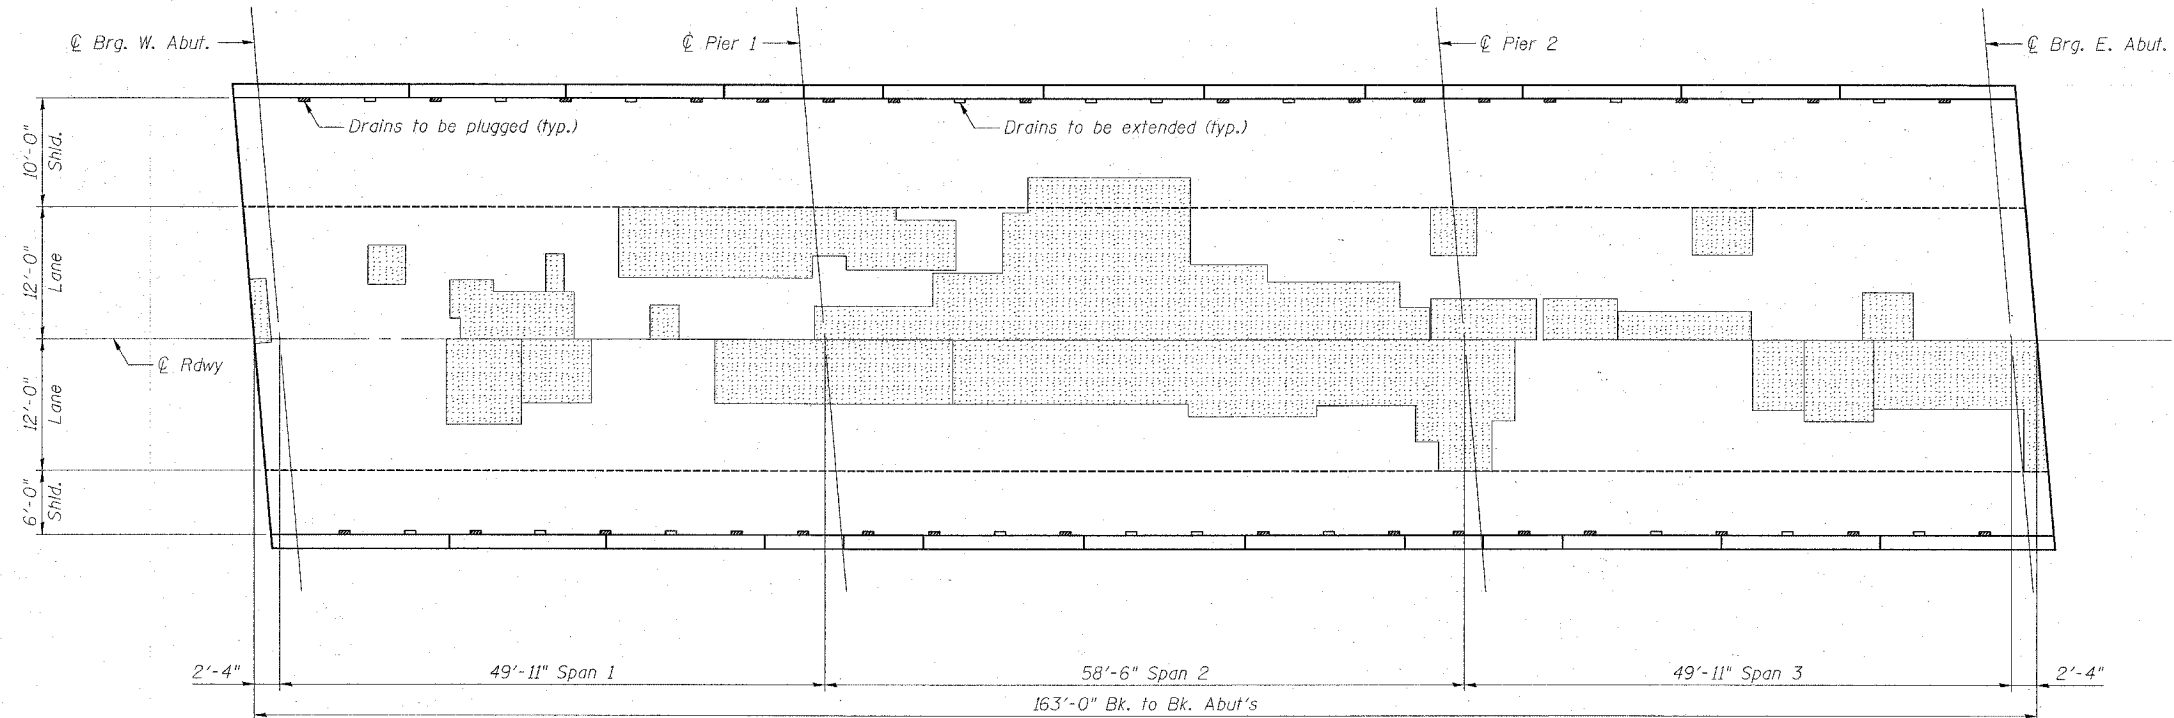
**DECK PLAN-TOP**

Existing Patches to Overlay (1615 S.F.)
-

Deck Plan-Top represents existing repairs made to the bituminous overlay, but may not represent the condition of the original concrete deck. Estimated quantities are provided for Deck Slab Repair, but actual quantities will be determined by the field Engineer as the work progresses.

The Engineer shall record actual locations of deck repair on the As-Built plans.

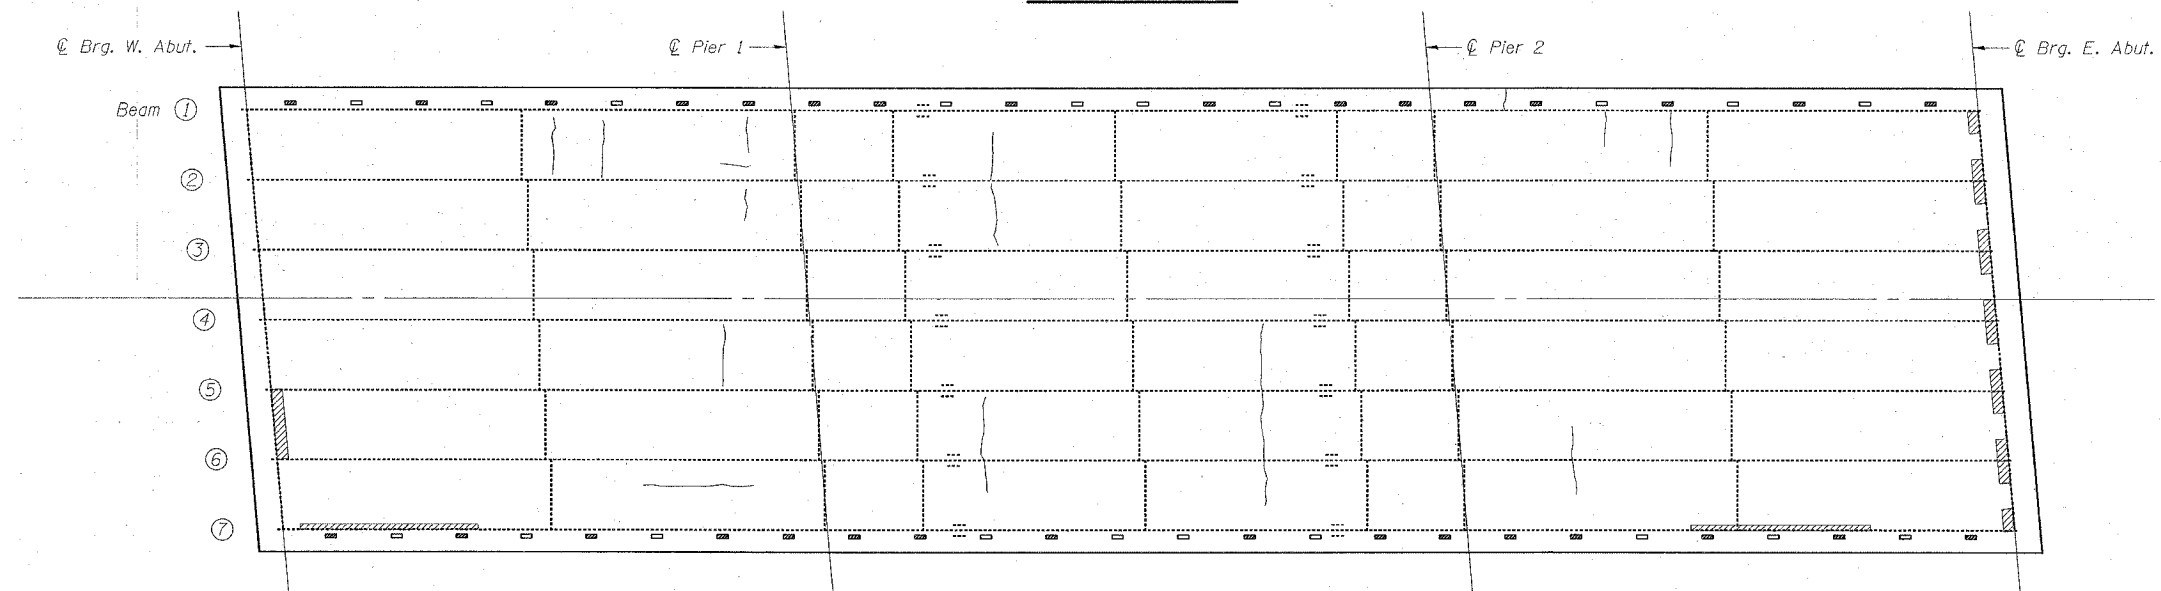
**DECK PLAN-BOTTOM**

Spalled Concrete (46 S.F.)
-

Spalled Concrete with Exposed Rebar (0 S.F.)
-

Hairline Crack
