STATE OF ILLINOIS
DEPARTMENT OF TRANSPORTATION

PIER 2 REPAIRS
WESTBOUND FAI-80 OVER HICKORY CREEK
STRUCTURE NO. 099-0063
SHEET NO. S-7 OF 8 SHEETS

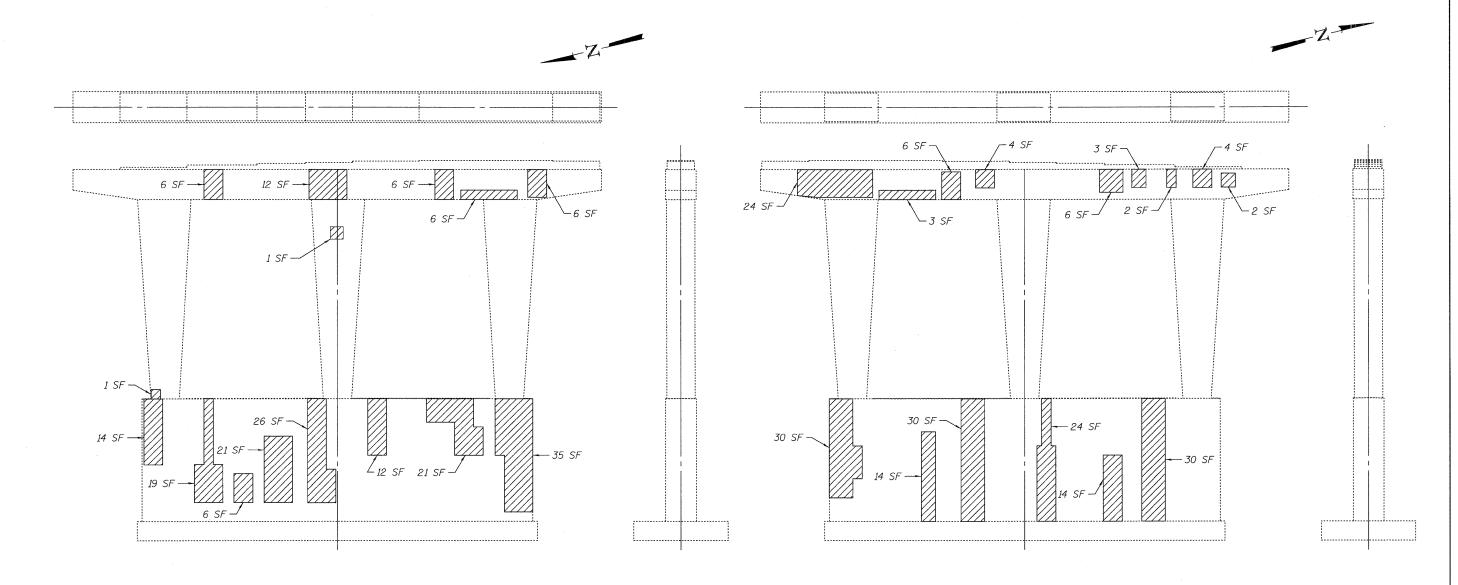
WEST ELEVATION
Looking East

SOUTH ELEVATION

Looking North

EAST ELEVATION

Looking West

NORTH ELEVATION
Looking South

Areas of proposed pier repairs are estimated. Actual type, location and dimensions of pier repairs are to be determined by the Engineer during construction.
