SUPERSTRUCTURE REPAIRS I
U.S. 52 OVER N. BR. JACKSON CREEK
STA. 524+51.00
S.N. 099-0129

SHEET NO. S4	F.A.P. RTE. 852	SECTION 18 B-4-R-1	COUNTY WILL	TOTAL SHEETS 27	SHEET NO. 20
S6 SHEETS			CONTRACT NO. 60D84		
FED. ROAD DIST. NO.		ILLINOIS	FED. AID PROJECT

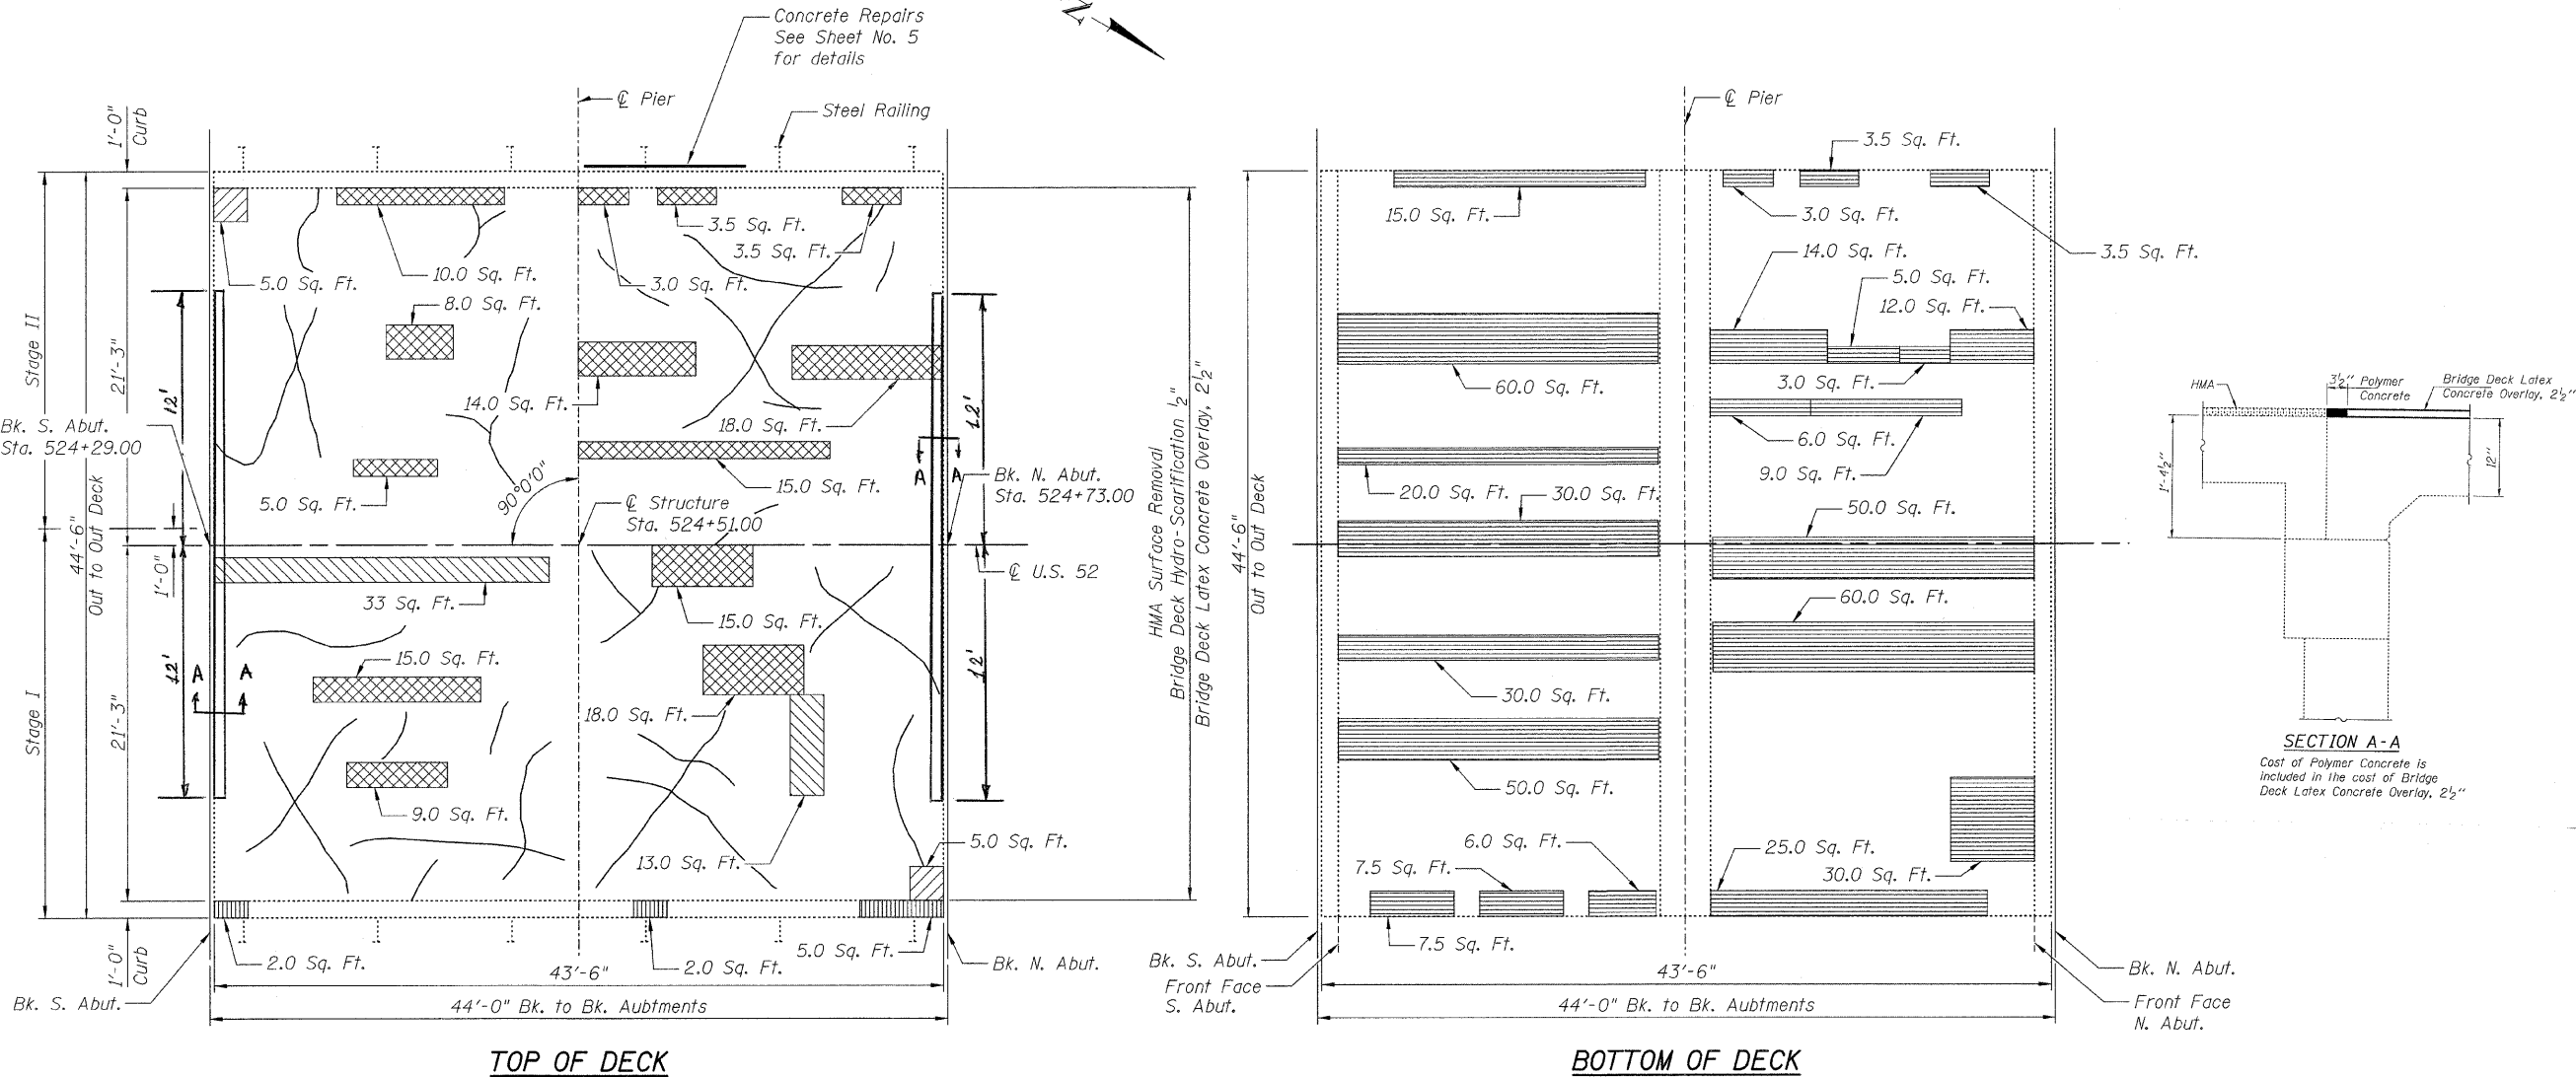
1. Repairs shall include but not be limited to the areas shown. The actual areas to be determined by engineer at the time of construction.
2. The engineer shall record the actual deck repair areas in order to document as-built conditions for the future reference.
3. See Sheet S6 for information about the existing deck reinforcement.
