USER NAME : p72m02mha	DESIGNED : J.C.N./B.N.S./J.W.	REVISED :	STATE OF ILLINOIS DEPARTMENT OF TRANSPORTATION	STRUCTURAL STEEL REPAIRS-III STRUCTURE NO'S. 099-0008 & 099-0009	F.A.I. RT# 55	SECTION 07B, D-BR-1	COUNTY WILL	TOTAL SHEETS 106	SHEET NO. 85
	PLOT SCALE : 1/8"=1'-0" / 1/4"=1'-0"	DRAWN : F.M.	REVISED :			CONTRACT NO. 60R62				
	PLOT DATE : 3/21/2013	DATE : MARCH 20, 2013	REVISED :			ILLINOIS FED. AID PROJECT

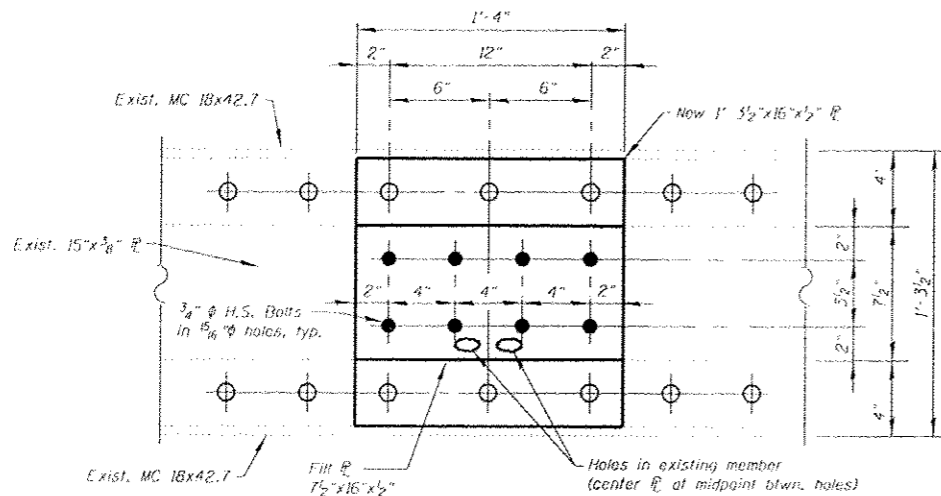
REPAIR DETAIL (10)

REPAIR NO'S. S23 & S28
(Top of bott. chord S23)
(Bott. of bott. chord S28)
