STATE OF ILLINOIS  
DEPARTMENT OF TRANSPORTATION

**SUPERSTRUCTURE REPAIR PLAN I  
STEGER ROAD OVER I-57  
F.A.I. RTE. 57 - SEC. (46-1,2)RS-3&I  
KANKAKEE COUNTY  
STA. 815+16.50  
S.N. 046-0083**

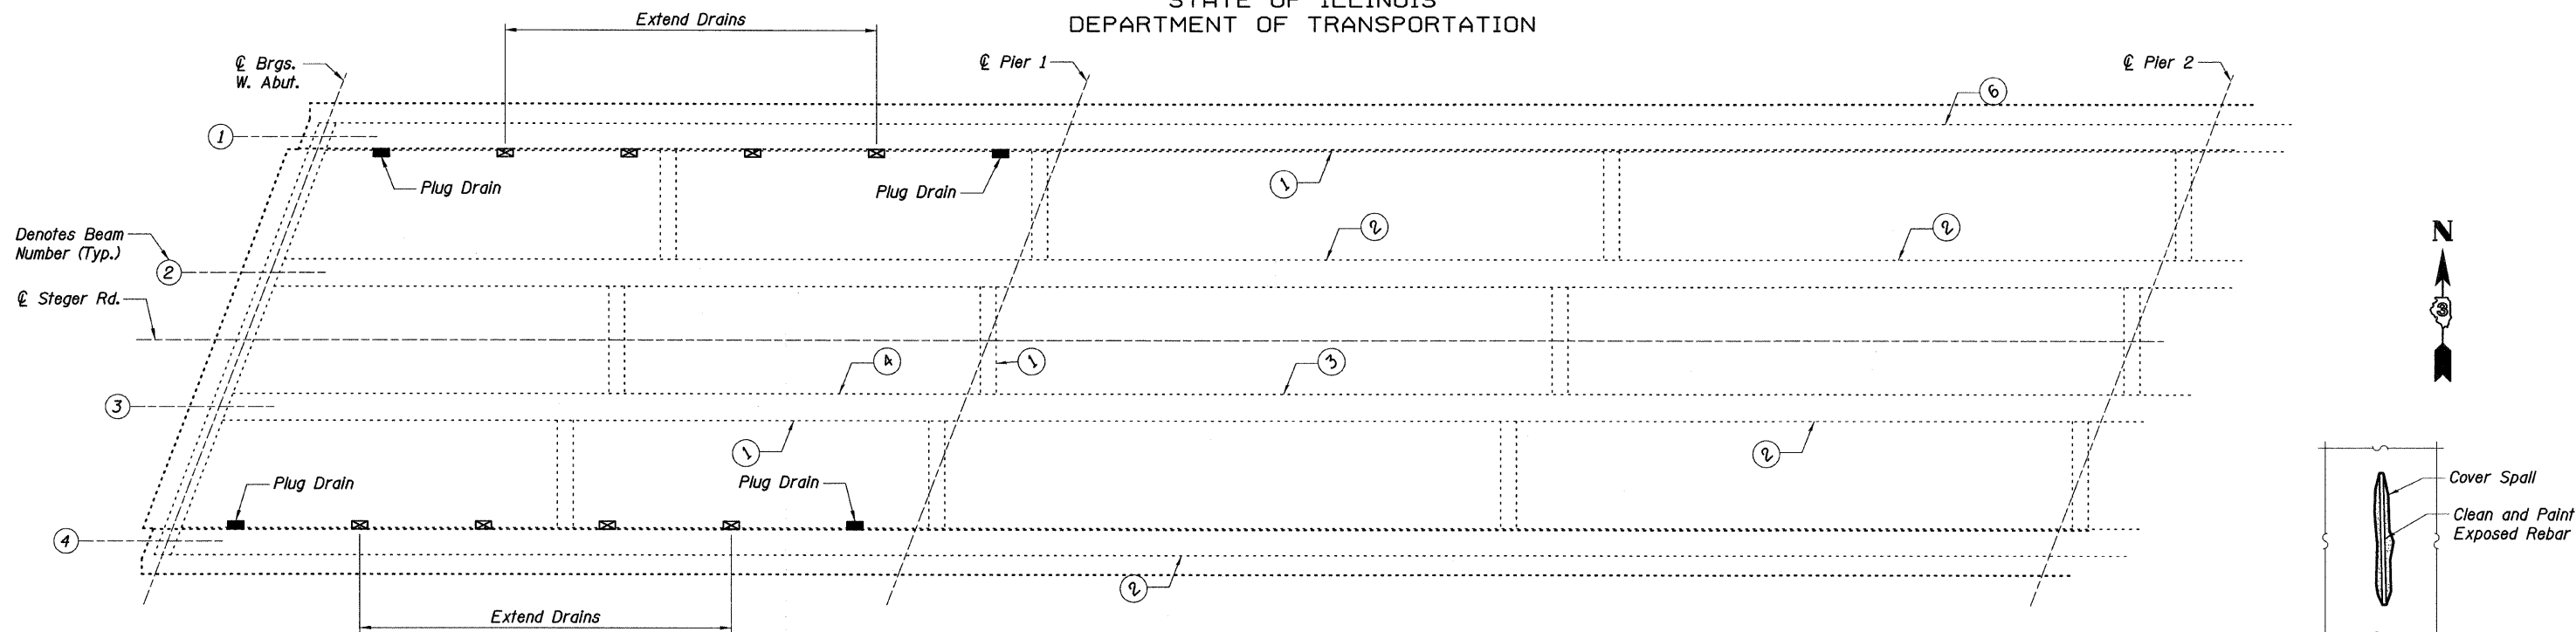
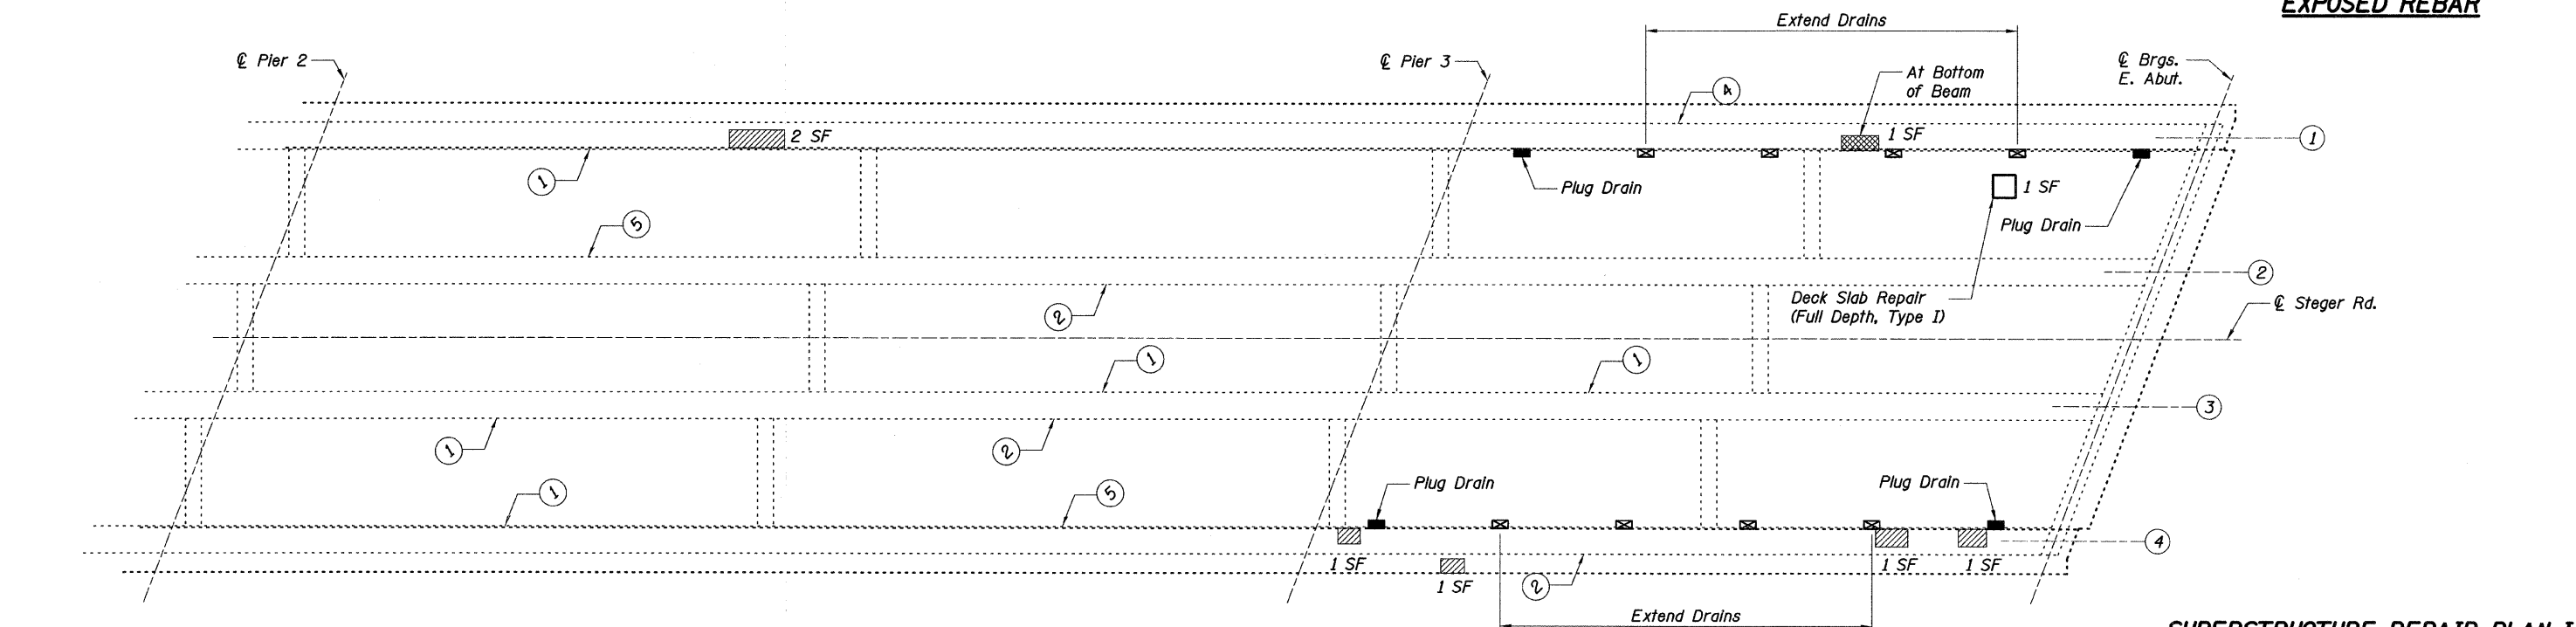
**SUPERSTRUCTURE REPAIR PLAN**

**CLEANING AND PAINTING  
EXPOSED REBAR**

Structural Repair of Concrete (Depth Equal to or Less Than 5") - Top of Deck
  -

Structural Repair of Concrete (Depth Equal to or Less Than 5") - Bottom of Deck
  -

Denotes Number of Cover Spalls w/ Exposed Reinforcement to be Cleaned and Painted
