**SUPERSTRUCTURE REPAIR PLAN**

**SUPERSTRUCTURE REPAIR PLAN I  
LAKE MANTENO RD. OVER I-57  
F.A.I. RTE. 57 - SEC. (46-1,2)RS-3&I  
KANKAKEE COUNTY  
STA. 697+99.50  
S.N. 046-0084**

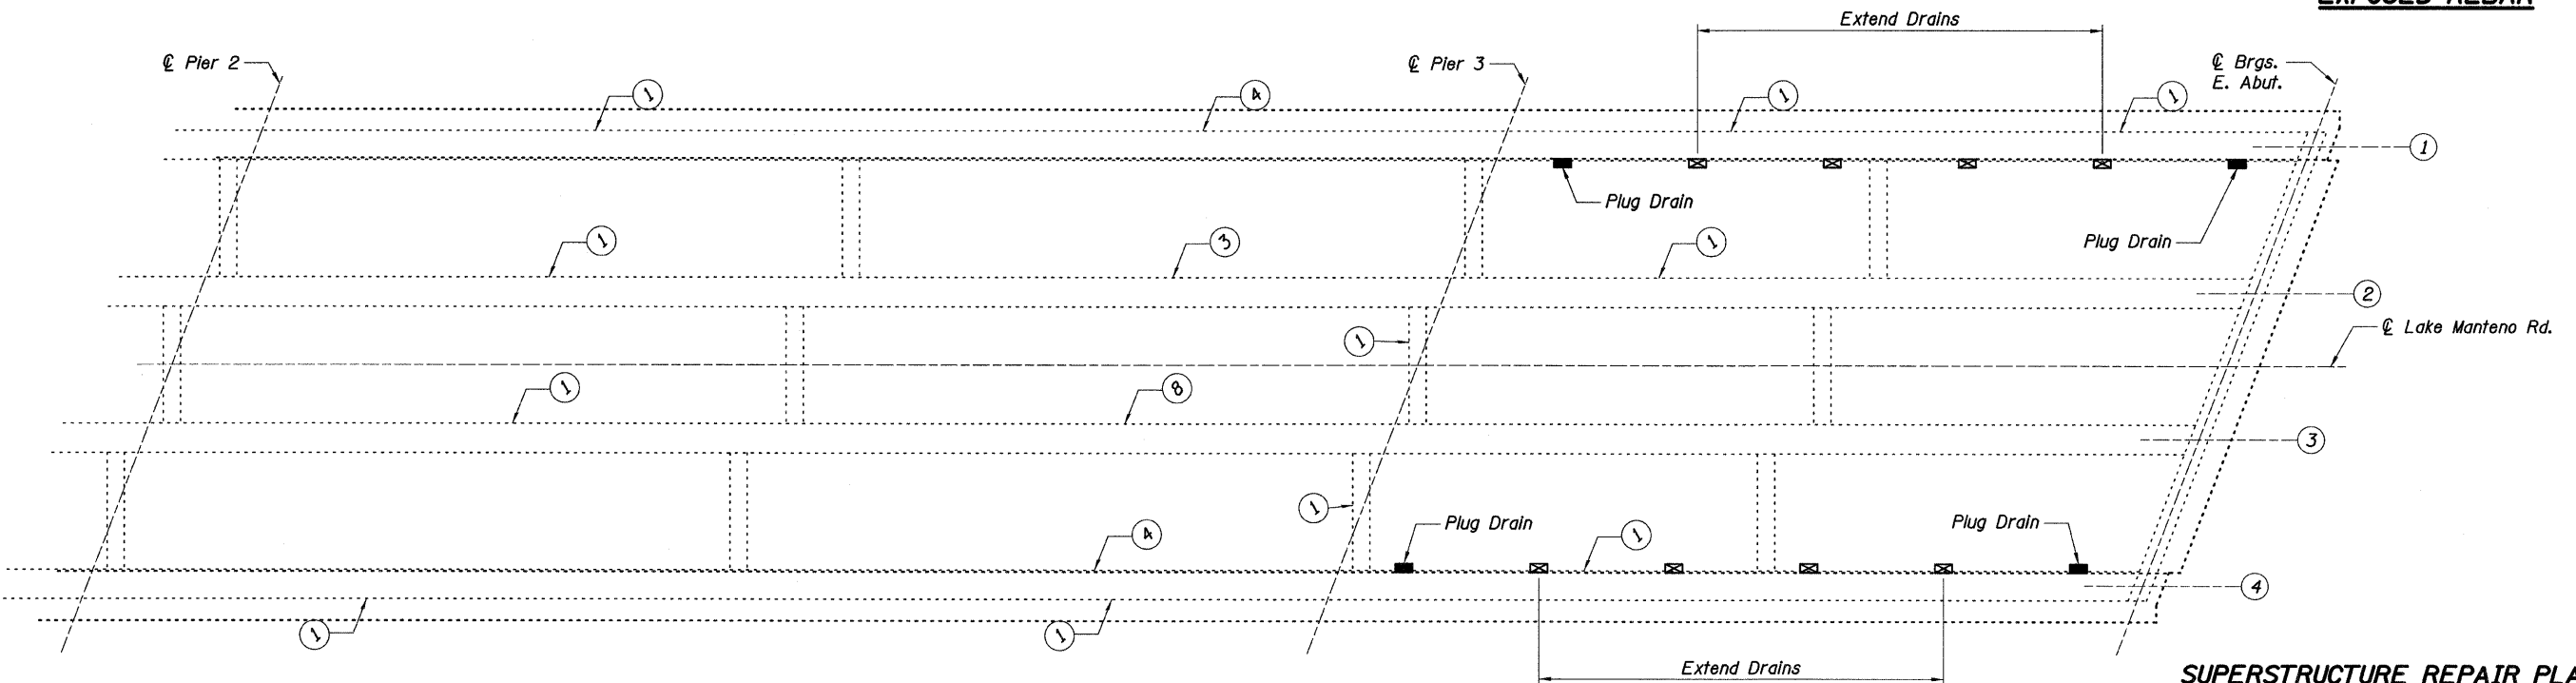
Structural Repair of Concrete (Depth Equal to or Less Than 5") - Top of Deck
  -

Structural Repair of Concrete (Depth Equal to or Less Than 5") - Bottom of Deck
  -

Denotes Number of Cover Spalls w/ Exposed Reinforcement to be Cleaned and Painted
