(Sheet 2 of 2)

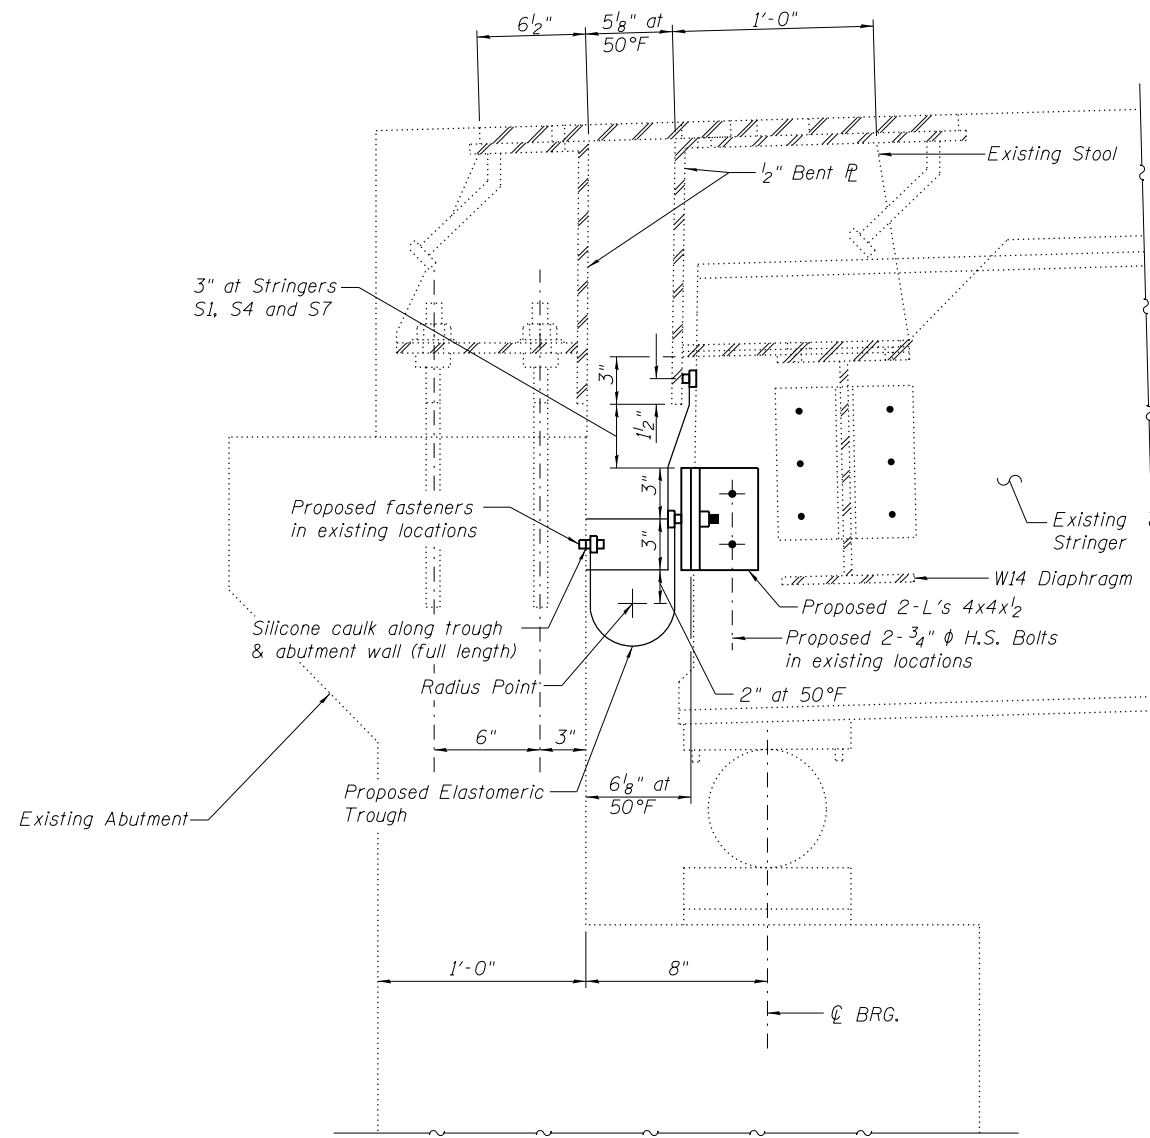
**SECTION THRU EXPANSION JOINT AT ABUTMENT A**

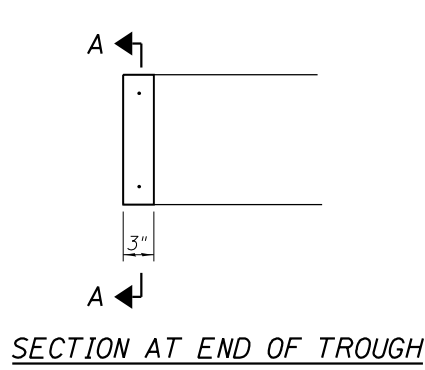
**SECTION AT END OF TROUGH**

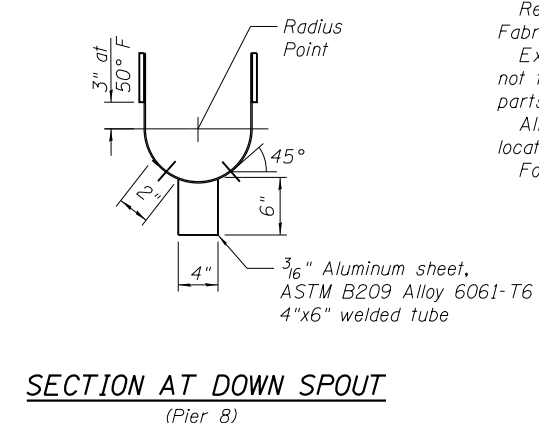
**SECTION AT DOWN SPOUT (Pier 8)**
