VAULT DOOR AT NORTH SIDE OF WEST ABUTMENT

BILL OF MATERIAL

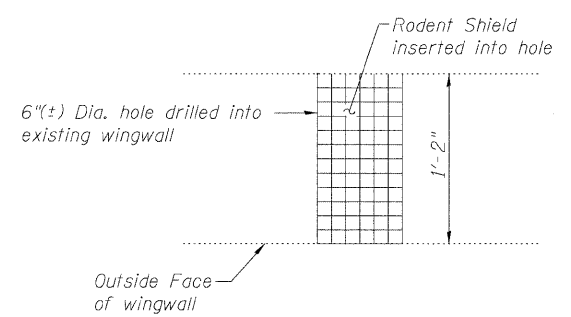
RODENT SHIELD PLACEMENT

DETAIL OF RODENT SHIELD  
(4 required)
