STATE OF ILLINOIS DEPARTMENT OF TRANSPORTATION

| RARRIE | WALL REPAIR | |
| | RE NO. 045-0004 | ļ |

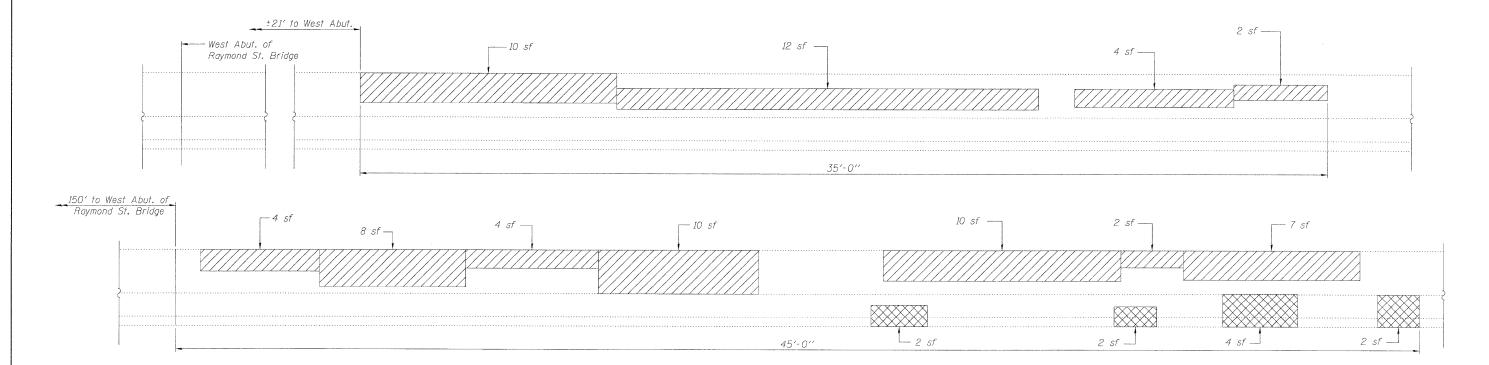
ELEVATION MEDIAN BARRIER

(Looking South)

Note:
Repair of the existing barrier shall include but may not be limited to the areas shown. The
