Plano Prairie Restoration 0014-20-KEND

Faxon Road (East of Needham Rd) Plano, IL 60545

Planting Plan

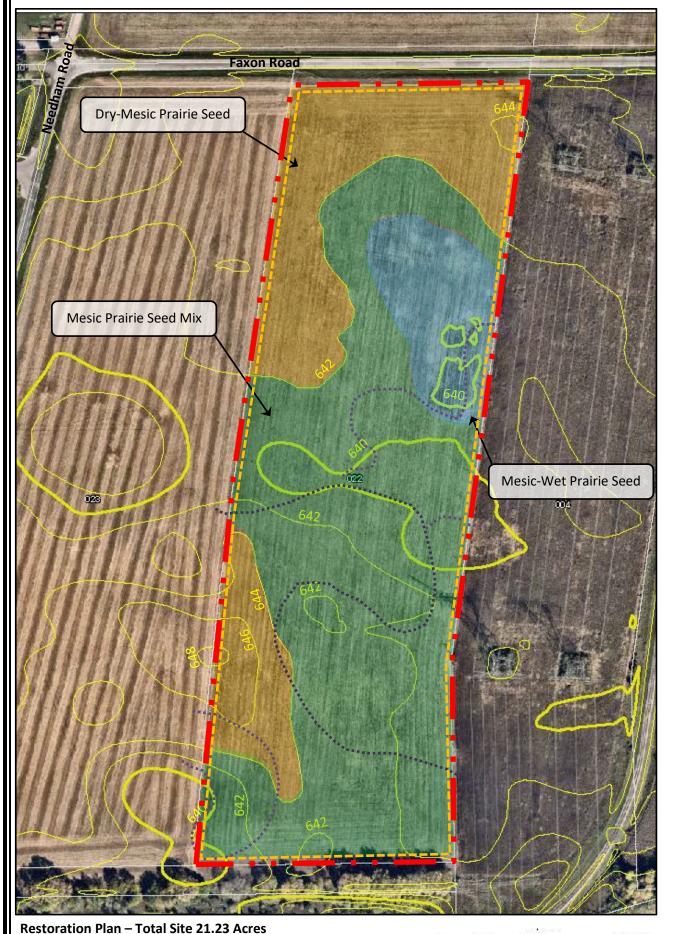
Approximate Property Line

Dry-Mesic Prairie – 6.0 Acres

Mesic Prairie – 9.83 Acres

Mesic-Wet Prairie – 1.75 Acres

Topographic Contour Lines (2' Intervals)

Soil Type Divider Lines

20' Wide Turfed Fire Break – 2.14 Acres
