DESIGNED - I.J.L.	EXAMINED - <i>Carl Proyer</i>	DATE - August 11, 2010	STATE OF ILLINOIS DEPARTMENT OF TRANSPORTATION	TEMP SUPPORT DETAILS SN 002-0022	F.A. RTE. 57	SECTION 69	COUNTY Alexander	TOTAL SHEETS 10	SHEET NO. 6
CHECKED - G.G.E.	PASSED - <i>Ralph E. Anderson</i>				SHEET NO. 2 OF 6 SHEETS	CONTRACT NO. 78220		ILLINOIS FED. AID PROJECT	
DRAWN - Drew Christopher									
CHECKED - I.J.L. G.G.E.

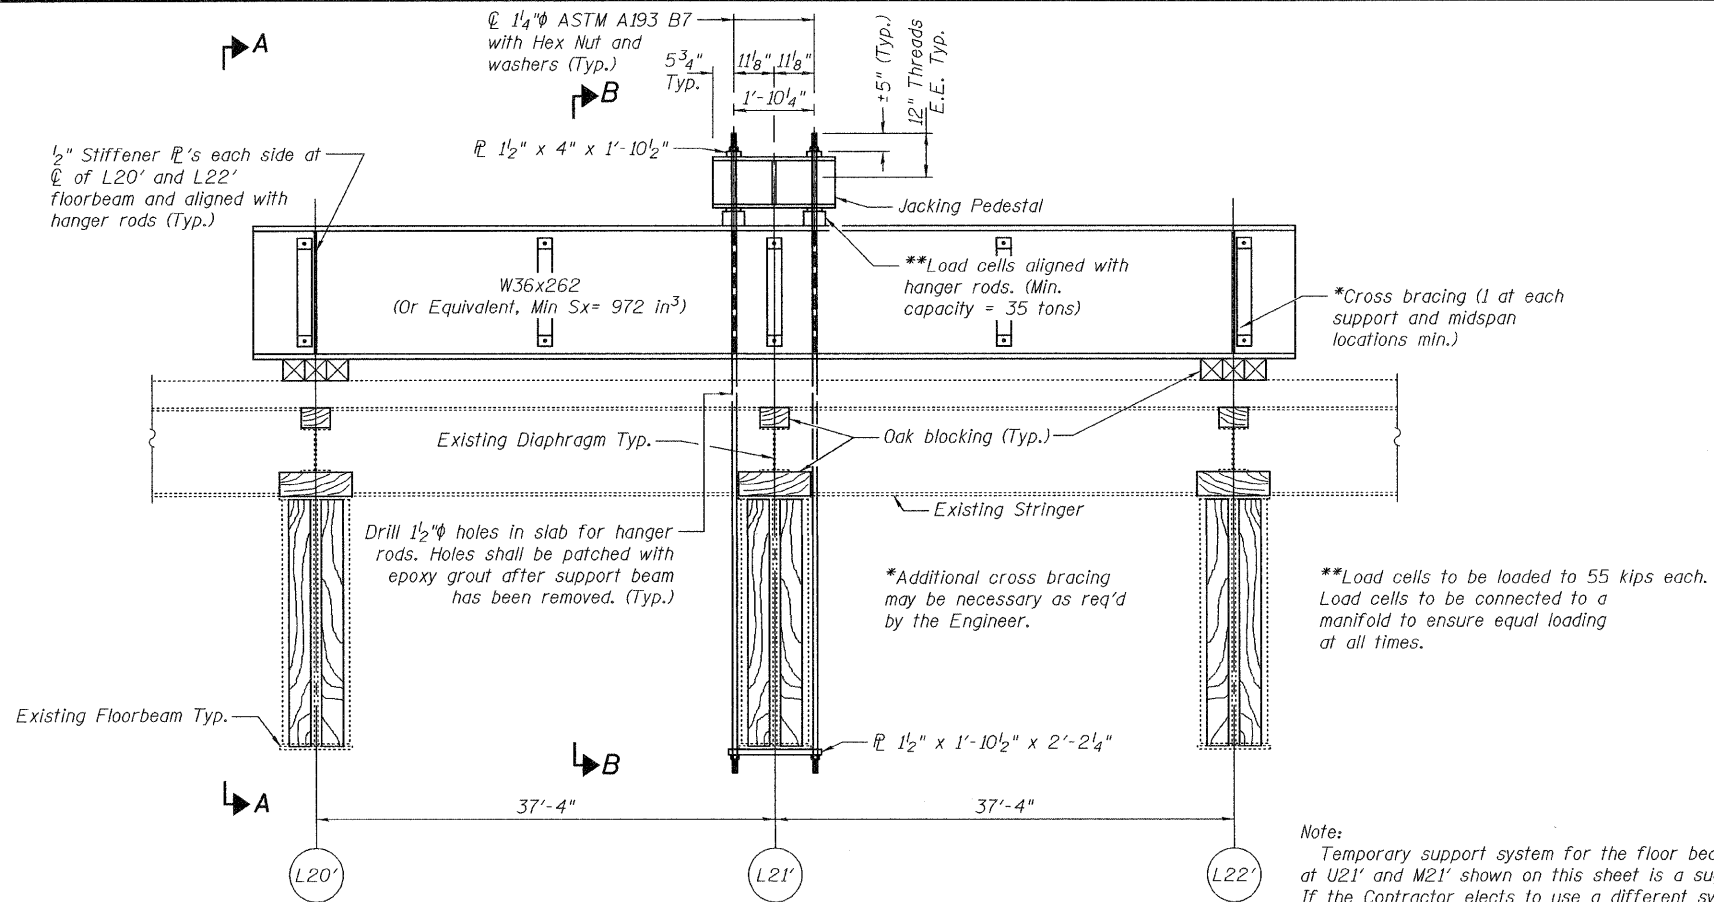
FLOORBEAM TEMPORARY SUPPORT ELEVATION
(Looking West)

Note:
Temporary support system for the floor beam and lower chord at U21' and M21' shown on this sheet is a suggested system. If the Contractor elects to use a different system, plans shall be submitted to the Bureau of Bridges and Structures for approval prior to commencement of the removal and replacement of the damaged vertical member.
