STATE OF ILLINOIS
DEPARTMENT OF TRANSPORTATION

PIER 2 REMOVAL & REPAIRS
STRUCTURE NO. 096 - 0063

F.A.P. RTE.	SECTION	COUNTY	TOTAL SHEETS	SHEET NO.
823	(22BR2)BR	WAYNE	34	33
CONTRACT NO. 74365			ILLINOIS FED. AID PROJECT

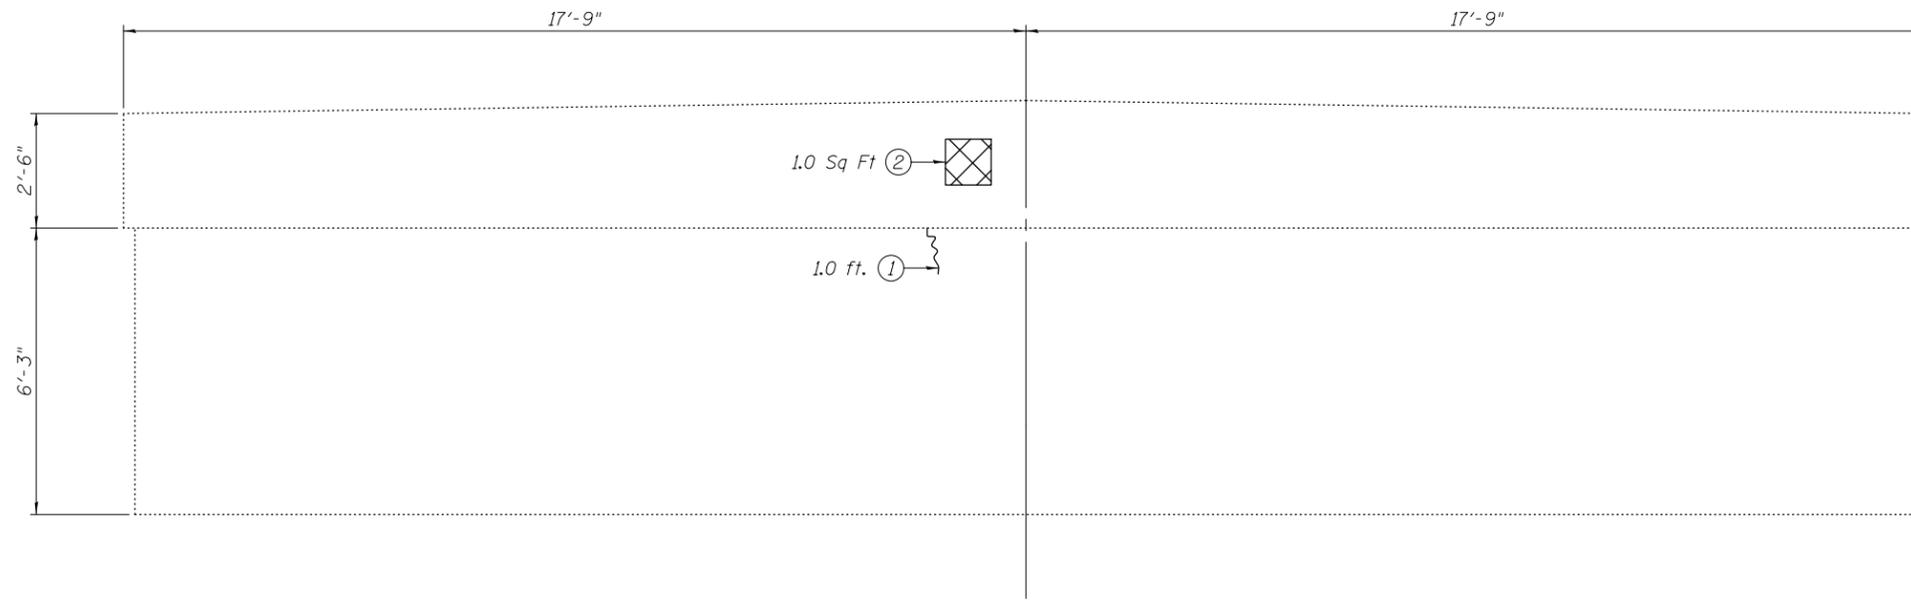
PIER 2 ELEVATION
(West face)

- ① Epoxy Crack Injection
- ② Structural Repair of Concrete (Depth equal to or less than 5 inches)

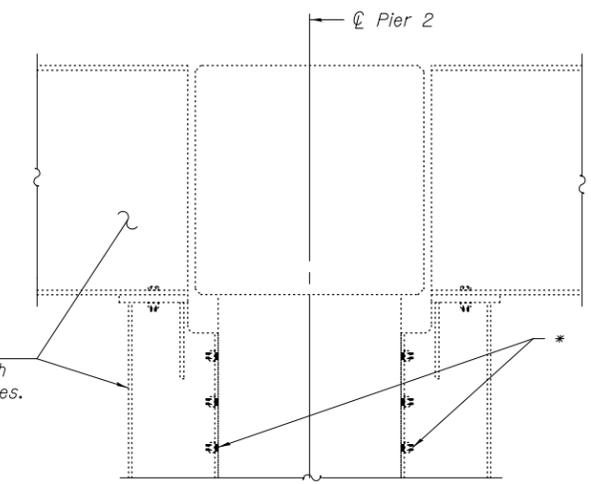
SECTION THRU PIER 2

Existing steel deck beam supports to be salvaged. Cost included with Removal of Existing Superstructures. See sheet 1 of 18.

* Existing grouted bars shall be cut off to existing concrete surface. Grind smooth and seal with epoxy. Cost included with Removal of Existing Superstructures.
